EL17-010

ITB17-015

NAVIGATION SYSTEM REBOOTS WHEN SXM TRAFFIC IS ENABLED

The Navigation system in an Applied Vehicle reboots when SXM Traffic is enabled.

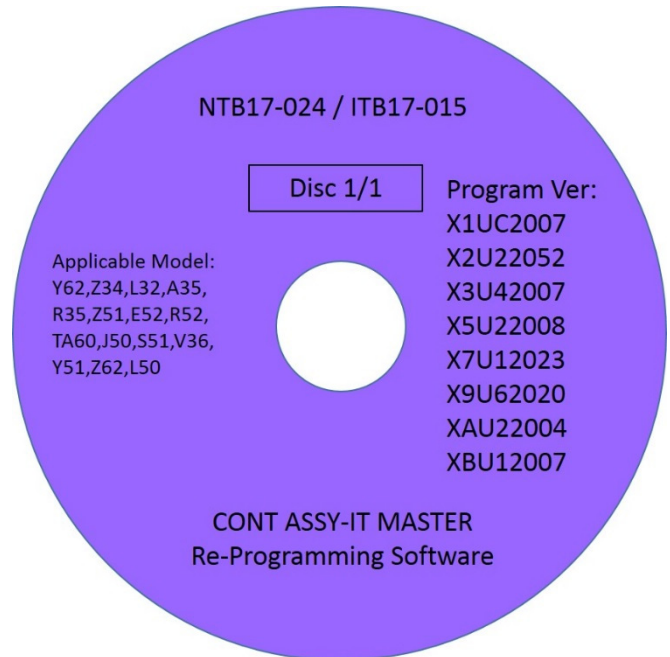
Figure A

Re-programming software DVD required for this procedure:

- Each dealer has been mailed one NTB17-024/ITB17-015 Re-programming Software DVD, free of charge, from Clarion.
- Should you require an additional NTB17-024/ITB17-015 Re-programming Software DVD due to loss or damage, it can be ordered free of charge by contacting Clarion toll free at 1-800-347-8933.

Update the Navigation system software using the DVD shown on page 2.

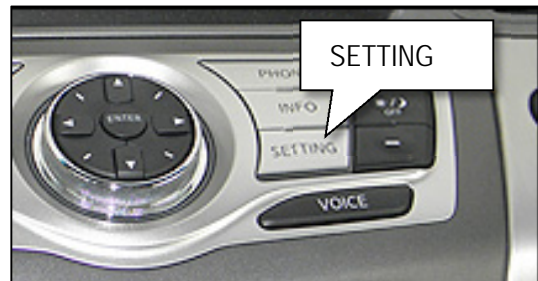
Figure 1

- a. Press the **SETTING** button.

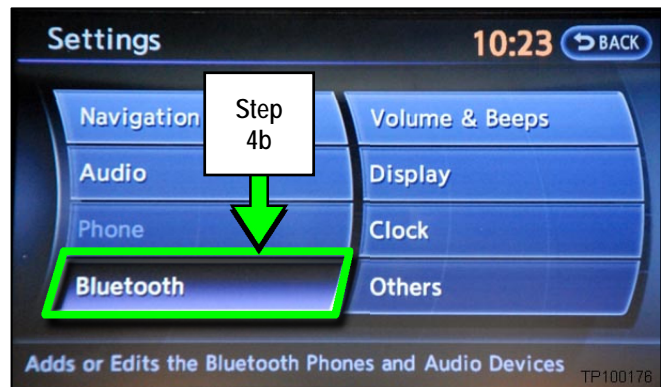
Figure 2

- b. Select **Bluetooth**.

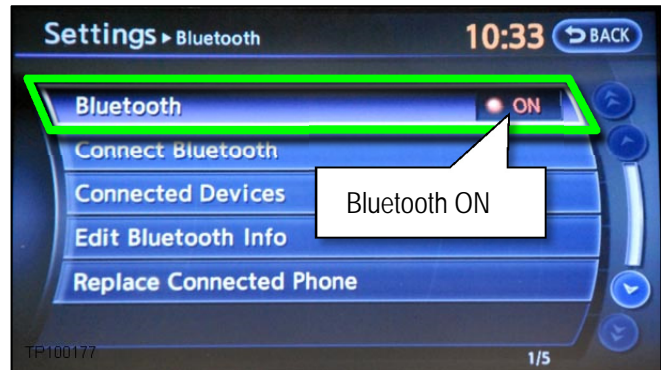
Figure 3

- c. Take note of the current setting (ON or OFF) for Bluetooth. See Figures 3 and 4.

- Bluetooth is ON when the ON indicator displays in orange.

- Bluetooth is OFF when the ON indicator is "grayed" out.

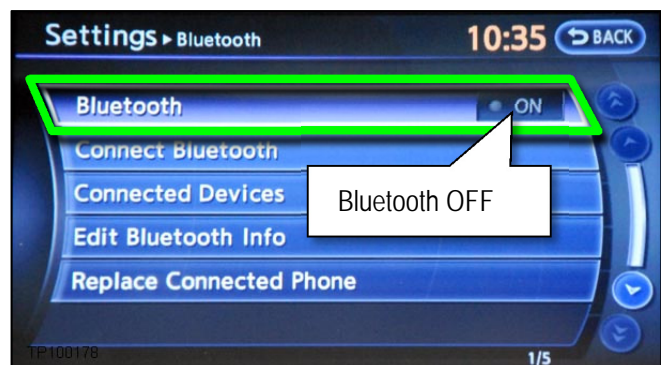
Figure 4

- d. Make sure Bluetooth is OFF.

- Selecting **Bluetooth** will change the setting from ON to OFF or OFF to ON.

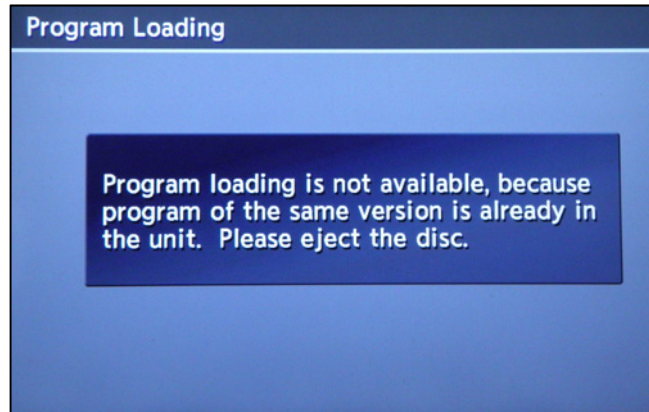
- If the screen in Figure 5 is displayed:
 - Remove the DVD from the CD slot.
 - Proceed to step 15 on page 7.

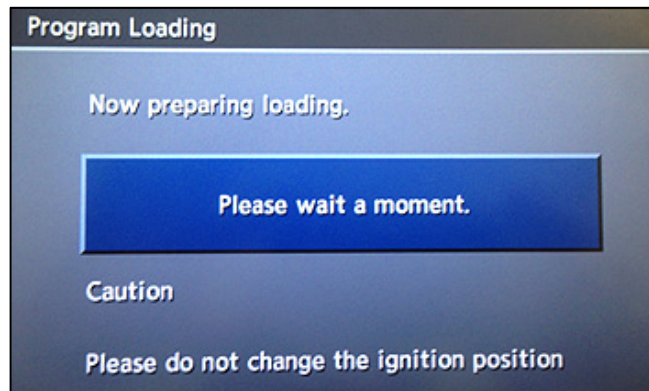
- If "Now preparing loading" shown in Figure 6 is displayed, follow the on screen Caution while the Navigation is updated.

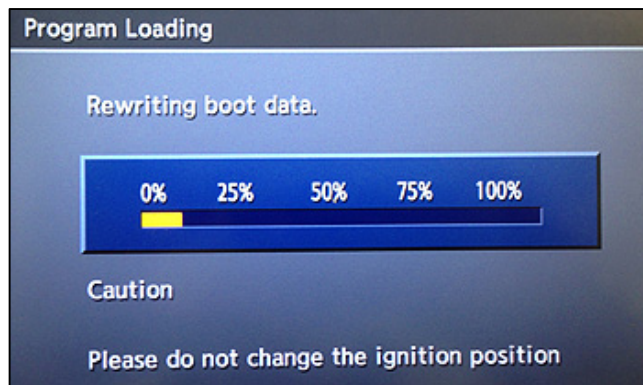
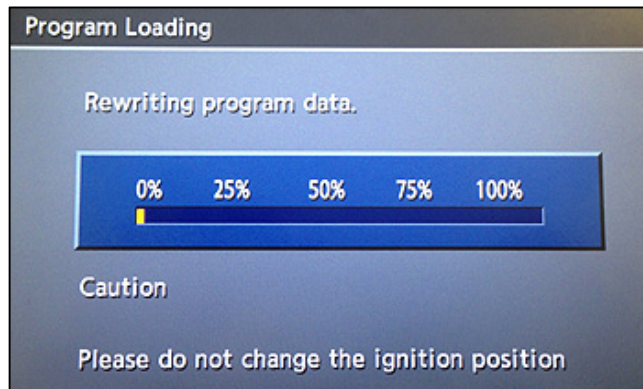
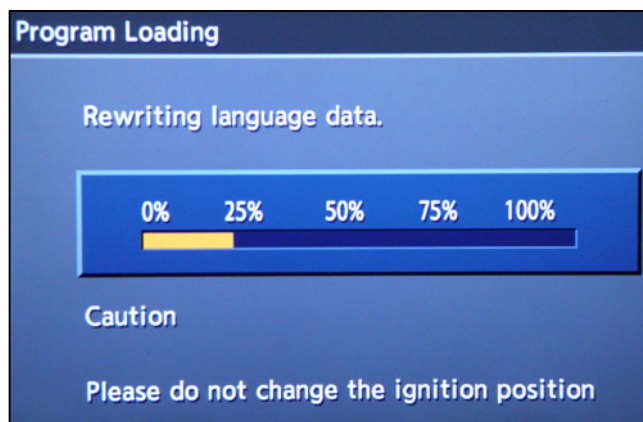
7. During the first part of the update process, 3 more screens will be displayed along with a percentage of completion (progress) bars:

- Rewriting boot data (Figure 7)
- Rewriting program data (Figure 8)
- Rewriting language data (Figure 9)

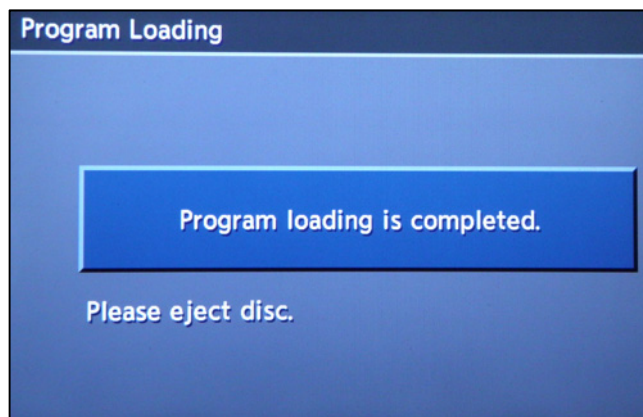
Figure 10

8. When the the program has finished loading:

- "Program loading is completed" will be displayed (Figure 10).
- The Re-programming Software DVD will automatically eject.

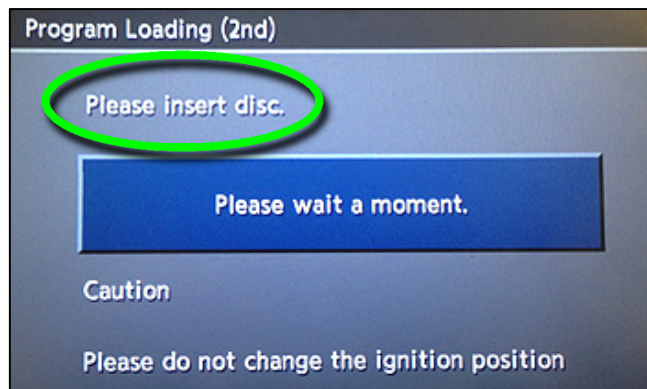
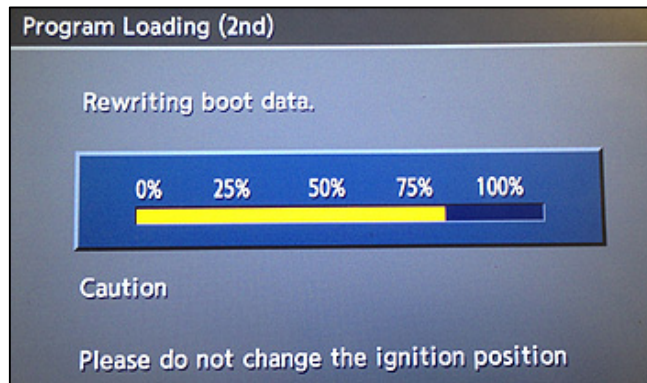
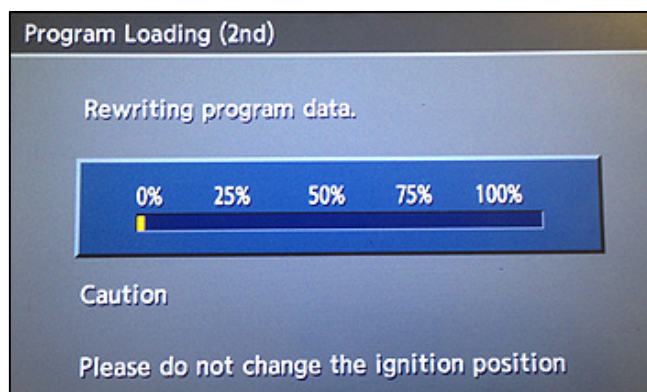
10. After the DVD is removed, the Navigation system will restart and a screen may display a message to "Please insert disc".

- If "Please insert disc" is displayed:
 - Re-insert the same Re-programming Software DVD for a second time.
- If "Please insert disc" is not displayed:
 - Re-programming is complete. Proceed to step 13.

11. "Rewriting boot data" and "Rewriting program data" will be displayed once the DVD is reinstalled.

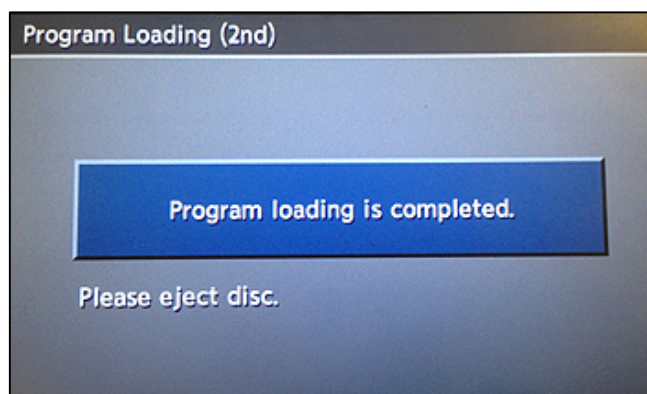
Figure 14

12. After the reprogram has completed:

- "Program loading is completed" will be displayed (Figure 14).
- The Re-programming Software DVD will automatically eject.
- The Navigation system will restart.

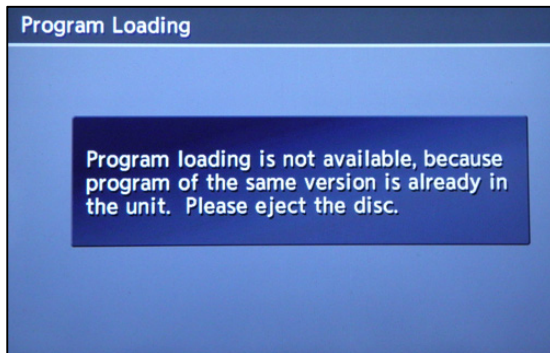
- If Figure 15 is displayed:
 - The re-program has been completed. Proceed to step 14.
- If Figure 16 is displayed:
 - Allow the update to complete (steps 7-12) and follow the on screen instructions, then perform step 13 to confirm the re-program has completed.

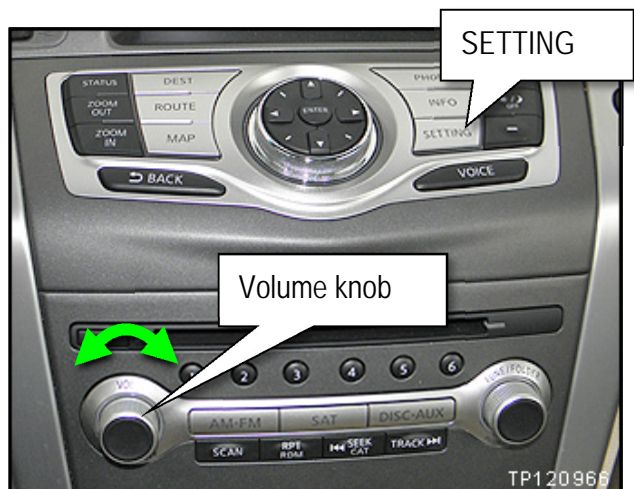
Figure 17

16. Put the AV system into System Diagnostic Mode as follows:

- a. Press and hold the **SETTING** button.
 - b. While holding the SETTING button, turn the volume control knob right and left several times.
- When the system goes into the System Diagnostic Menu, the screen in Figure 18 on the next page will display.

Your vehicle may look different

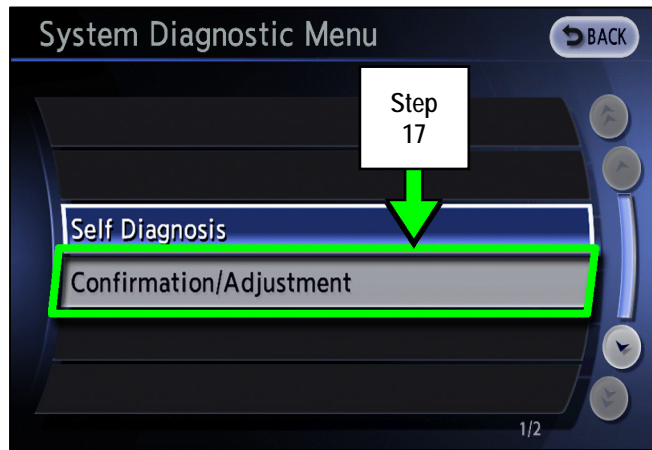
Figure 18

17. Select Confirmation/Adjustment.

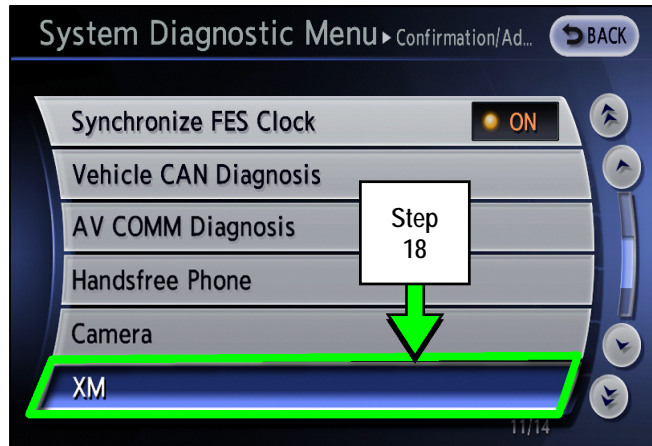
Figure 19

18. Select XM.

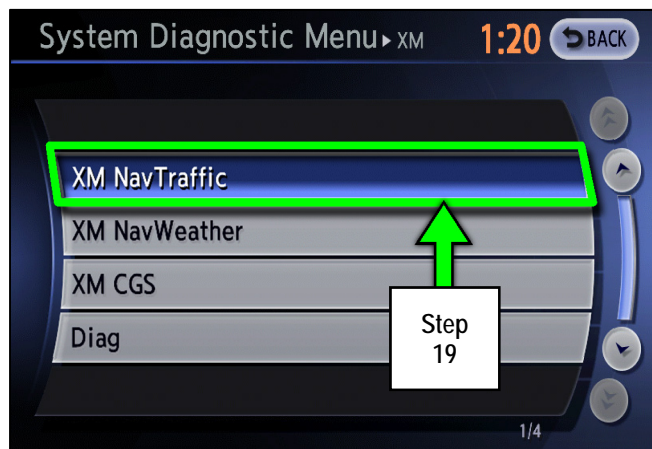
Figure 20

19. Select XM NavTraffic.

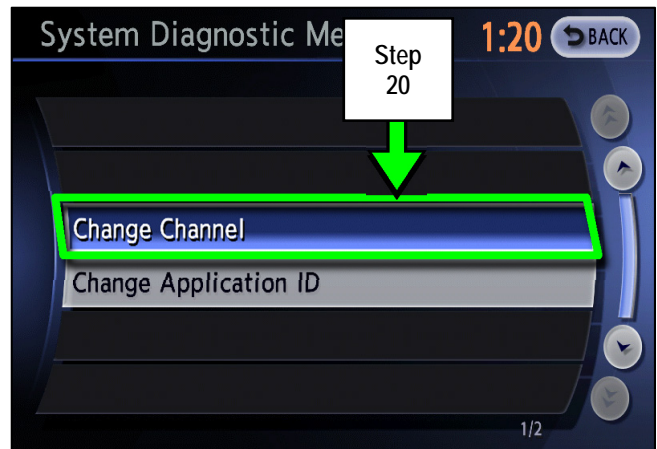
Figure 21

20. Select **Change Channel**.

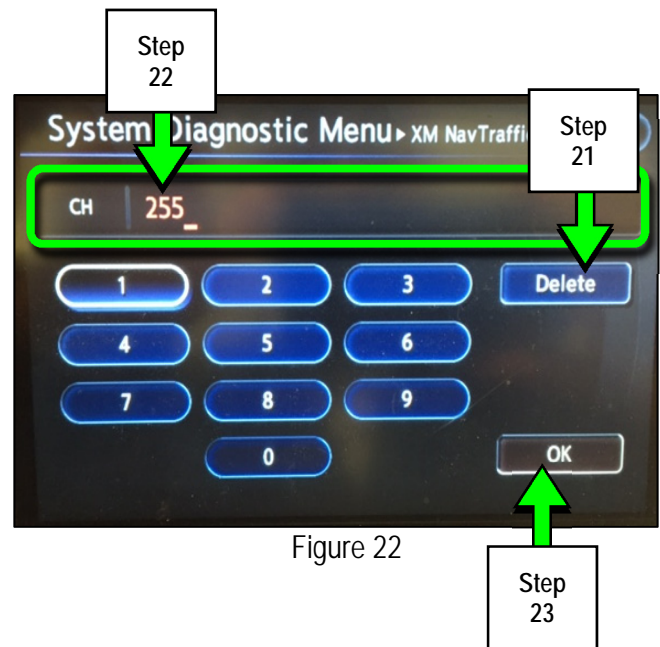
Figure 22

21. Press **Delete** until all numbers entered in the "CH" field are erased.

22. Enter "255".

23. Select **OK**.

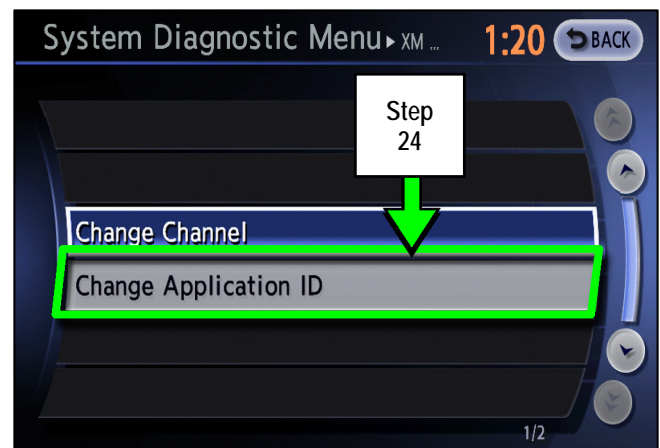
Figure 23

24. Select **Change Application ID**.

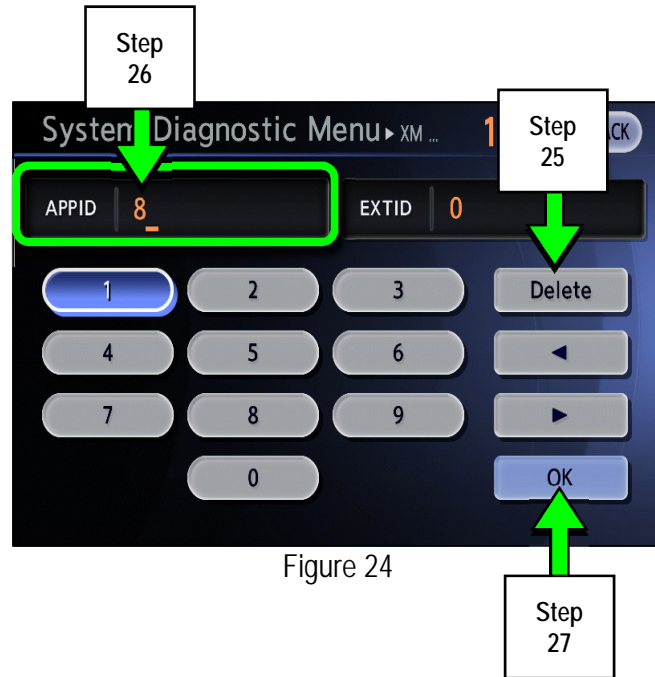
Figure 24

25. Press **Delete** until all numbers entered in the "APPID" field are erased.

26. Enter "8" into the APPID field.

27. Select **OK**.

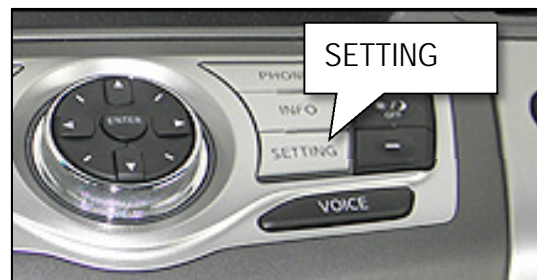
Figure 25

- a. Press the **SETTING** button.

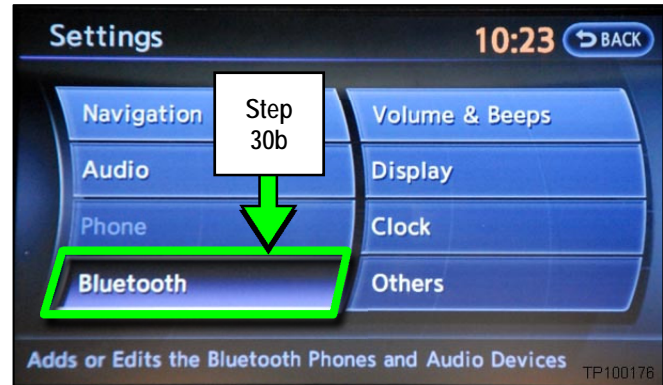
Figure 26

b. Select **Bluetooth**.

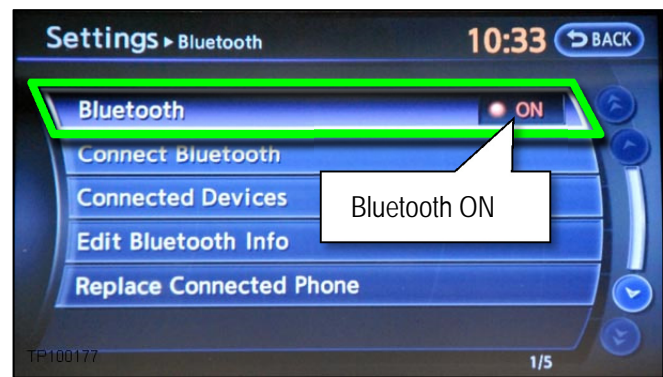
Figure 27

c. Select **Bluetooth** to change the setting to ON.

- Bluetooth is ON when the ON indicator displays in orange.
