WD09 - Re-programming PDK Control Unit (Workshop Campaign)

Vehicle Type: **911 Carrera (991)/911 Carrera 4 (991)
911 Carrera S (991)/911 Carrera 4S (991)**

Concerns: **PDK control unit**

Information: This is to inform you of a voluntary Workshop Campaign on the above-mentioned vehicles. **A shift rod movement at a shift gate that was not selected can be detected incorrectly on the affected vehicles due to a software error.**

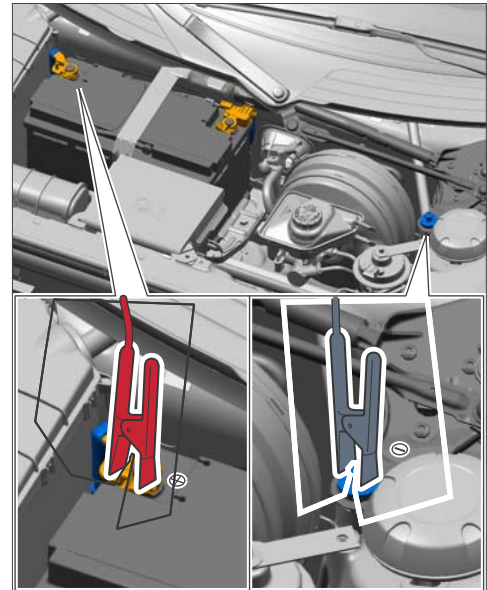
External power supply

- 1 Connect a battery charger or power supply, suitable for AGM type batteries, recommended current rating of 70A fixed voltage 13.5V to 14.5V.
First connect the positive cable of the charger to the positive terminal of the battery and then connect the negative cable of the charger to the ground point for jump-lead starting ⇒ *External power supply*.

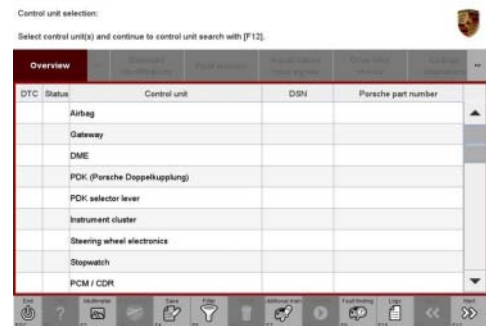
Control unit selection

- 8 Once the control unit has been programmed and coded successfully, press •>>“ to continue.
 - 9 Select the ⇒ **'Overview'** menu and press •<<“ to return to the control unit selection screen ⇒ *Control unit selection*.

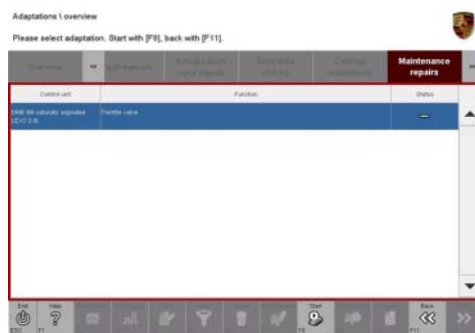
Throttle valve adaptation

- 4 Comply with the displayed preconditions
 - Engine off
 - Ignition on
 - Accelerator pedal not pressed
 - Parking brake on
 and press **•>>** to confirm.
- 5 Select the ⇒ **'Throttle valve'** function so that the corresponding text line turns blue and press **•F8** to start throttle valve adaptation ⇒ *Throttle valve adaptation*.

- 6 Follow the instructions on the PIWIS Tester while throttle valve adaptation is being performed. Once throttle valve adaptation is complete, a tick will appear in the "Value" field on the PIWIS Tester display.

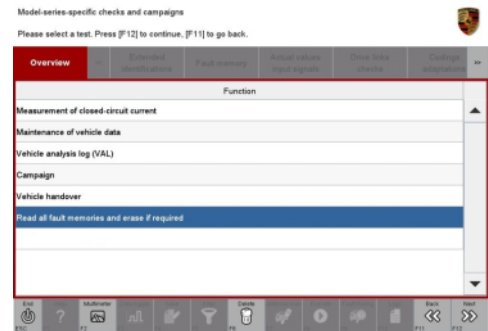
Erasing fault memories

- 1 In the control unit selection screen (⇒ 'Overview' menu), press •F7" to call up the Additional menu.
- 2 Select the function "Read all fault memories and erase if required" and press •>>" to confirm ⇒ *Erasing fault memories*.

- 3 Once you have read out the fault memories, delete the fault memory entries by pressing •F8" .
- 4 Press •F12" ("Yes") in response to the question as to whether you really want to erase all fault memory entries.

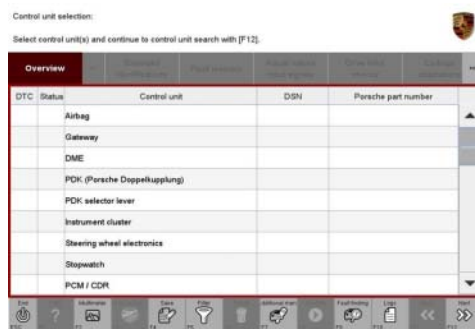
Control unit selection

- Once you have erased the fault memories, select the ⇒ **'Overview'** menu and press •<<“ to return to the control unit selection screen ⇒ *Control unit selection*.
