WC03 - Re-programming Front-end Electronics Control Unit and Rear-end Electronics Control Unit (Workshop Campaign)

Vehicle Type: **911 Carrera (991)/911 Carrera S (991)**

Model Year: **2012**

Concerns: **Front-end electronics control unit
Rear-end electronics control unit**

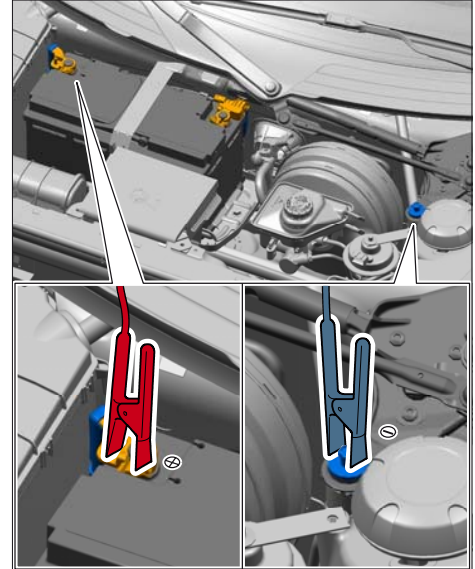
External power connection

- 1 Connect a battery charger with a current rating of **at least 40 A**.
First connect the positive cable of the charger to the positive terminal of the battery and then connect the negative cable of the charger to the ground point for jump-lead starting ⇒ *External power connection*.

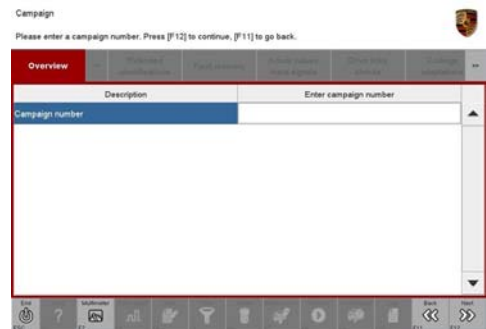
Campaign number input field

- To enter the campaign number, click in the relevant text box so that the cursor starts to flash
⇒ Campaign number input field.

- Enter campaign number **WC03** and confirm your entry by pressing **Enter** .
The text box turns blue.
Press **>>** to start the guided programming sequence.
