**WC27 Re-programming PDK Control Unit (Workshop Campaign)**

Vehicle Type: **911 Carrera (991)/911 Carrera S (991)**

Concerns: **PDK control unit**

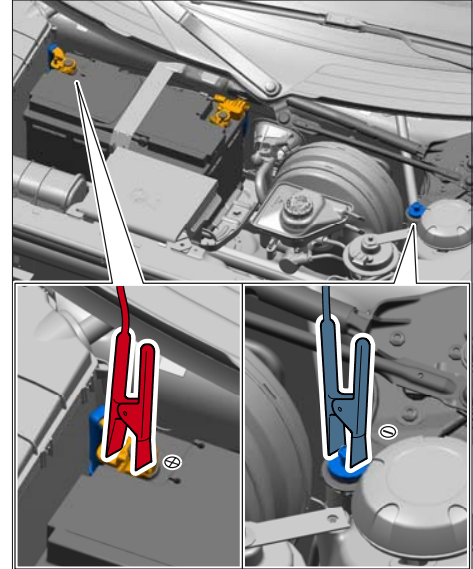
*External power connection*

- 1 Connect a battery charger with a current rating of **at least 40 A**.  
First connect the positive cable of the charger to the positive terminal of the battery and then connect the negative cable of the charger to the ground point for jump-lead starting ⇒ *External power connection*.

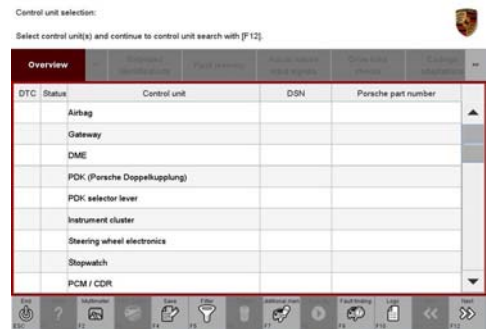
*Control unit selection*

- 8 Once programming is completed successfully, press **>>** to continue.
- 9 Select the ⇒ **'Overview'** menu and press **<<** to return to the control unit selection screen ⇒ *Control unit selection*.

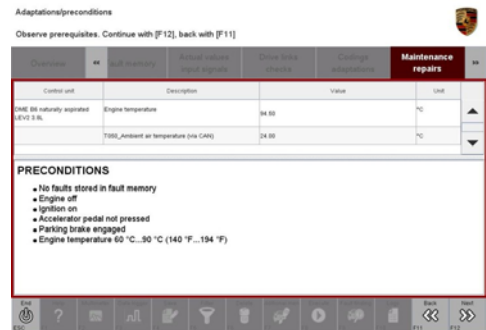
*Adaptations - preconditions*

- 4 Comply with the displayed preconditions and press **[>>]** to confirm ⇒ *Adaptations - preconditions*.

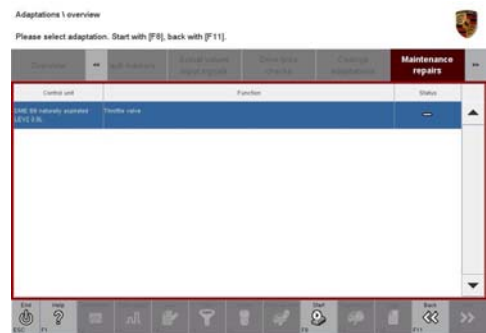
*Throttle valve adaptation*

- 5 Select the ⇒ **'Throttle valve'** function so that the corresponding text line turns blue and press **[F8]** to start throttle valve adaptation ⇒ *Throttle valve adaptation*.

- 6 Follow the instructions on the PIWIS Tester while throttle valve adaptation is being performed. Once throttle valve adaptation is complete, a tick appears in the "Value" field on the PIWIS Tester display. If throttle valve adaptation is **not** completed successfully, adaptation must be **repeated**.
- 7 Press **[F8]** ("Stop") to end throttle valve adaptation.
- 8 Press **[<<]** to return to the start page of the ⇒ **'Maintenance/repairs'** menu.
- 9 Select the ⇒ **'Overview'** menu and press **[<<]** to return to the control unit selection screen.

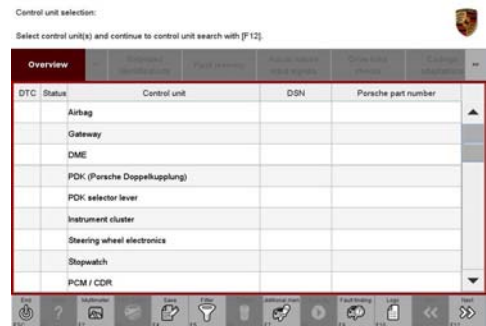
*Control unit selection*

- Once you have erased the fault memories, select the ⇒ **'Overview'** menu and press **<<** to return to the control unit selection screen ⇒ *Control unit selection*.
