WC34 - Re-programming Front-end Electronics Control Unit and Rear-end Electronics Control Unit (Workshop Campaign)

Vehicle Type: 911 Carrera (991)/911 Carrera S (991)

**Concerns: Front-end electronics control unit
Rear-end electronics control unit**

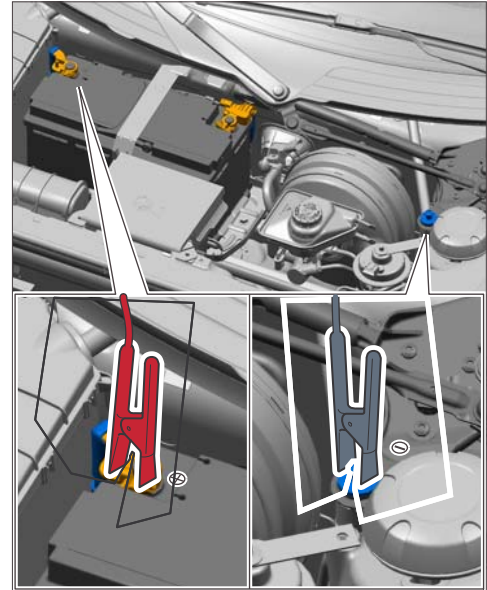
External power connection

- 1 Connect a battery charger with a current rating of **at least 40 A**.
First connect the positive cable of the charger to the positive terminal of the battery and then connect the negative cable of the charger to the ground point for jump-lead starting ⇒ *External power connection*.

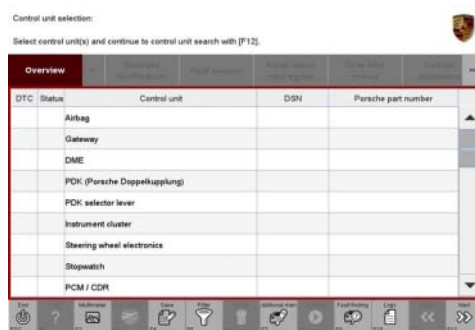
Control unit selection

- 2 In the control unit selection screen (⇒ **'Overview'** menu), press **•F7** to call up the ⇒ **'Additional menu'** (⇒ *Control unit selection*).

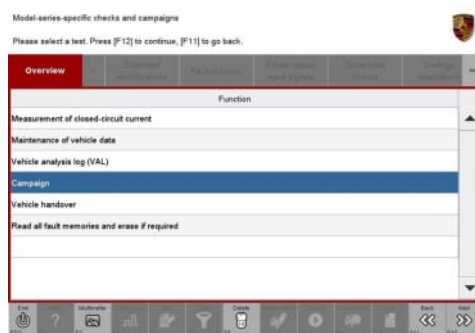
Additional menu – Campaign

- 3 When the question "Create Vehicle Analysis Log (VAL)?" appears, either press **•F12** to create a VAL or press **•F11** if you do not want to create a VAL.
- 4 Press **•>>** to acknowledge the message informing you that campaigns for the vehicle are stored in the PIWIS information system.
- 5 Select the ⇒ **'Campaign'** function and press **•>>** to confirm your selection ⇒ *Additional menu – Campaign*.
