Navigation System Firmware Improvement (Generation 5)

Service Category Audio/Visual/Telematics

Section Navigation/Multi Info Display

YEAR(S)	MODEL(S)	ADDITIONAL INFORMATION
2007 – 2009	LS460	
2008 – 2009	LS600H, LX570

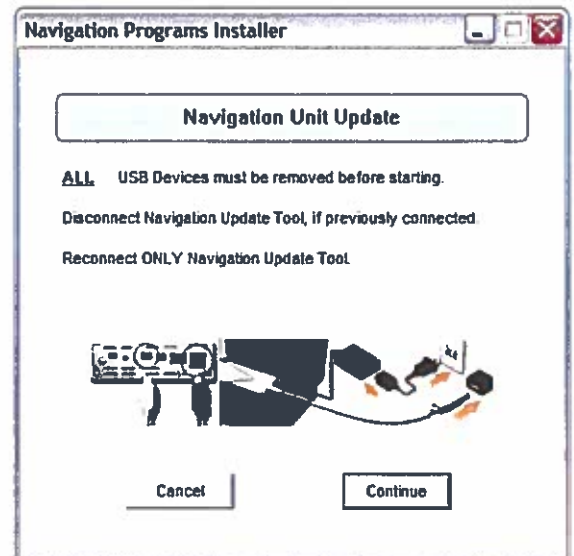
Figure 2.

6. Connect the Navigation Update Tool to the PC using the USB cable.
 - A. Make sure the USB cable is secured in **both** the PC and the Navigation Update Tool USB ports.
 - B. Confirm that the Navigation Update Tool is powered correctly.
 - C. Turn the power ON.
 - D. Click *Continue*.
7. Verify that both the transfer mode display light (green) and power supply display light (blue) are lit, then click *Continue*.

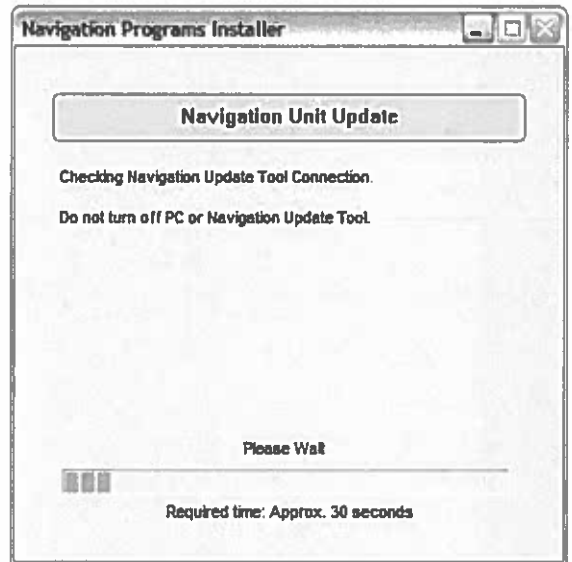
Figure 3.

8. The software will perform a connection check with the Navigation Update Tool. In the event an error is shown, please recheck the USB connection.

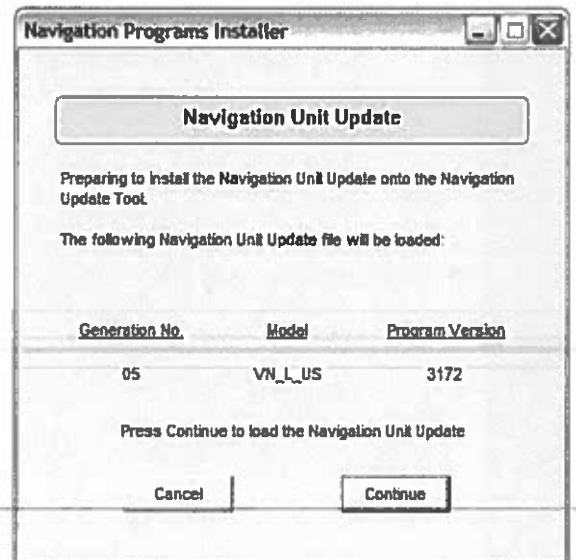
Figure 4.

9. Navigation Firmware is ready to be loaded onto the Navigation Update Tool, click *Continue*.

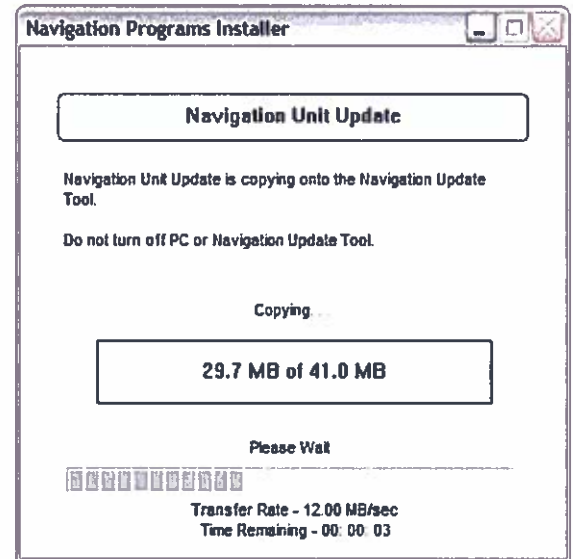
Figure 5.

- Navigation Firmware will now load onto the Navigation Update Tool.

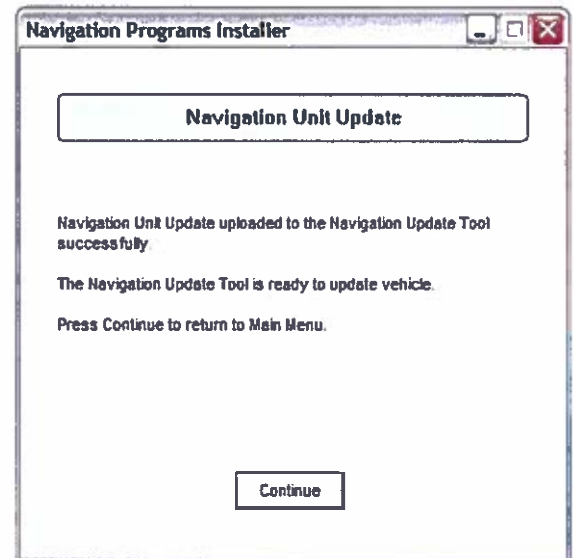
Figure 6.

- Once the Navigation Firmware is successfully loaded onto the Navigation Update Tool, click *Continue* to finish the installer.

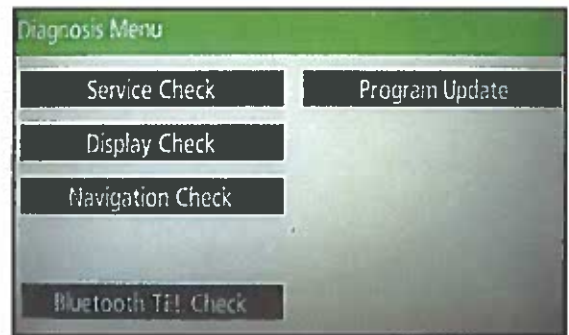
Figure 7.

1. Connect the Navigation Update Tool to the vehicle (tool MUST be disconnected from the PC).
2. Connect the GR8 Battery Diagnostic Station to the vehicle.
3. Press the "ENGINE START STOP" switch two times with the brake pedal released to cycle the ignition ON (Engine/Hybrid system OFF), and wait for the *Caution* screen to appear on the navigation display.
4. Press the *MAP* button, wait for the map to appear.
5. Hold down the *INFO* button and rotate the headlamp stalk switch ON and OFF 3 or more times until the navigation system enters the diagnostic mode.
6. Select *MENU* on the upper right side of the multi-display screen.
7. Select *Program Update*.

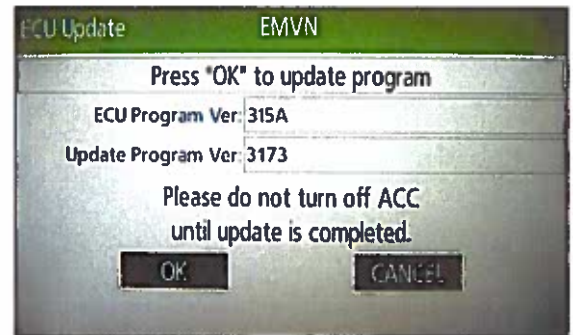
Figure 9.

10. When the *EMVN* screen is shown, select *OK*.

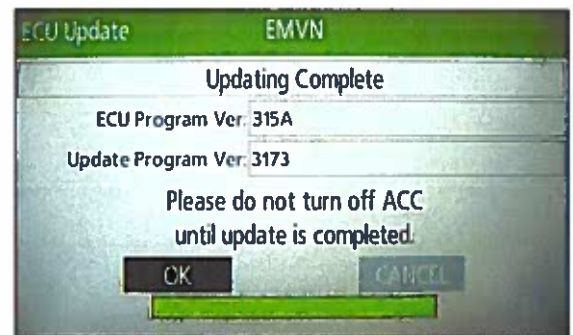
Figure 10.

11. After about 1 minute, if the update was successful the display will indicate *Updating Complete* at the top of the screen. Select *OK* to continue.

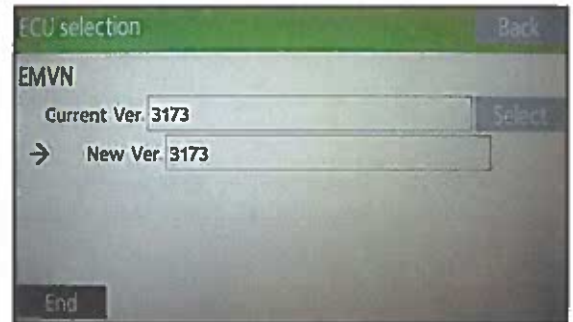
Figure 11.

12. Confirm the Current Version reads "3173," then select *End* to complete the procedure.

NOTE
 If the Current Version is NOT "3173," then turn ignition OFF and start again at step 1 of the programming procedure.

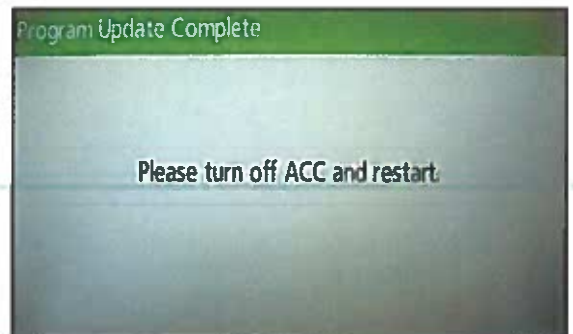
Figure 13.

14. Cycle the Ignition OFF to finish the updating procedure.
