Techstream ECU Flash Reprogramming Procedure

Service Category Engine/Hybrid System

Section Emission Control

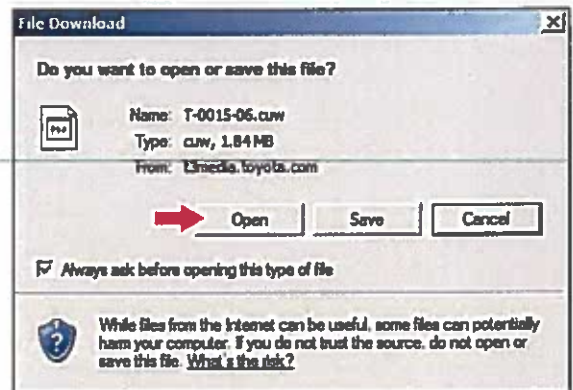
Figure 9.

- B. Click *Open* to load calibration file information.

Techstream pulls calibration files as needed to ensure the latest calibration file is used. Do NOT save calibrations locally on the hard drive or other media.
