## TECHNICAL SERVICE BULLETIN

**SUBJECT:** SERVICE ACTION: NAVIGATION UNIT SOFTWARE  
UPGRADE (SA172)

This bulletin provides the procedure for upgrading the navigation system software of some Sedona (YP), Soul (PS) and Optima (QF) vehicles to resolve concerns related to no sound coming from the head unit after ending a Bluetooth call. Kia is requesting the completion of this Service Action on all affected vehicles. Before conducting the procedure, verify that the vehicle is included in the list of the affected VINs.

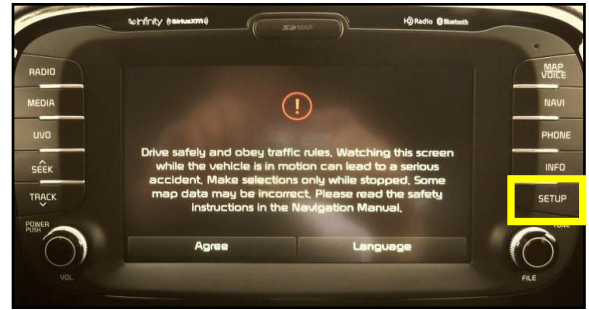
4. Press the **SETUP** button.

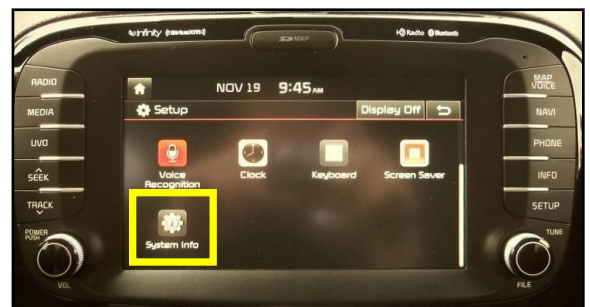
5. Scroll to the bottom of the screen and touch **System Info**.

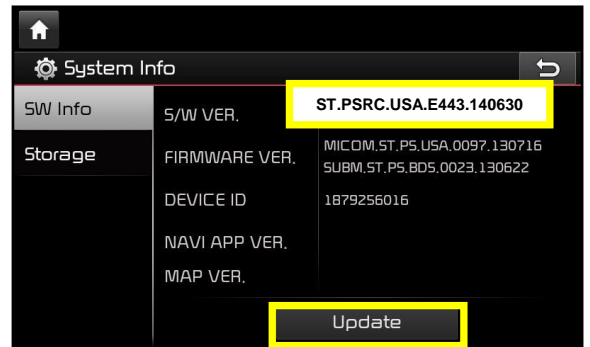
6. Compare the original software version to the versions shown in the table below and press **Update**.

Model	Original Software Version
Sedona (YP)	ST.YP.USA.E445.140708
Soul (PS)	ST.PSRC.USA.E443.140630
Optima (QF)	ST.TF.USA.E443.140630

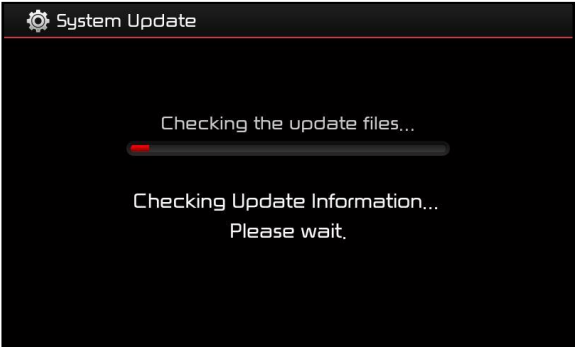
- 7. The upgrade screen will be displayed and the system will install multiple updates.

**\* NOTICE**  
**Do NOT turn the vehicle OFF while the update is in progress.**

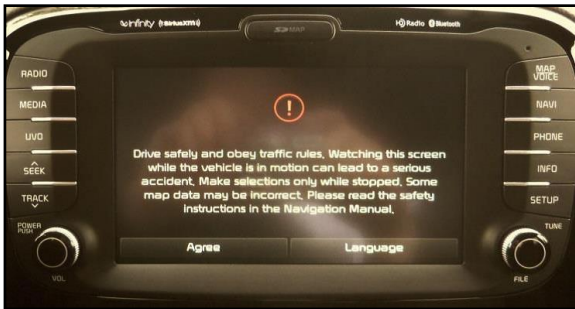
- 8. If the updates are completed successfully, the display will turn off. Once the Kia logo is displayed on the screen, cycle power to the navigation system by pressing the ON/OFF button.

**\* NOTICE**  
**If the AVN update fails, turn the ignition OFF and restart the procedure from step 1.**

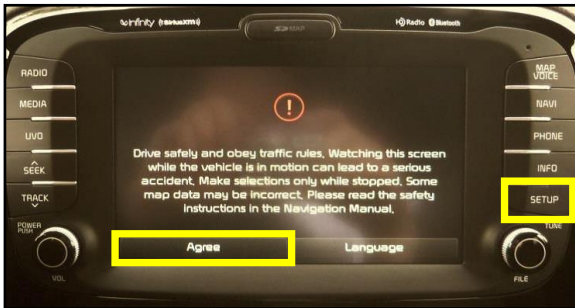
- 9. Remove the upgrade SD Card and reinstall the original map SD Card. Allow the system to reboot and press the **Agree** button on the screen. Then, touch the **Setup** button.

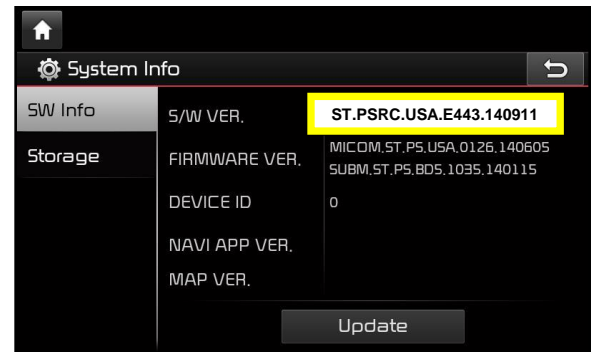
10. Touch the **System Info** button on the screen and verify the software version by referring to the information on the table below.

Model	New Software Version
Sedona (YP)	ST.YP.USA.E445.140904
Soul (PS)	ST.PSRC.USA.E443.140911
Optima (QF)	ST.TF.USA.E443.140911
