MODEL
2014MY Soul (PS)
2014MY Sorento (XMa)
2014MY Optima (TF/QF)
2014MY Forte (YD)
2014MY Sportage (SL)
2014MY Rio (UB)

NUMBER
101 (Rev 3,
04/17/2017)

TECHNICAL SERVICE BULLETIN

SUBJECT: BASE AUDIO SYSTEM UPGRADE

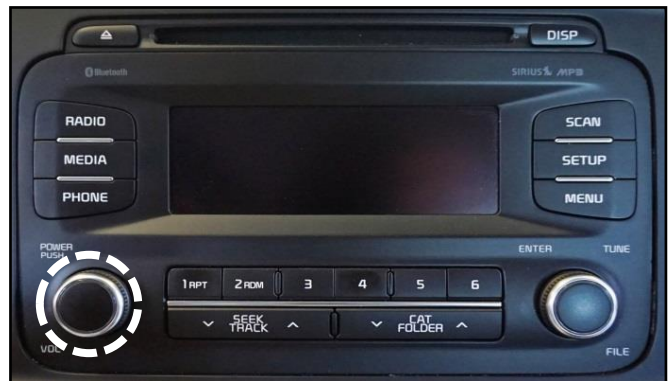
1. Start the vehicle or connect the Midtronics GR8-1299 charger.
2. Record the customer's radio presets before performing the upgrade.
3. Turn the head unit OFF.

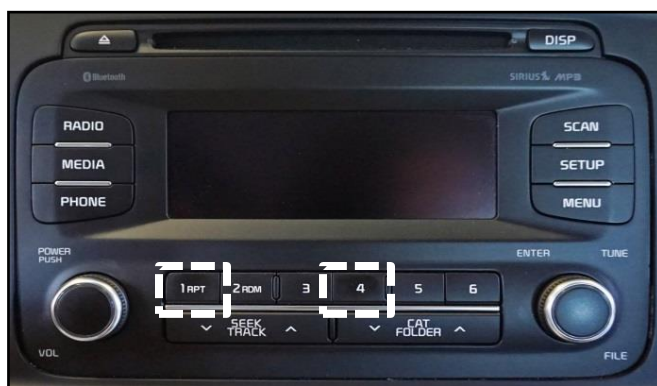
- Press and hold preset button “1” and then preset button “4” and continue to hold both for five (5) seconds.
For the **Rio (UB)**, press and hold preset button “1” and then preset button “5” and hold both for five (5) seconds.

If the software version screen is displayed when pressing and holding the preset buttons “1” and “4” only, restart the procedure from step 3.

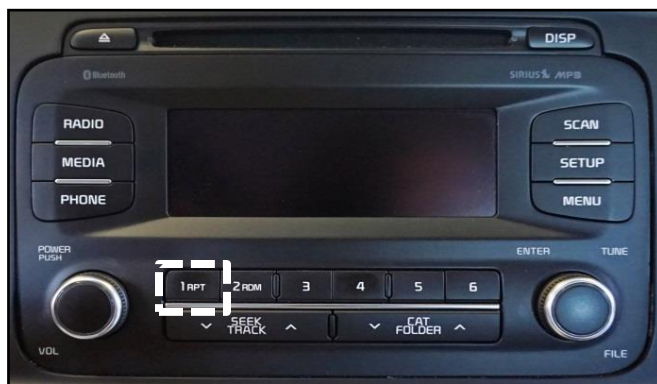
- Immediately after releasing preset buttons “1” and “4”, press preset button “1” four (4) times in a row quickly within half a second.
For the **Rio (UB)**, immediately after releasing preset buttons “1” and “5”, press preset button “1” four (4) times in a row quickly within half a second.

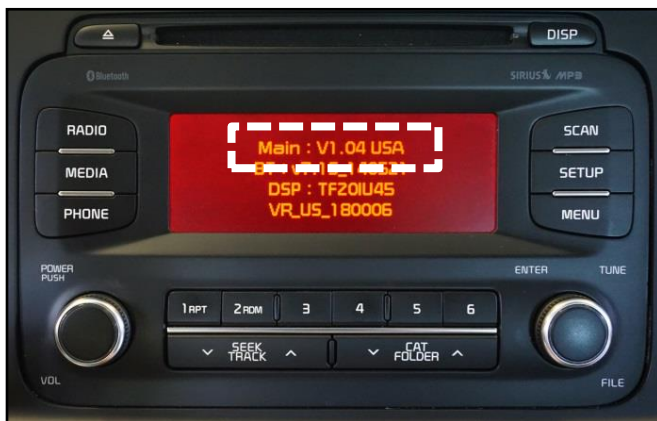
- Check the software version and verify that it matches the versions below:

Model	Current Version
Sorento (XMa) 3.3V	V1.01 or higher
Sorento (XMa) 8V	V1.04 or higher
Forte (YD) 8V	V1.05 or higher
Optima (TF/QF) 8V	V1.00 or higher
Soul (PS) 8V	V1.00 or higher
Sportage (SL) 3.3V	V1.03 or higher
Rio (UB) 3.3V	V1.07 or higher

If it matches, continue to the next step.
If it does not match, contact Techline.

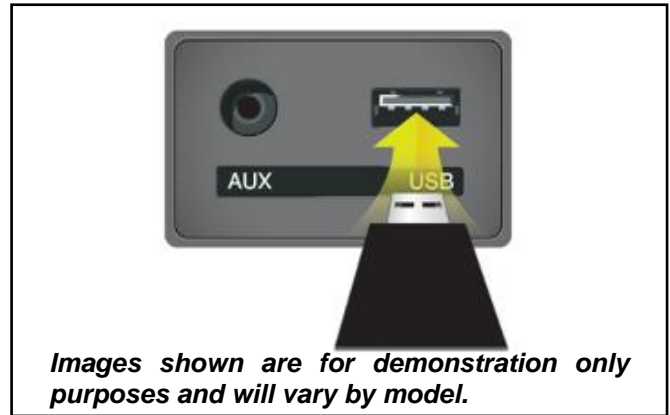
8. If performing the upgrade using a USB stick, with the S/W version screen displayed, obtain the USB stick labeled **14MY Audio Upgrade USB Drive** (red or blue) from your Service Manager and insert it in the vehicle's USB port.

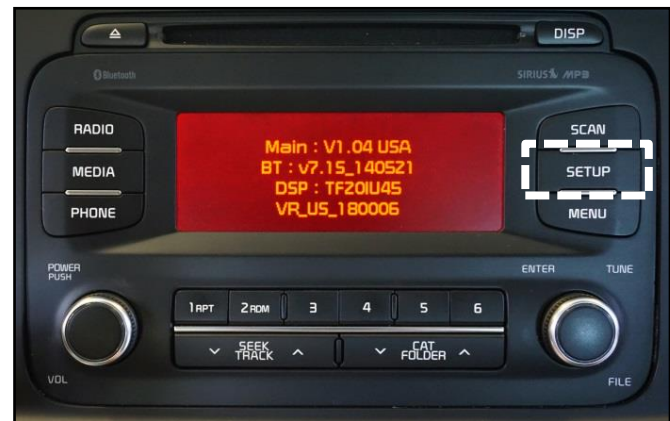
9. Press the **SETUP** button.

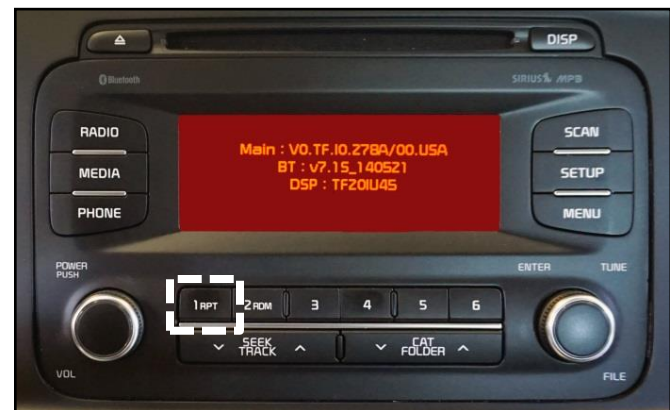
10. Press preset button "1" to display the firmware upgrade menu.

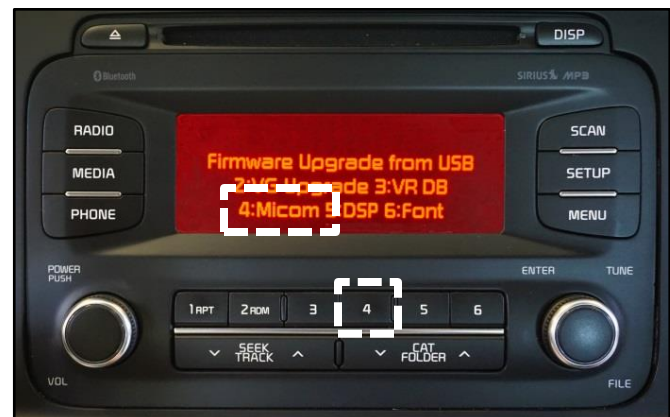
11. Once the Firmware upgrade menu is displayed, press preset button "4" to update **MICOM**.

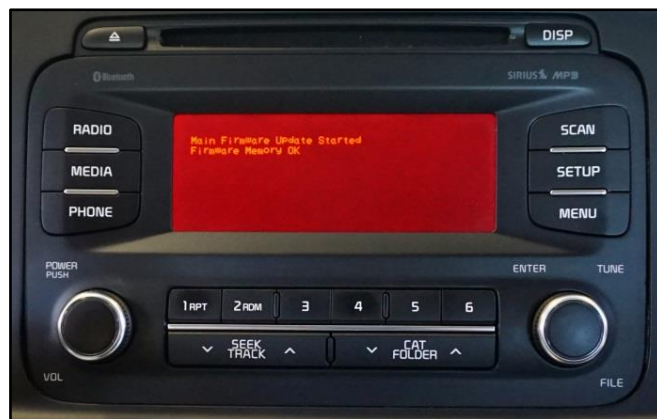
12. In some cases, the firmware upgrade (1/2) will begin and system will display the progress on the screen. Once the upgrade is complete, the head unit will automatically reset and then turn off. Monitor this part of the upgrade to ensure the second upgrade begins (see step 13 below).

The firmware update will take approximately three (3) minutes to complete. Do NOT remove the USB or turn the radio or vehicle OFF while the update is in progress.

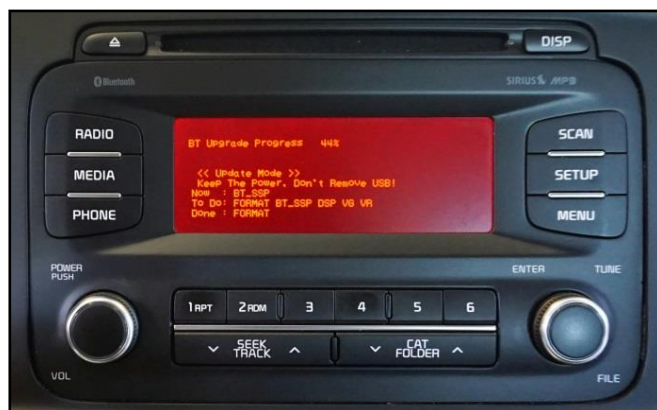
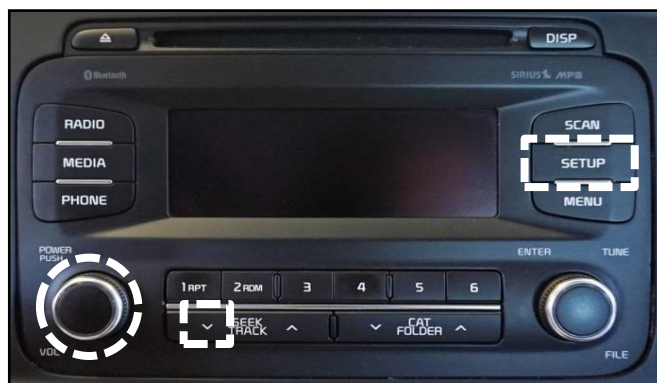
13. In some cases, the upgrade (2/2) will automatically begin and system will display the progress on the screen. Once the upgrade is complete, the head unit will automatically reset and then turn off.

On other vehicles, the upgrade (2/2) will not automatically begin. Turn off the head unit, press and hold **SEEK DOWN V** and then press **SETUP** and continue to hold both for two (2) seconds or more and then release.

The upgrade will proceed to "Format → Font → BT → DSP → VG → VR".

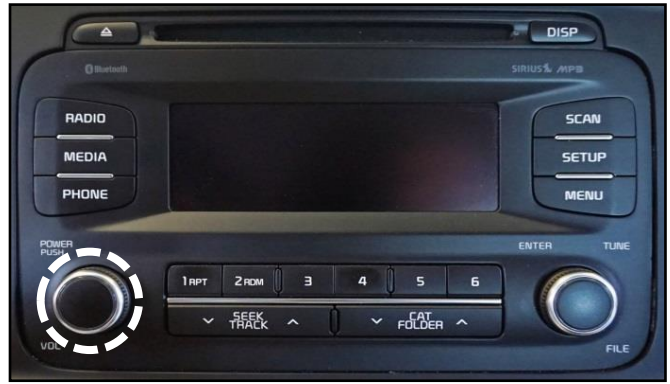
- 14. Once the upgrade is complete, an “Update Complete” message will display. Press the power button to restart the unit.

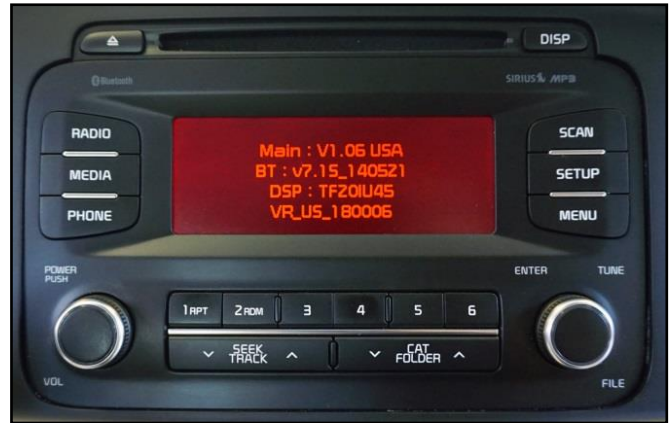
- 15. Verify that the software upgrade is successful by checking the software version by following software inspection procedure steps 3 to 6 starting on page 2 of this bulletin and confirming the “After” software version matches the table below. If update is not successful, restart the procedure from step 3.

Model	Mic Type	Before	After
UB	3.3V	V1.07 or higher	V1.10
YD (4DR)	3.3V	V1.02 or higher	V1.07
YD (4DR)	8V	V1.05 or higher	V1.07
YD (2DR)	8V	V1.05 or higher	V1.07
YD (5DR)	8V	V1.05 or higher	V1.07
QF/TF	8V	V1.00 or higher	V1.06
PS	8V	V1.00 or higher	V1.04
XMa	3.3V	V1.01 or higher	V1.06
XMa	8V	V1.04 or higher	V1.06
SL	3.3V	V1.03 or higher	V1.07
