K437NAS2

**TECHNICAL BULLETIN**

**SECTION:**415-00

**SUBJECT/CONCERN:**Service Action: InControl Touch Pro Phase 2.5 Software Update

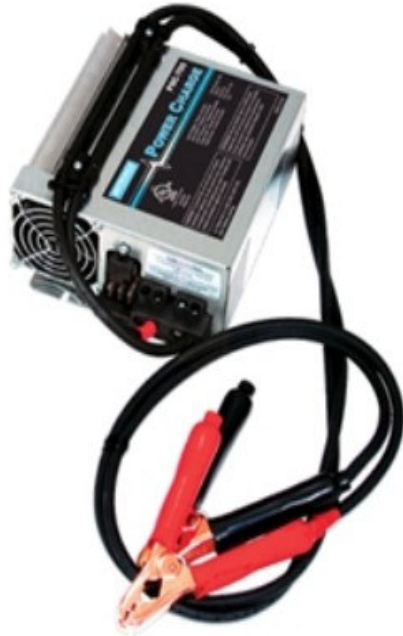
E192494

Jaguar Land Rover-approved Midtronics Battery Power Supply

- **Battery support unit:** it is extremely critical to use a battery support unit and have a vehicle with a battery that has a good state of health to start. The battery support unit must also be in proper working condition to be able to supply 13v consistently. If the voltage is compromised during the installation of software, the IMC may switch off.
