Entune Audio Head Unit Software Update (Panasonic)

Service Category Audio/Visual/Telematics

Section Audio/Video

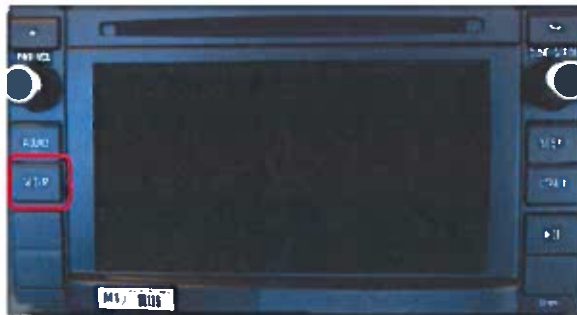
Figure 3. 4Runner, Highlander, Highlander HV, Sequoia, Tacoma & Tundra

2. Insert the USB Drive SST into the vehicle USB port.
3. Start the engine.
4. Go to the *Setup* screen.
 - A. **For Entune™ Audio:**
Press the *SETUP* button on the panel.

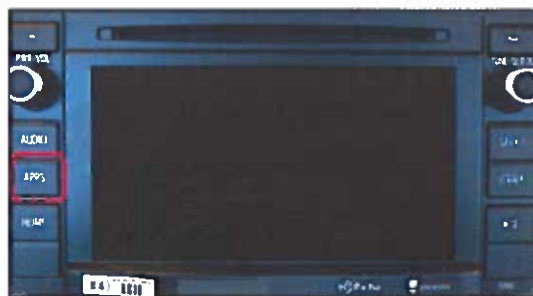
Figure 5. 4Runner, Highlander, Highlander HV, Sequoia, Tacoma & Tundra

- (1) Press the *APPS* button on the panel.

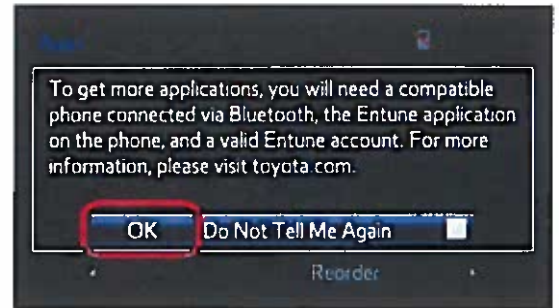
Figure 7.

If Entune™ pop-up displays, select **OK**.

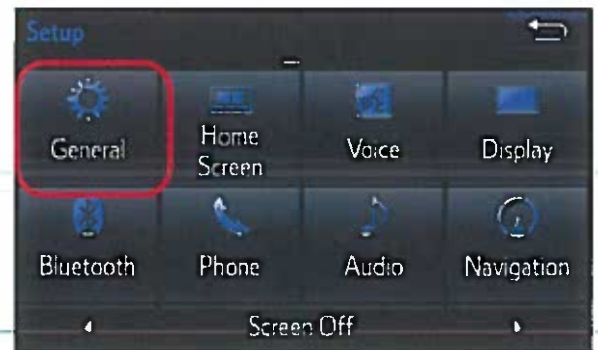
Figure 9.

5. Select *General* on the *Setup* screen.

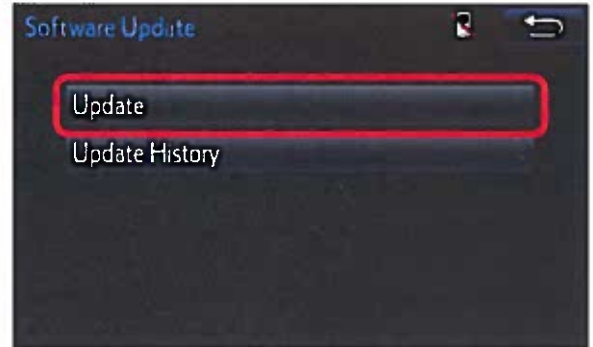
Figure 11.

7. Select *Update* on the *Software Update* screen.

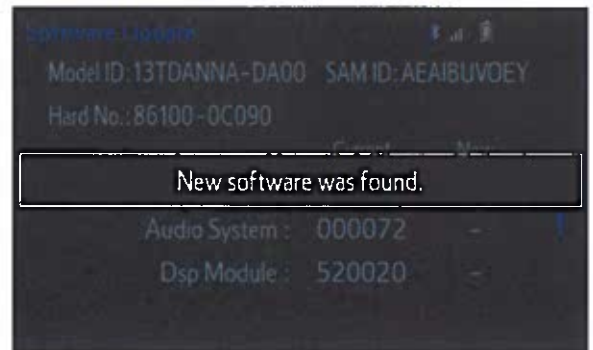
Figure 12.

If software has been detected properly, a "New software was found." pop-up will be displayed.

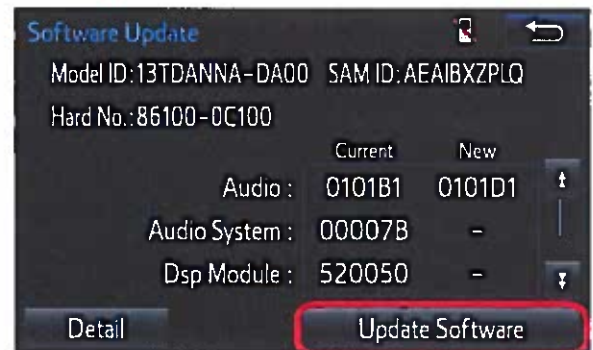
Figure 14.

9. Select *Update Software* on the *Software Update* screen.

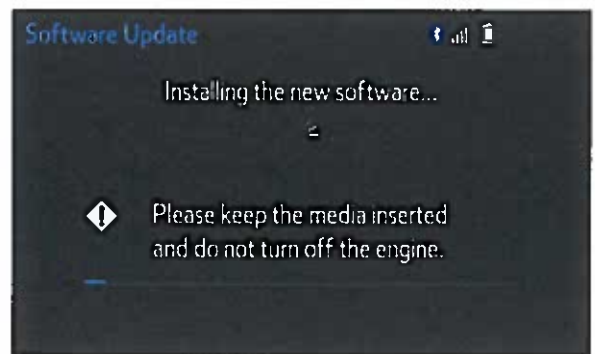
Figure 16.

11. The unit begins installation. The update will take about 10 minutes.

- Do NOT turn off the engine or ACC before the software is ready for updating.
- Do NOT pull the USB Drive SST out of the vehicle USB port.

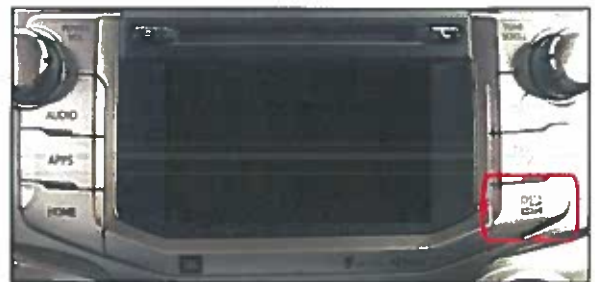
Figure 17.

If update fails and the error message “New software is not compatible with the system.” displays, cycle the ignition OFF, remove the Map Micro SD Card from the head unit, and repeat steps 2 – 11.

Software update error is more likely to occur in areas with more traffic information.

Once update is complete, reinsert the Map Micro SD card into the head unit, cycle the ignition OFF, and proceed to step 13.

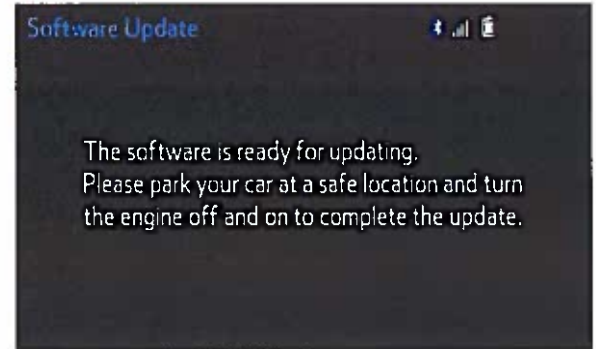
Figure 18.

12. When "*The software is ready for updating.*" displays, cycle the ignition OFF.
