SERVICE BULLETIN

Classification: EC17-013	Reference: NTB17-061	Date: June 8, 2017
-----------------------------	-------------------------	-----------------------

2016-2017 TITAN XD; DELAY WITH RE-ACCELERATION

APPLIED VEHICLES: 2016-2017 Titan XD (A61)
APPLIED VIN & DATE: 2016 Titan XD: All
2017 Titan XD:
Built before: 1N6BA1(***)HN 541181 // March 27, 2017
APPLIED ENGINE: Cummins 5.0L V8 Diesel

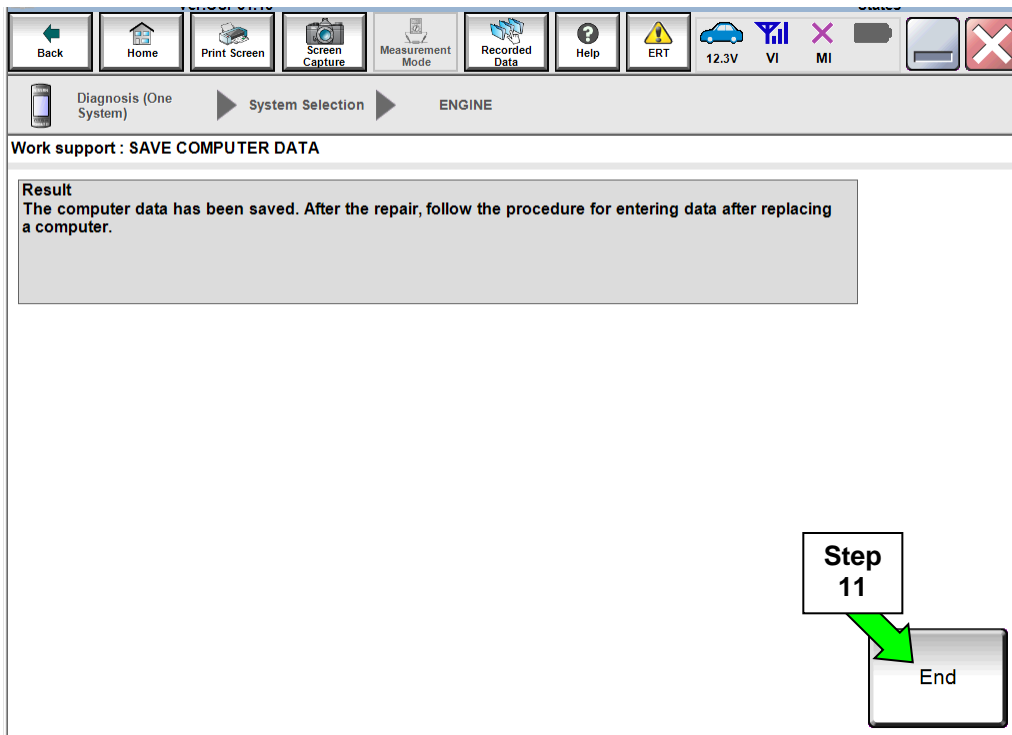
Figure D

11. Select **End**.

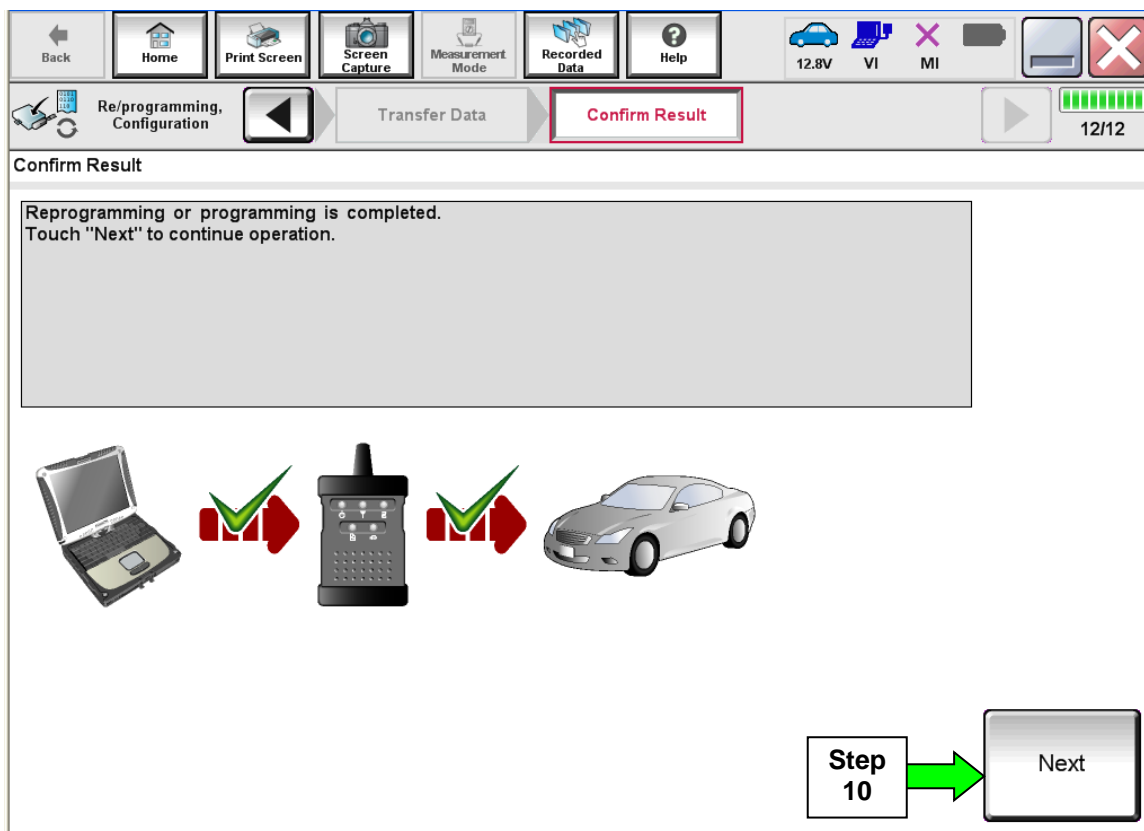
8. When the screen in Figure 4 displays, reprogramming is complete.

NOTE: If the screen in Figure 4 does not display (indicating that reprogramming did not complete), refer to ECM recovery on the next page.
