JTB00413NAS1

TECHNICAL BULLETIN

Engine MIL Illuminated With DTC P008B Stored

MODEL:	MODEL YEAR:	VIN:	ASSEMBLY PLANT:	APPLICABILITY:
XE (X760)	2017 Onwards	Y00008 Onwards	Castle Bromwich	GTDi 2.0L Petrol
XF (X250)	2013-2015	S61362-U88785	Castle Bromwich	GTDi 2.0L Petrol

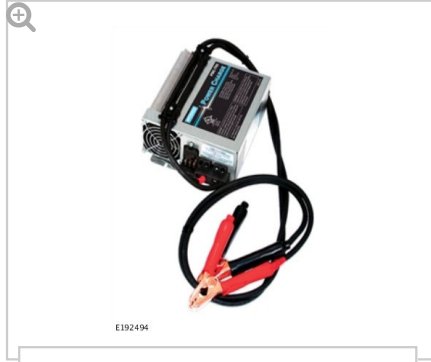
Jaguar Land Rover-
approved Midtronics
battery power supply

- **A Jaguar Land Rover-approved Midtronics battery power supply must be connected to the vehicle battery during diagnosis / module programming.**
- **Make sure all ignition ON/OFF requests are carried out; failure to perform these steps may cause damage to control modules in the vehicle.**
