WE30 - Re-programming DME Control Unit (Workshop Campaign)

Model Year: **As of 2013 up to 2015**

Model Line: **911 Carrera (991)**

Concerns: **DME control unit**

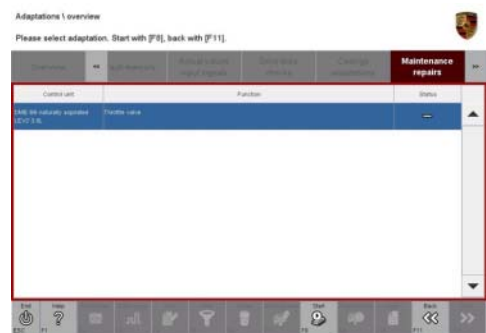
Throttle valve adaptation

- 4 Comply with the displayed preconditions
 - Engine off
 - Ignition on
 - Accelerator pedal not pressed.
 - Parking brake on
 and press **•>>** to confirm.
- 5 Select the **'Throttle valve'** function so that the corresponding text line turns blue and press **•F8** to start throttle valve adaptation **⇒ Throttle valve adaptation**.

- 6 Follow the instructions on the PIWIS Tester while throttle valve adaptation is being performed. Once throttle valve adaptation is complete, a tick will appear in the "Value" field on the PIWIS Tester display.

- 7 Press •F8" ("Stop") to end throttle valve adaptation.
- 8 Press •<<" to return to the start page of the ⇒ **'Maintenance/repairs'** menu.
- 9 Select the ⇒ **'Overview'** menu and press •<<" to return to the control unit selection screen.
