WE53 - Re-programming DME Control Unit (Workshop Campaign)

Vehicle Type: **911 Turbo (991)/911 Turbo S (991)**

Concerns: **DME control unit**

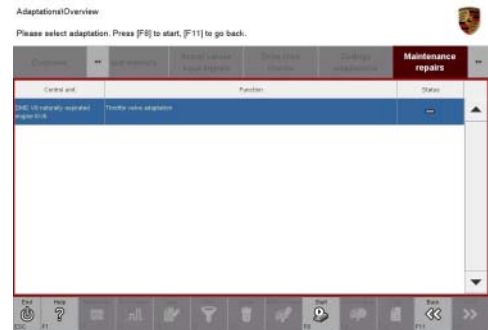
Throttle valve adaptation

- Select the ⇒ **'Throttle valve adaptation'** function so that the corresponding text line turns blue and press •F8" to start the throttle valve adaptation ⇒ *Throttle valve adaptation*.

- Follow the instructions on the PIWIS Tester while throttle valve adaptation is being performed. Once throttle valve adaptation is complete, a tick will appear in the "Value" field on the PIWIS Tester display. If throttle valve adaptation is **not** completed successfully, adaptation must be **repeated**.
- Press •F8" ("Stop") to end throttle valve adaptation.
- Press •<<" to return to the start page of the ⇒ **'Maintenance/repairs'** menu.
- Select the ⇒ **'Overview'** menu and press •<<" to return to the control unit selection screen.
