07329 Version 3

## MIL Comes On with DTC P0430 (Front Bank Catalyst System Efficiency Below Threshold [Bank 2])

Supersedes 17-036, dated August 16, 2017; to revise the section highlighted in **yellow**

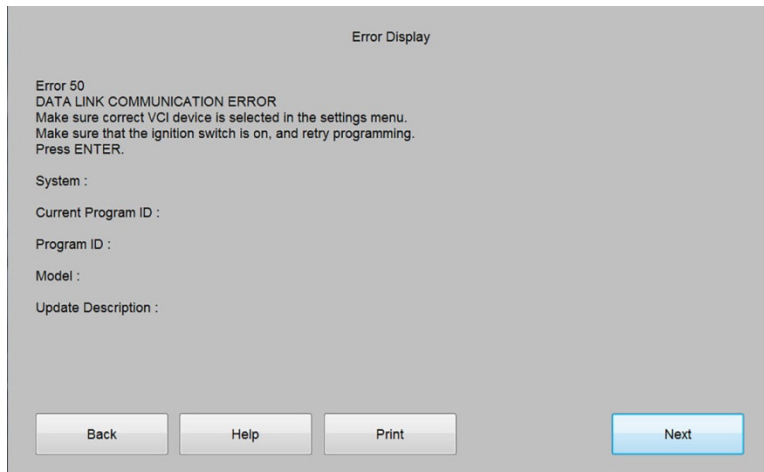
- You cannot update the vehicle using the MVCI as a standalone tool.
- **Do not** use the MongoosePro VCI tool.
- Make sure the 12-volt battery is fully charged before starting an update.
- Connect a fully charged jumper battery to the vehicle, and leave it connected during the entire procedure to maintain steady voltage.
- Never turn the ignition to OFF or ACCESSORY during the update. If there is a problem with the update, leave the ignition turned to ON.
- To prevent PCM damage, do not operate anything electrical (headlights, audio system, brakes, A/C, power windows, door locks, etc.) during the update.
- If you see the following **Error Display**, check that you are using the correct tool (MVCI or DST-i) with the i-HDS.

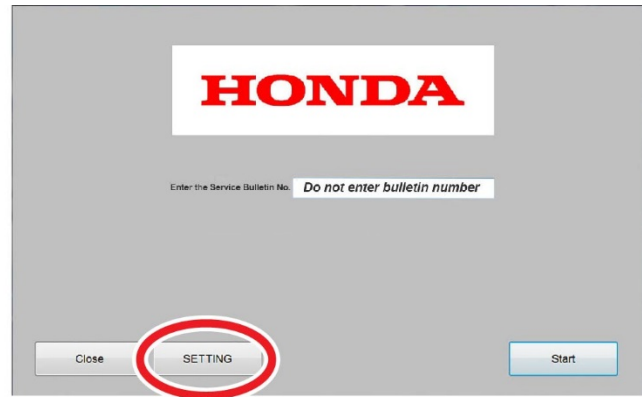
To change this, click on either of the **SETTING** selection buttons at the bottom of the J2534 initial screens as shown.

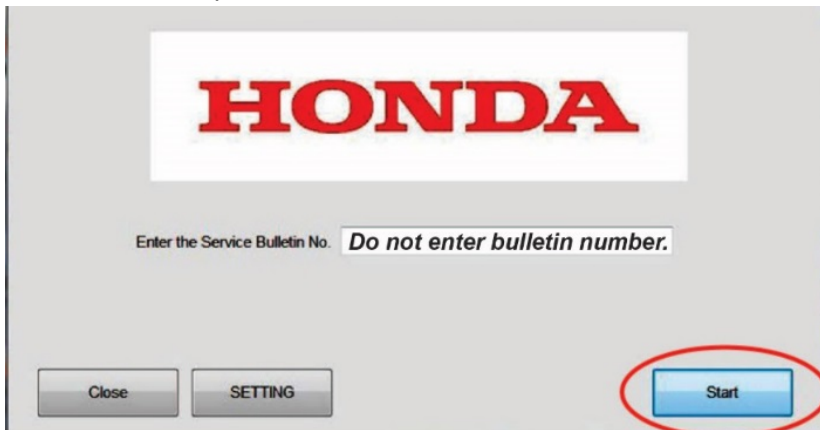
- Do not enter a bulletin number.
- If you receive a message that the vehicle has been already updated or that no update is available, check the **PGM-FI Data List**. The header should indicate one of the following numbers (or later):

- If the program part numbers do not match those listed above, the i-HDS software needs to be reinstalled. Contact the Special Tools Hotline at **800-346-6327** for assistance.

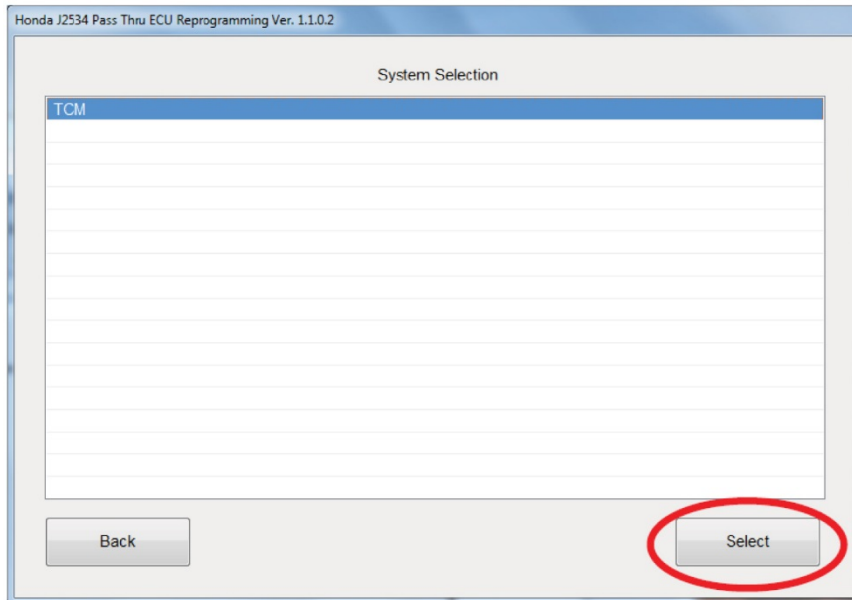
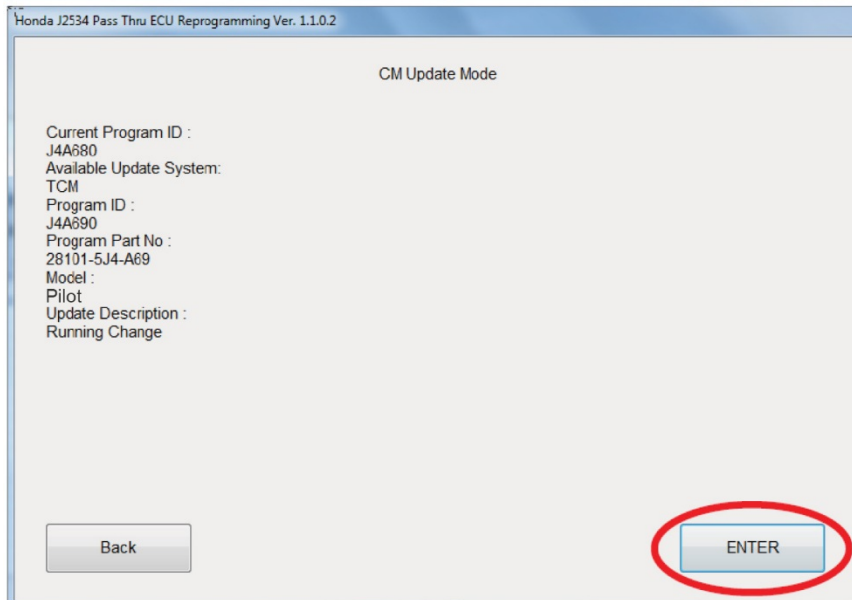
7. Check if **TCM** appears under **System Selection**?

- If it appears, choose **Select** then **ENTER** on the next screen to update the TCM software.
- If it does not appear, the TCM software is up to date.
