**JAGUAR LAND ROVER SHOP FOREMAN CONFERENCE CALL**  
MARCH 9, 2017

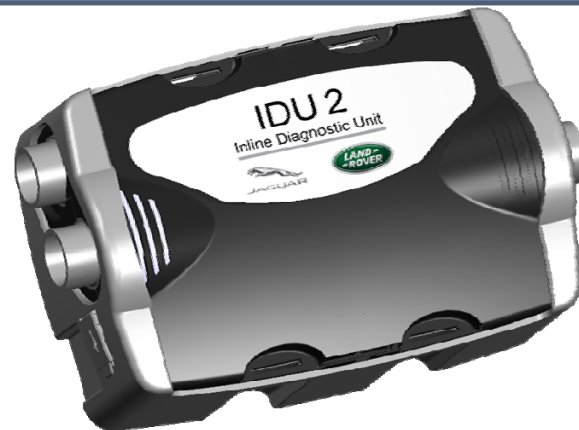
- The IDU2 is an inline voltmeter, ammeter and output state controller with the capability to simultaneously measure the electrical circuits of a component .
- Additional features:
  - CAN logging, LIN logging, Voltage and Current multimeter, 2 channel oscilloscope, and on board data logger
- Through integration into SDD and Pathfinder the tool is able to compare results of the suspect system to known good limits for a Pass or Fail judgement.

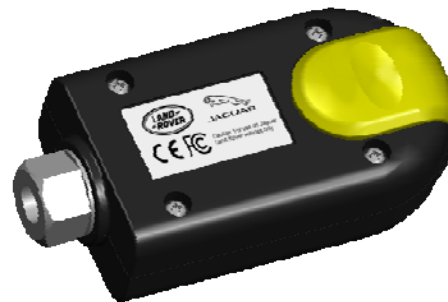
## NVH sensor overview

- The NVH sensor is stand alone vibration analysis tool that has been integrated into SDD and Pathfinder
- Features:
  - Up to 1 hour continuous wireless use following 30 minute charge from SDD laptop.
  - USB or Bluetooth connectivity
  - 4 accelerometers (2x 8G 3 axis and 2x 70g single axis)
  - Through integration into SDD and Pathfinder the tool is able to compare results of the suspect system to known good limits for a Pass or Fail judgement.
