SERVICE BULLETIN

Classification: EC17-028	Reference: NTB17-104	Date: September 14, 2017
-----------------------------	-------------------------	-----------------------------

2017 SENTRA; ENGINE TURNS OFF OR HESITATES WHEN ACCELERATING FROM A STOP DURING HOT AMBIENT TEMPERATURES (100° F OR MORE)

APPLIED VEHICLE: 2017 Sentra (B17)

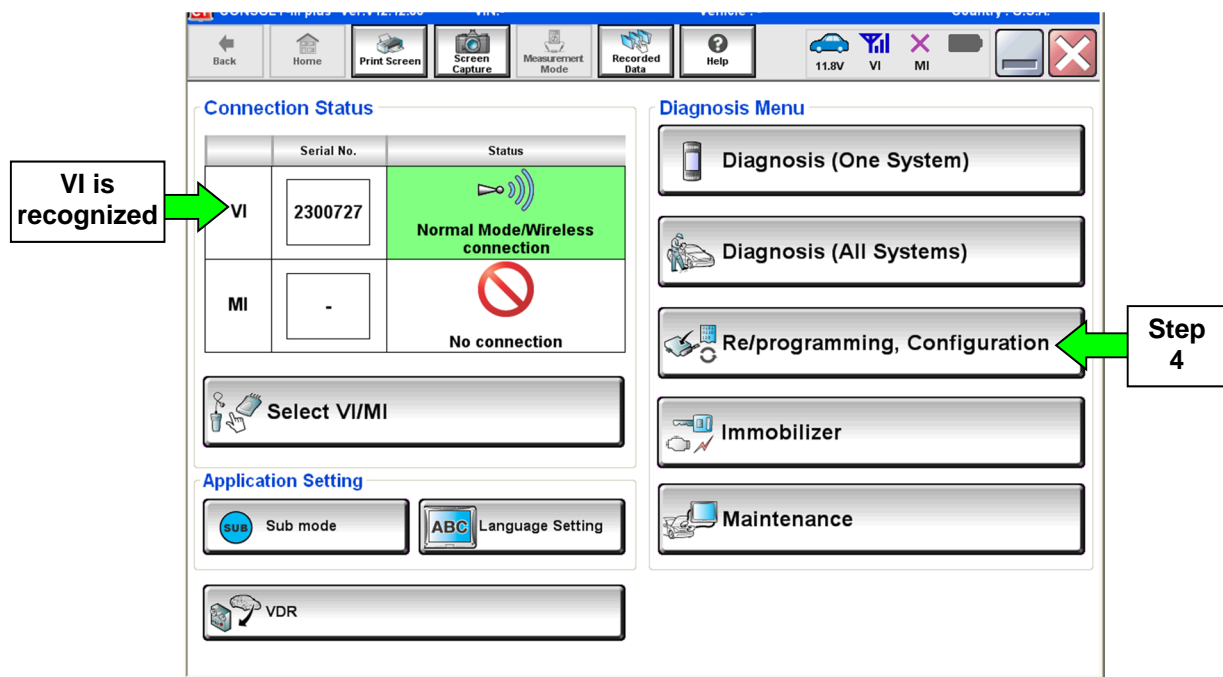
Figure 1

1. Connect the CONSULT PC to the vehicle to begin the reprogramming procedure.
- 2 Start C-III plus.
3. Wait for the plus VI to be recognized.
 - The serial number will display when the plus VI is recognized.
4. Select **Re/programming, Configuration**.

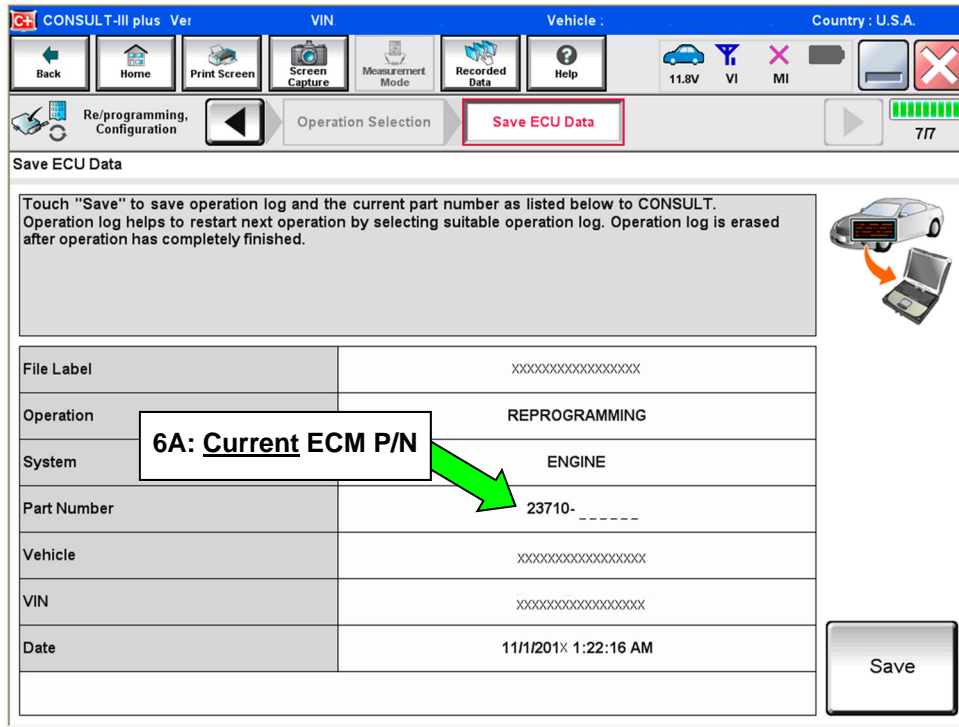
6. When you get to the screen shown in Figure 2, confirm this bulletin applies as follows.

A. Find the ECM **Part Number** and write it on the repair order.

NOTE: This is the current ECM Part Number (P/N).

5. Follow the on-screen instructions and navigate the C-III plus to the screen shown in Figure 2 on the next page.

B. Compare the P/N you wrote down to the numbers in the **Current ECM Part Number** column in **Table A** on below.

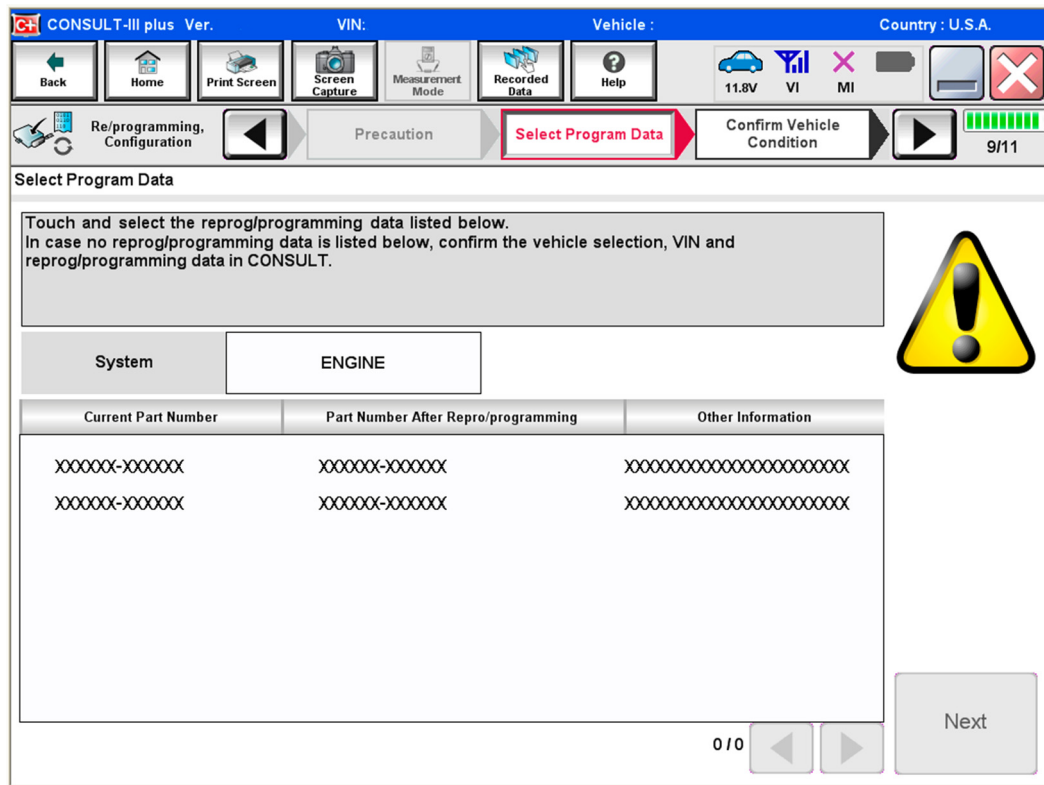
- In some cases, more than one new P/N for reprogramming is available.
 - If there is more than one new P/N, the screen in Figure 3 displays.
 - Select and use the reprogramming option that **does not** have the message “Caution! Use ONLY with NTBXX-XXX”.
- If you get this screen and it is blank (no reprogramming listed), it means there is no reprogramming available for this vehicle.

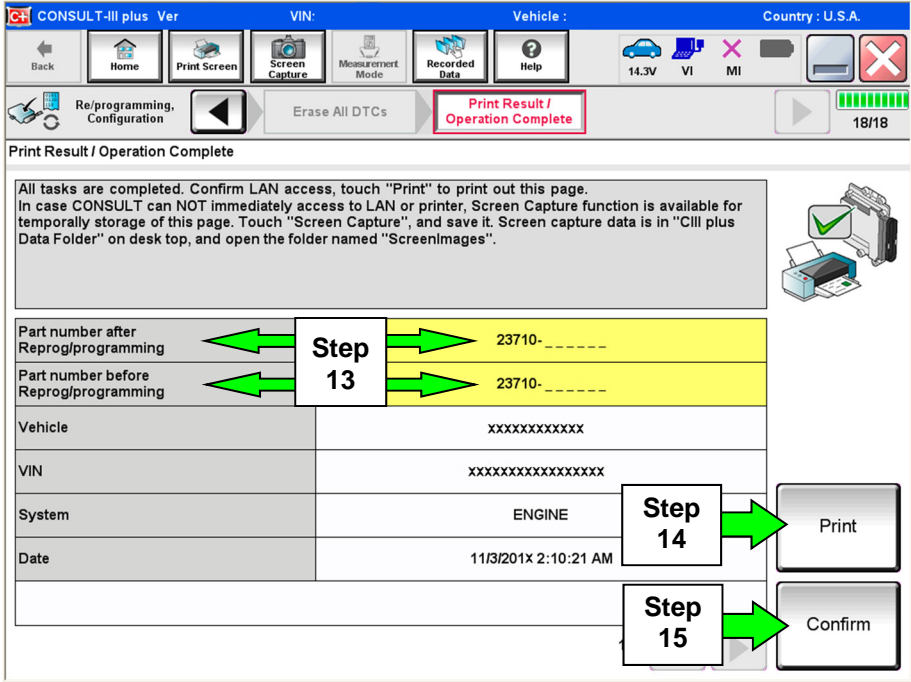
- 12. When the entire reprogramming process is complete, the screen in Figure 7 will display.
- 13. Verify the before and after part numbers are different.
- 14. Print a copy of this screen (Figure 7) and attach it to the repair order for warranty documentation.
- 15. Select **Confirm**.
