SERVICE BULLETIN

Classification: EC17-016	Reference: NTB17-063	Date: June 8, 2017
-----------------------------	-------------------------	-----------------------

2016-2017 TITAN XD; MIL ON WITH DTC P0604 AND/OR P2299

APPLIED VEHICLE: 2016-2017 Titan XD (A61)

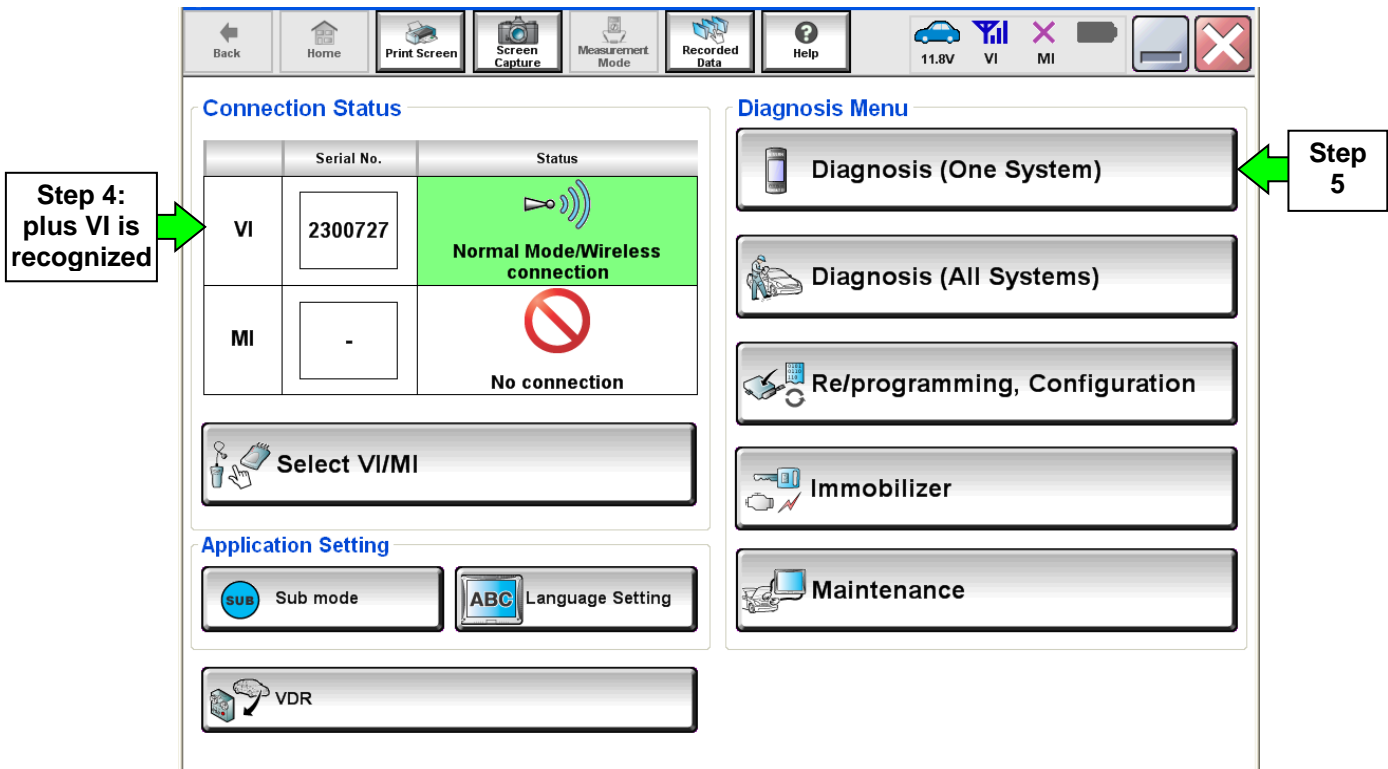
Figure A

1. Connect the CONSULT PC to the vehicle.
2. Open / start C-III plus.
3. Turn the ignition ON, with engine OFF (engine not running).
4. Wait for the plus VI to be recognized.
 - The **Serial No.** will display when the plus VI is recognized.
5. Select **Diagnosis (One System)**.

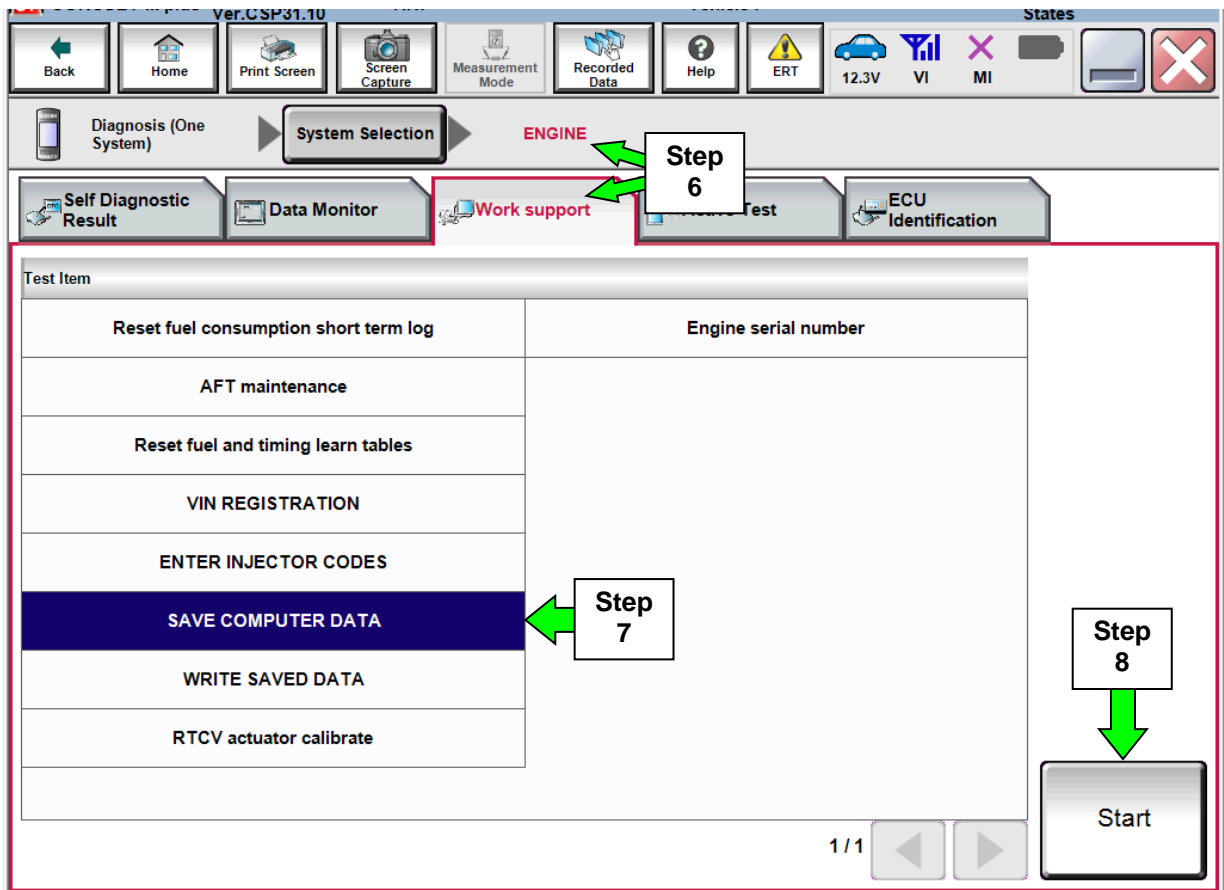
Figure B

6. Navigate C-III plus to ENGINE > Work Support (see Figure B).
7. Select **SAVE COMPUTER DATA**.
8. Select **Start**.

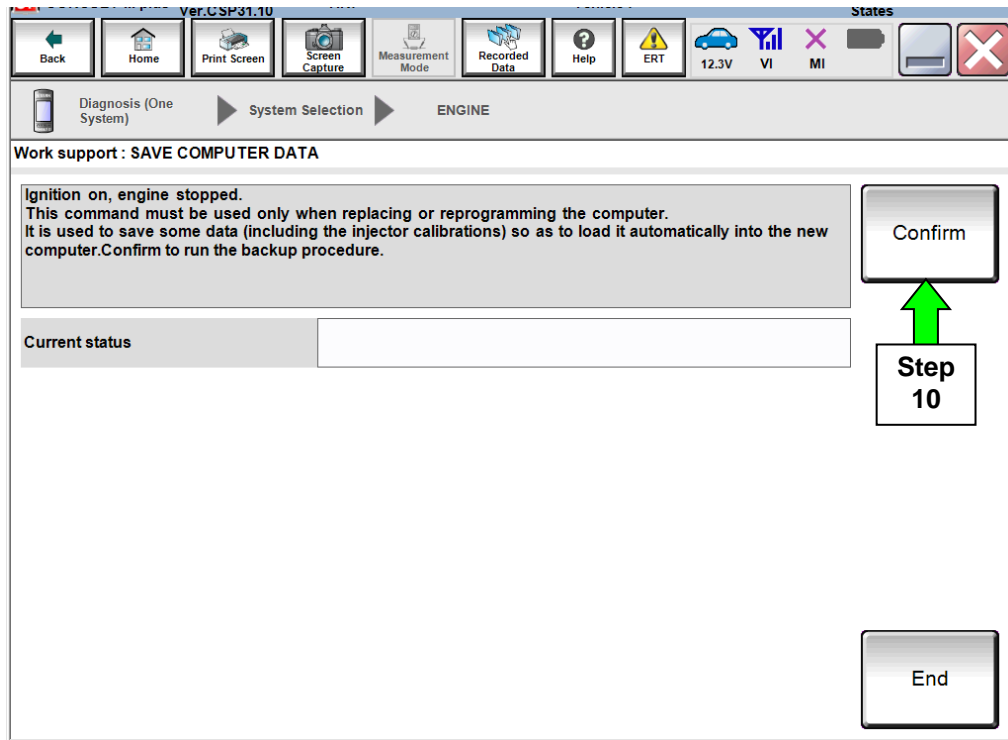
Figure C

9. Make sure the ignition is ON and the engine is OFF (engine not running).

10. Select **Confirm**.

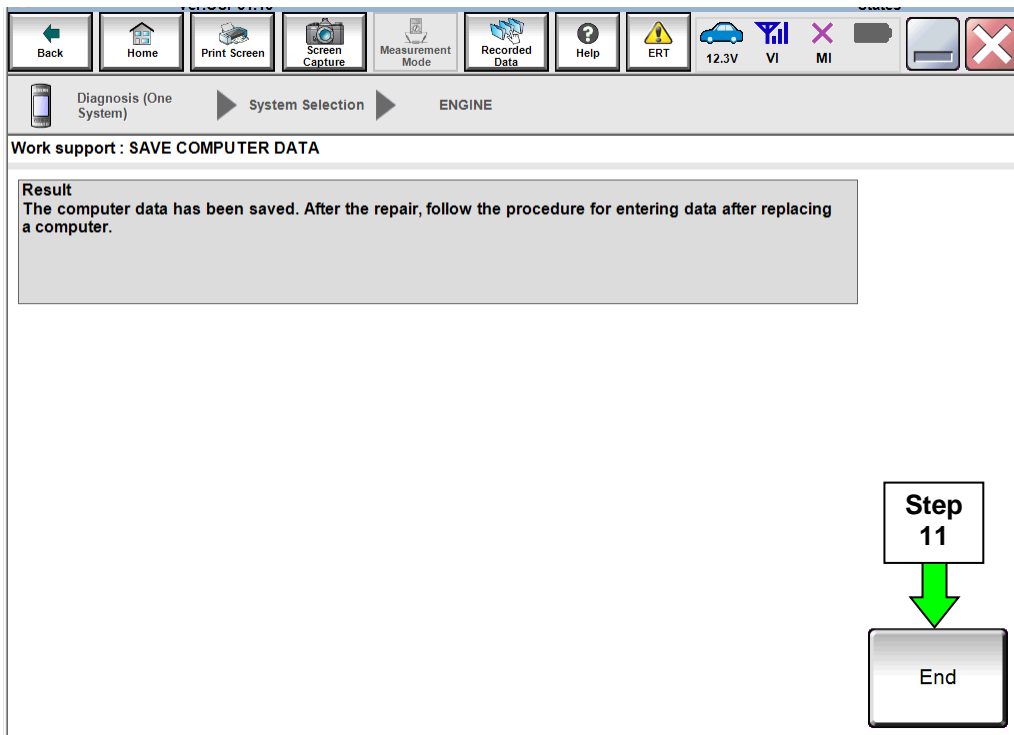
Figure D

11. Select **End**.

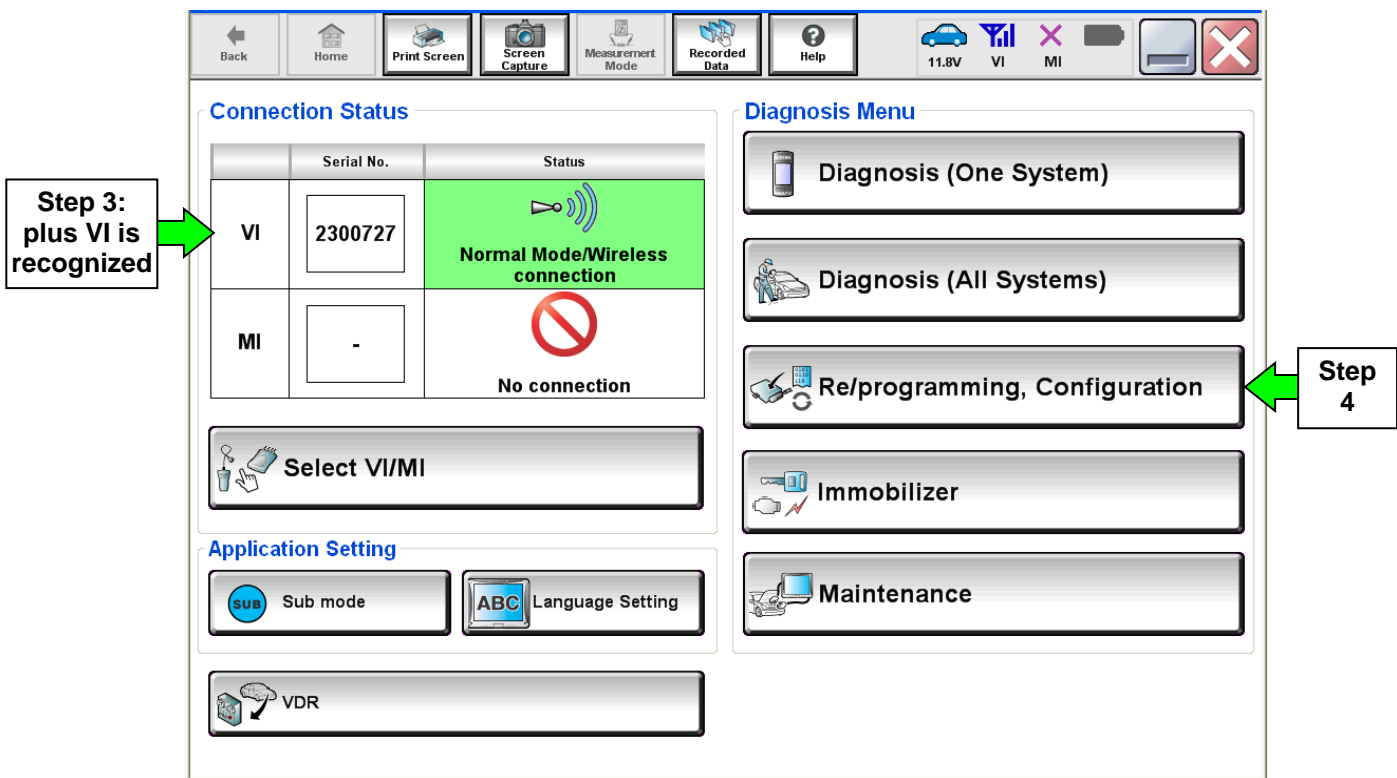
Figure 1

1. Return to the C-III plus Home screen (see Figure 1).
2. Confirm the ignition is ON, with engine OFF.
3. Confirm the plus VI is recognized.
 - The **Serial No.** will display when the plus VI is recognized.
4. Select **Re/programming, Configuration.**

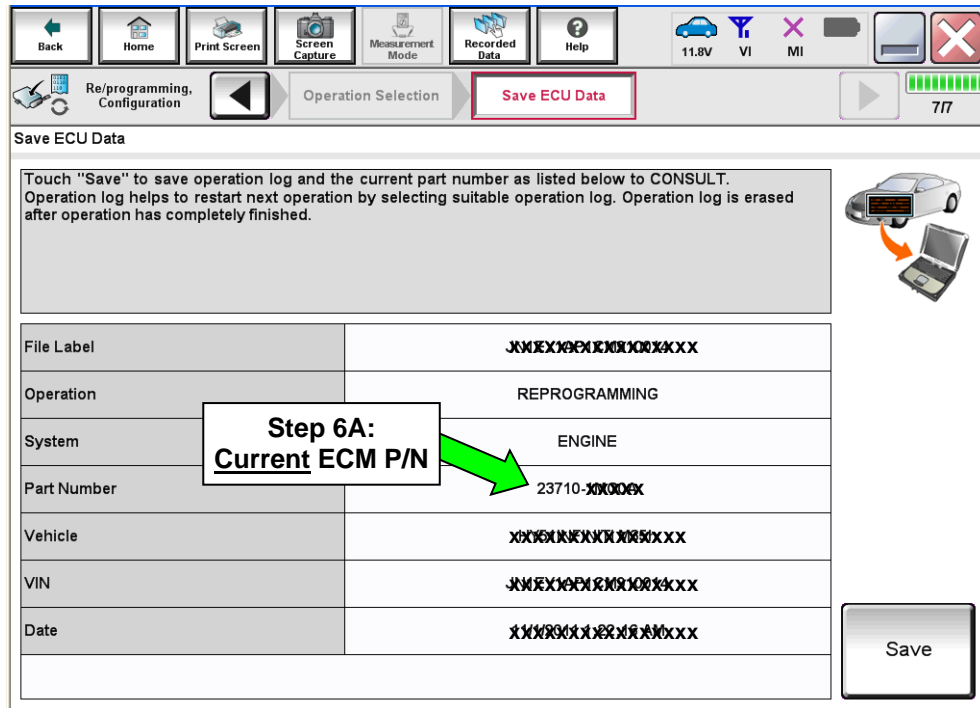
5. Follow the on-screen instructions and navigate C-III plus to the screen shown in Figure 2 on the next page.

6. When you get to the screen shown in Figure 2, confirm this bulletin applies as follows.

A. Find the ECM **Part Number** and write it on the repair order.

NOTE: This is the current ECM Part Number (P/N).

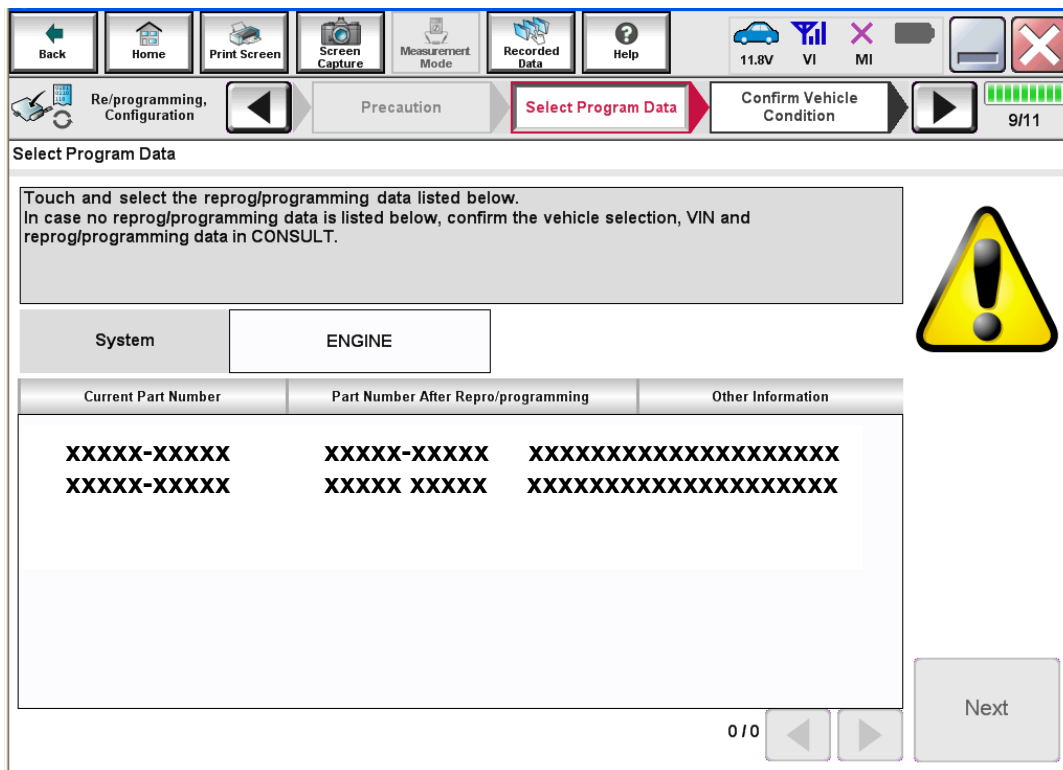
- In some cases, more than one new P/N for reprogramming is available.
 - If more than one new P/N is available, the screen in Figure 3 displays.
 - Select and use the reprogramming option that **does not** have the message “Caution! Use ONLY with NTBXX-XXX”.
- If you get this screen and it is blank (no reprogramming listed), it means there is no reprogramming available for this vehicle. Close C-III plus and refer back to ASIST for further diagnosis.

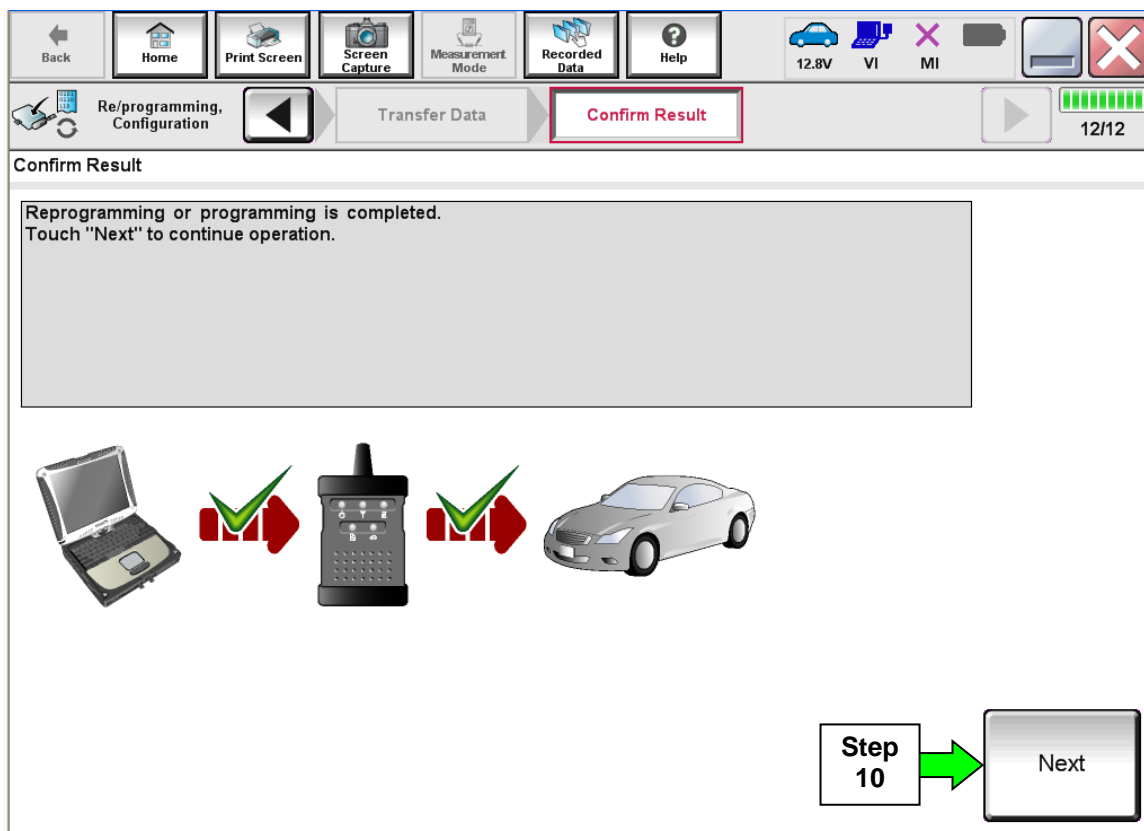
8. When the screen in Figure 4 displays, reprogramming is complete.

NOTE: If the screen in Figure 4 does not display (indicating that reprogramming did not complete), refer to ECM recovery on the next page.

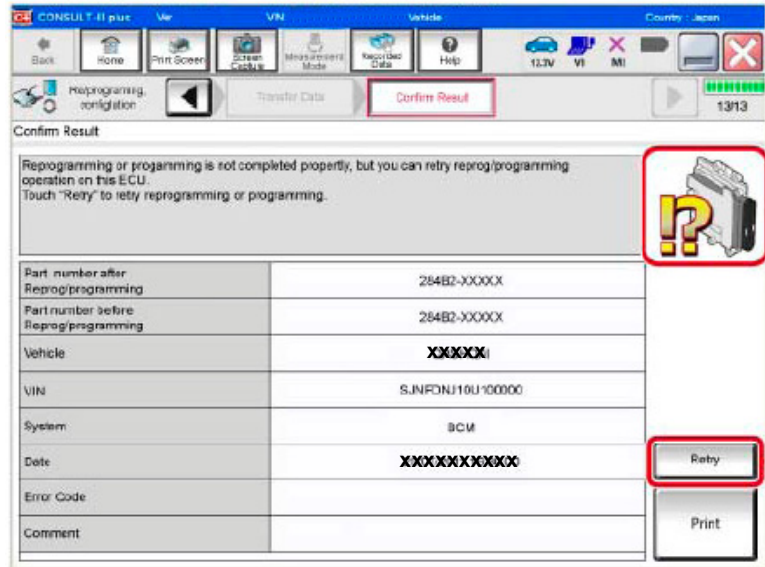
Figure 5

If reprogramming does not complete and the “!?” icon displays as shown in Figure 5:

- Check battery voltage (12.0 - 15.5 V).
- Ignition is ON, engine OFF.
- External Bluetooth® devices are OFF.
- All electrical loads are OFF.
- **Select retry and follow the on screen instructions.**
- “Retry” may not go through on the first attempt and can be selected more than once.

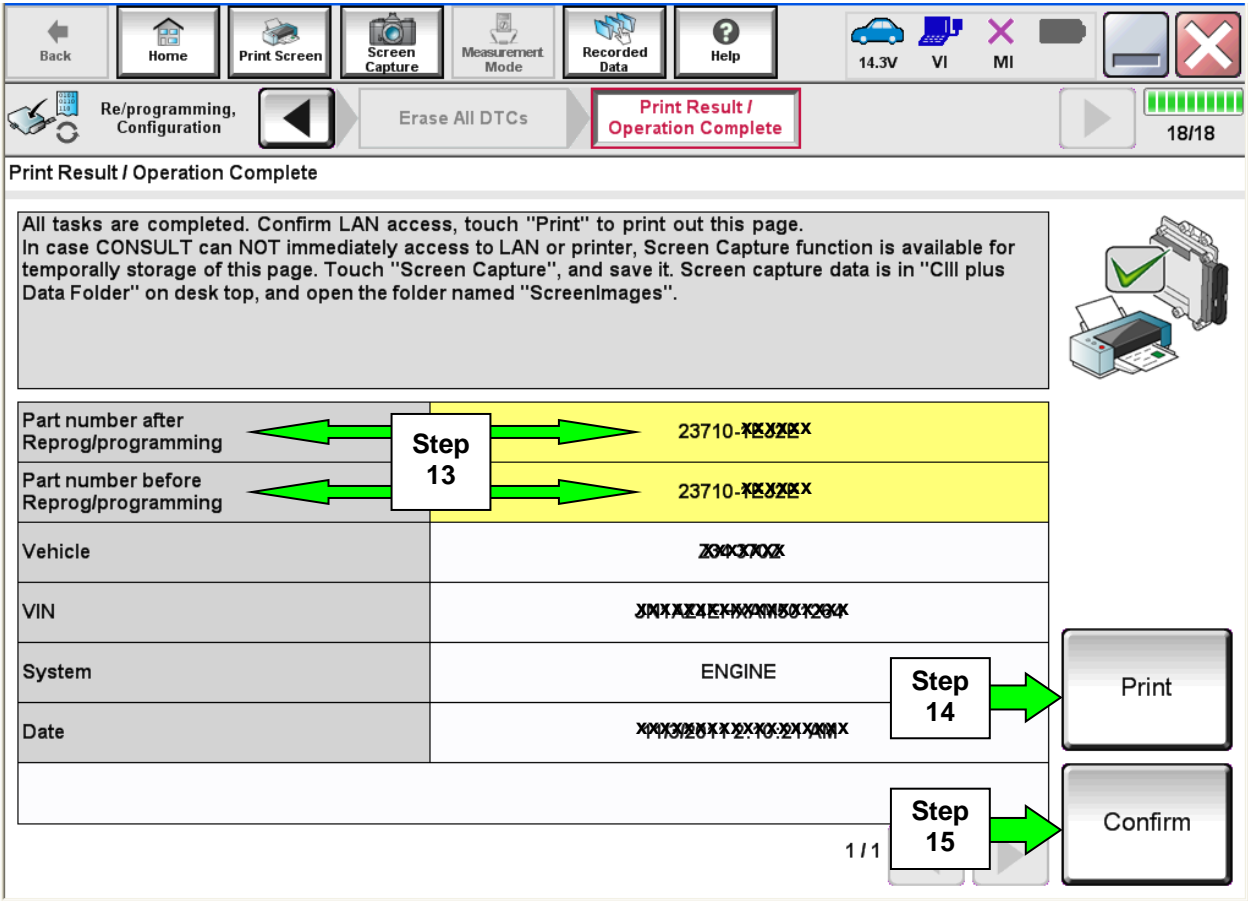
11. Follow the on-screen instructions to **Erase DTCs**.
12. When the entire reprogramming process is complete, the screen in Figure 7 will display.
13. Verify the before and after part numbers are different.
14. Print a copy of this screen (Figure 7) and attach it to the repair order for warranty documentation.
15. Select **Confirm**.

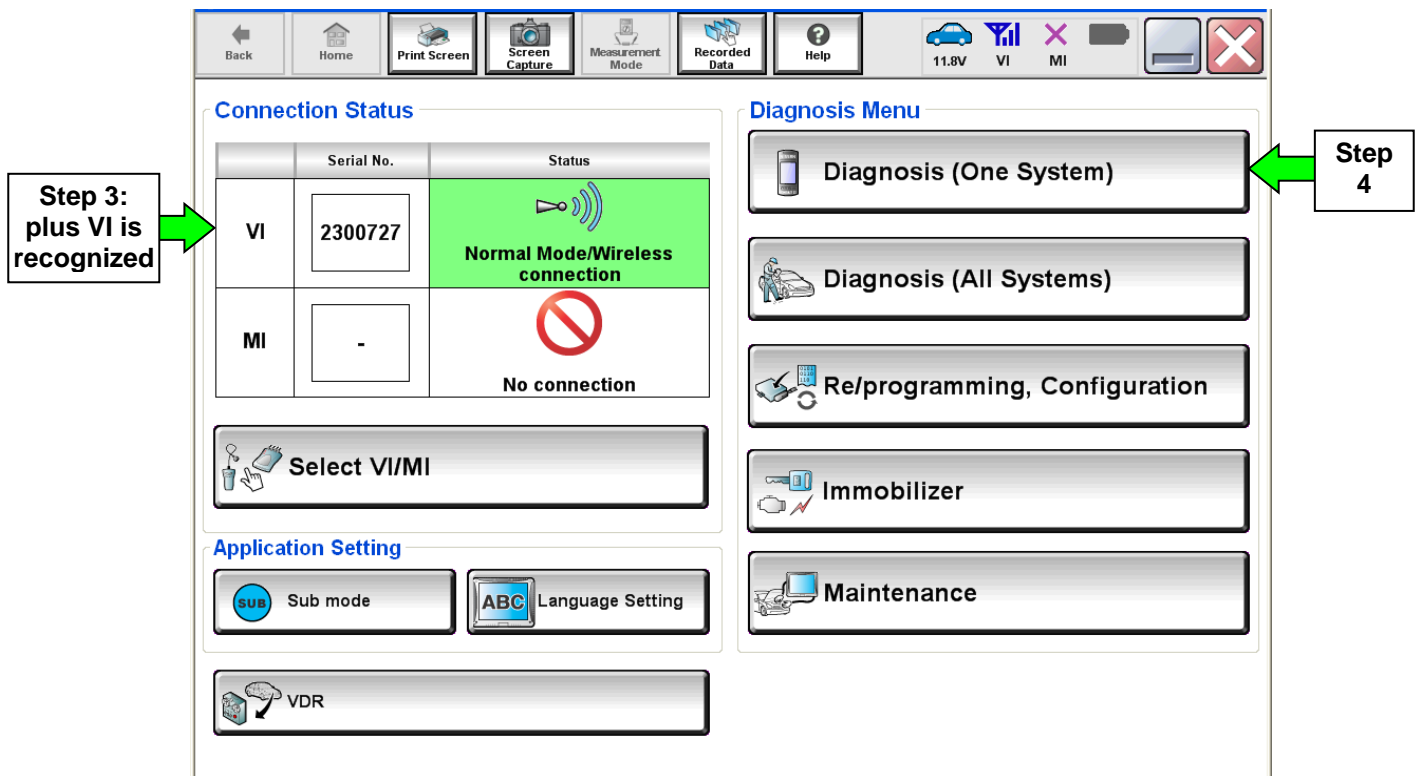
Figure 1A

1. Return to the C-III plus Home screen (see Figure 1A).
2. Confirm the ignition is ON, with engine OFF.
3. Confirm the plus VI is recognized.
 - The **Serial No.** will display when the plus VI is recognized.
4. Select **Diagnosis (One System)**.

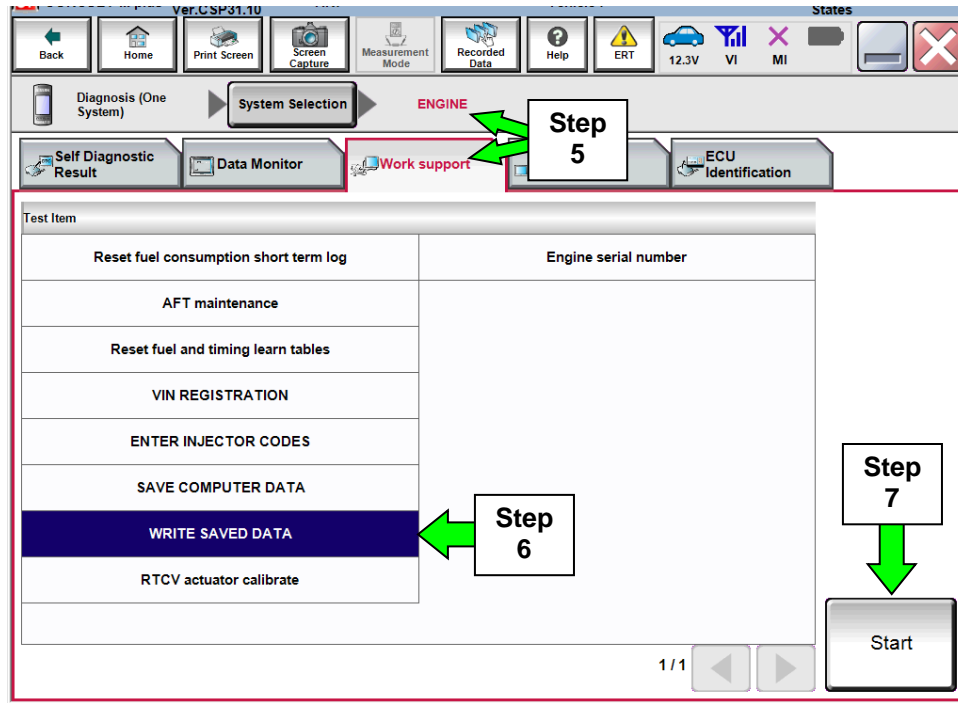
Figure 2A

5. Navigate C-III plus to ENGINE > Work support (see Figure 2A).
6. Select **WRITE SAVED DATA**.
7. Select **Start**.

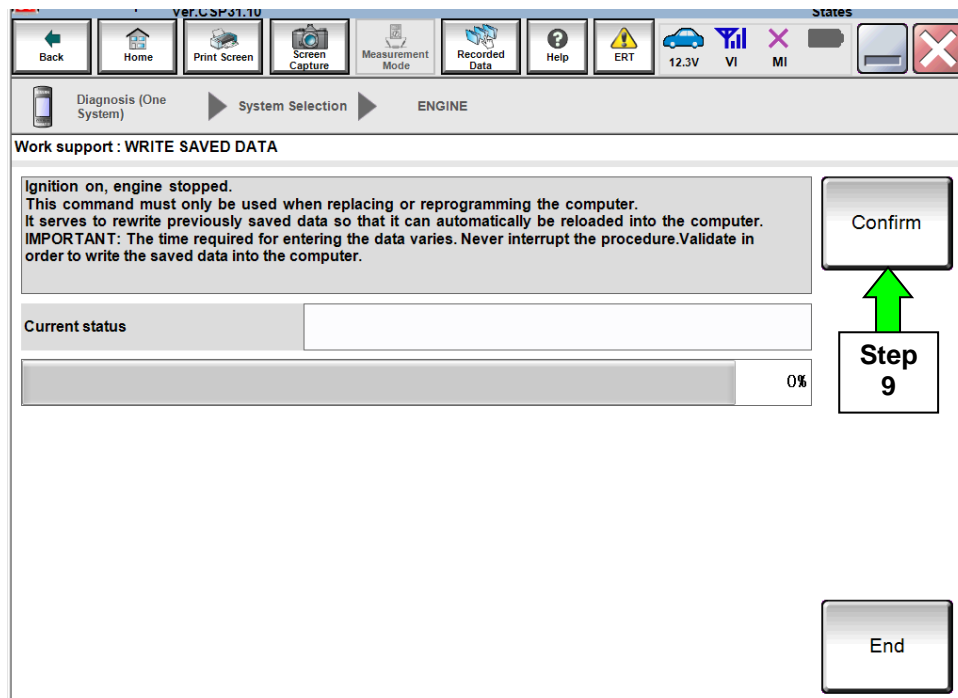
Figure 3A

8. Make sure the ignition is ON and the engine is OFF (engine not running).
9. Select **Confirm**.

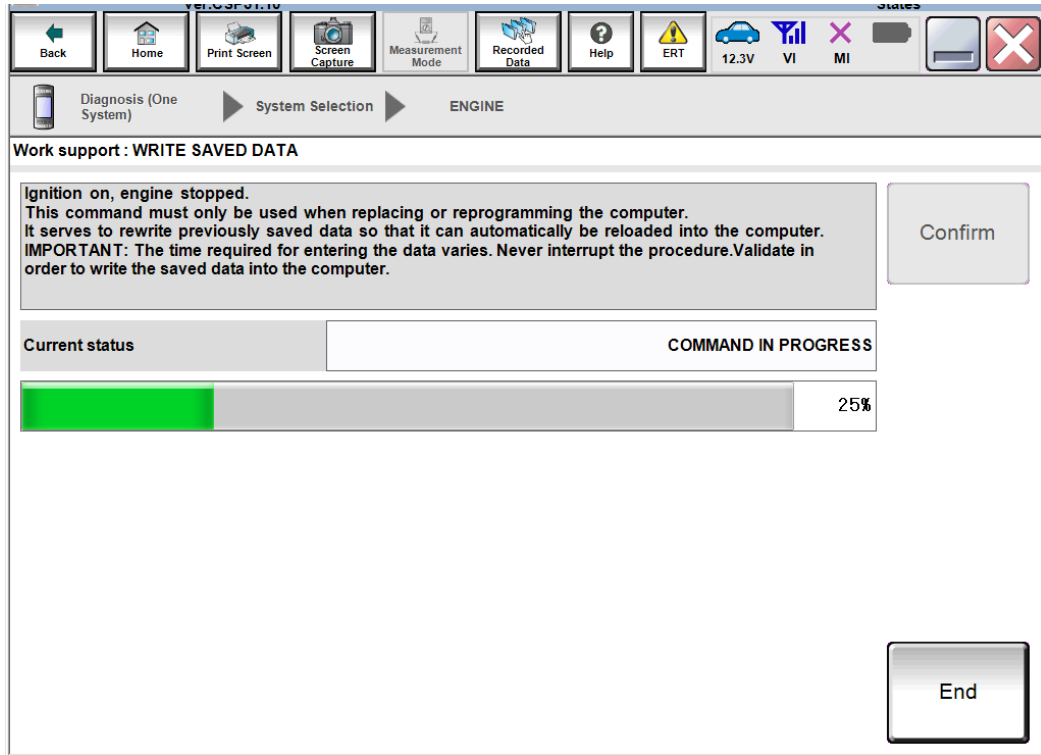
Figure 4A

10. Wait for the procedure to complete.

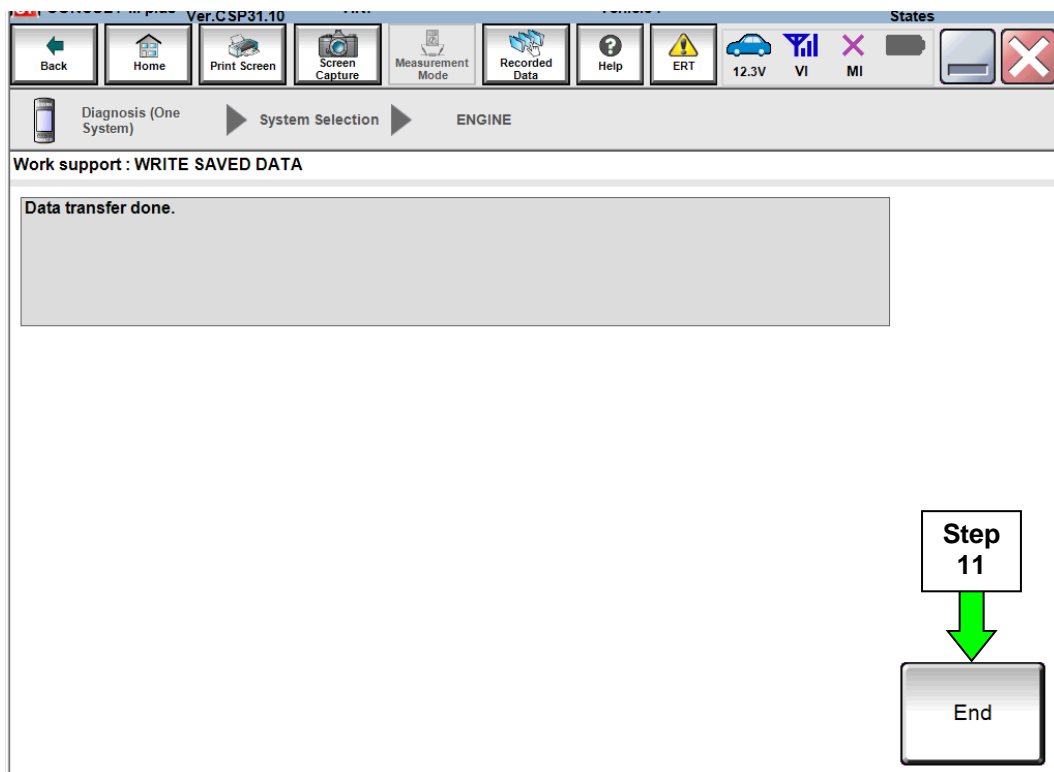
Figure 5A

11. Select **End**.
