**WG39 - Updating Porsche Communication Management (PCM) and Re-programming Instrument Cluster (Workshop Campaign)**

**Model Year:** 2017

**Model line:** 718 (982)  
911 (991)

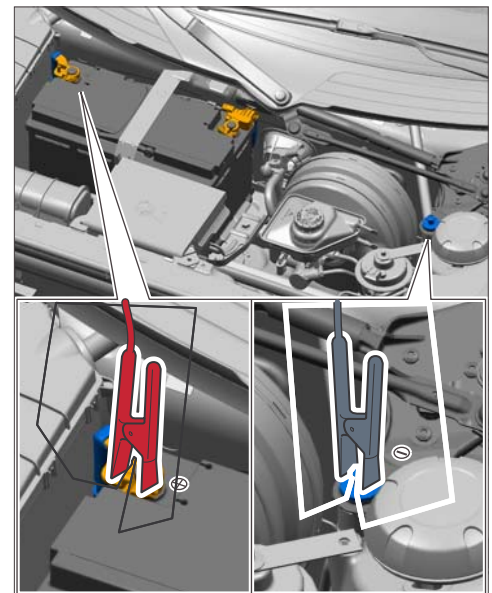
*External power connection*

- Procedure:
- 1 Connect battery charger.  
First connect the positive cable of the charger to the positive terminal of the battery and then connect the negative cable of the charger to the ground point for jump-lead starting ⇒ *External power connection*.
  - 2 Switch on the ignition using the **original driver's key**. For vehicles with "Porsche Entry & Drive", replace the control panel in the ignition lock with the original driver's key, if necessary.

- Increased current draw during diagnosis or control unit programming can cause a drop in voltage, which can result in one or more fault entries and the abnormal termination of the programming process.
- ⇒ Before starting control unit programming, connect a battery charger or power supply, suitable for AGM type batteries, recommended current rating of 70A fixed voltage 13.5V to 14.5V.
