Entune Audio Head Unit Software Update (Panasonic)

Service Category Audio/Visual/Telematics

Section Navigation/Multi Info Display

The information contained in this bulletin supersedes SB No. T-SB-0103-16.

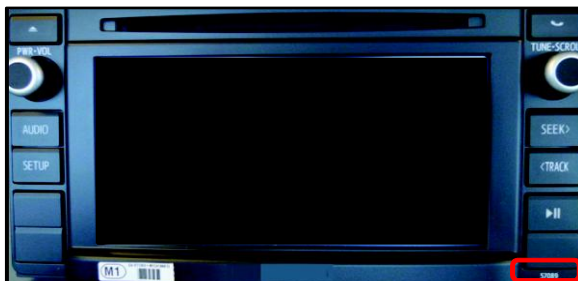
1. Confirm the audio system type by checking the faceplate ID printed on the bottom-right or bottom-center of the head unit. See Table 1 for the applicable model faceplate ID number.

Figure 1. Avalon, Avalon HV, Highlander, Highlander HV, Prius, Prius V, Sienna, Sequoia, Tacoma, and Tundra

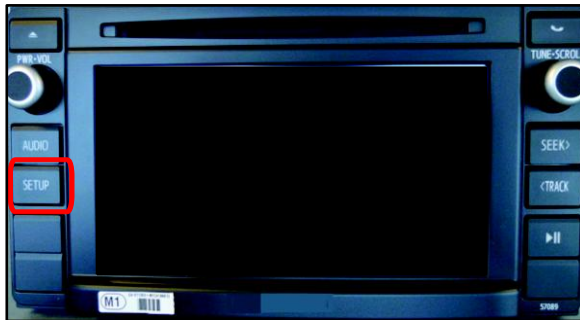
4. Go to the "Setup" screen.
 - A. For Entune™ Audio: Press the *SETUP* button on the panel.

Figure 3. Tacoma, Prius, Prius V

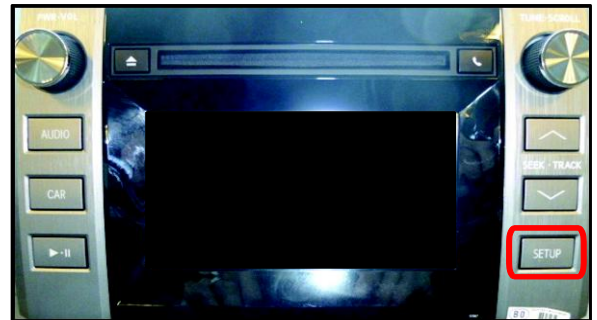
Figure 4. Tundra

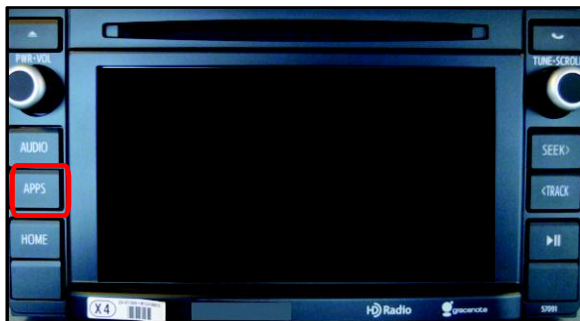
- B. For Entune™ Audio Plus and Entune™ Premium Audio: Press the *APPS* button on the panel.

Figure 5. 4Runner, Avalon, Avalon HV, Highlander, Highlander HV, Prius, Prius V, Sienna, Sequoia, and Tacoma

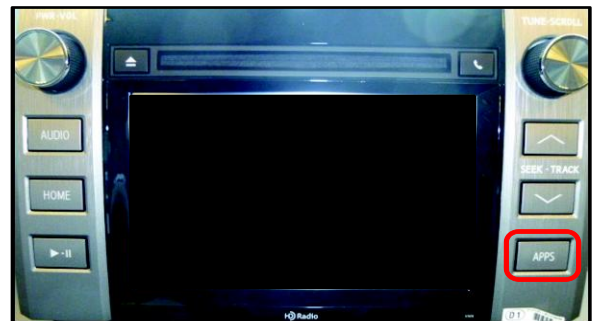
Figure 6. Tundra

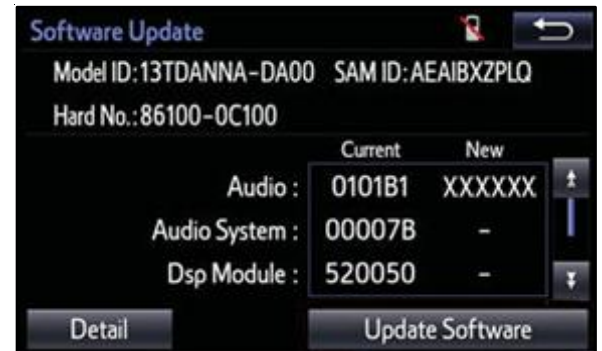
Figure 13.

- Verify that the NEW software is up to date on the “Software Update” screen.

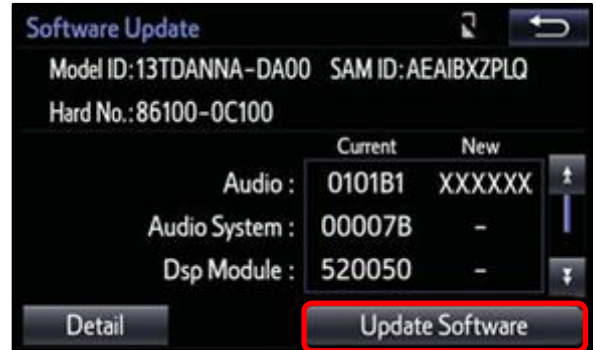
Figure 14.

10. Select *Update Software* on the “Software Update” screen.

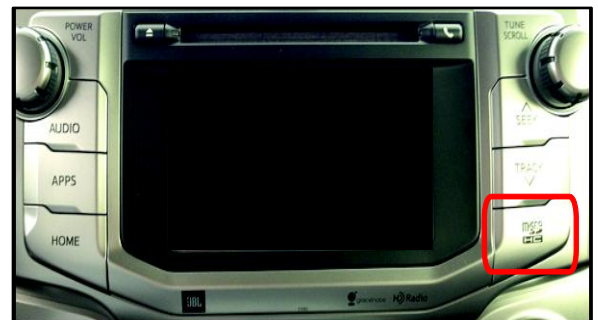
12. The unit will begin installation. The update will take about 10 minutes.

- If the update fails and the error message “New software is not compatible with the system.” displays, cycle the ignition OFF, remove the map micro SD card from the head unit, and repeat steps 3 – 12.
- Software update error is more likely to occur in areas with more traffic information.
