NUMBER: 08-028-17 REV. B

GROUP: 08 - Electrical

RA3 and RA4 Radio Over The Air Software Updates

This bulletin provides information regarding the latest Flash Over The Air (FOTA) update and provides the service technician an overview of the steps a customer will need to take to complete the update.

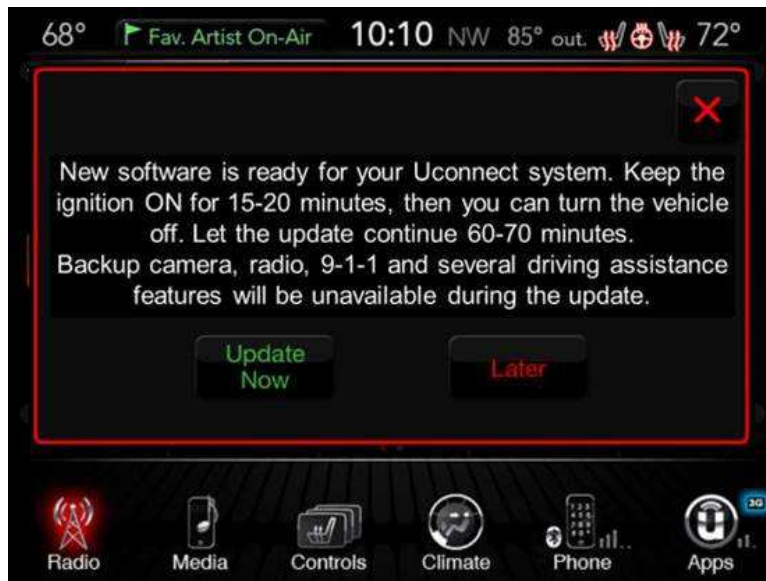
Fig. 1
Software Acceptance Screen

Vehicles sold in the U.S. with the RA3 or RA4 radio can now receive software updates “over-the-air”. Updates to software will occur in a phased roll-out. The software is updated through the built-in cellular modem in the radio which is connected to the Sprint® 3G network. Customers will see a notification on their radio screen when new software is available for their radio (Fig. 1) . The owner will have the option to update the radio or schedule the update for later. There is not an option to decline the update indefinitely. The update must be performed.

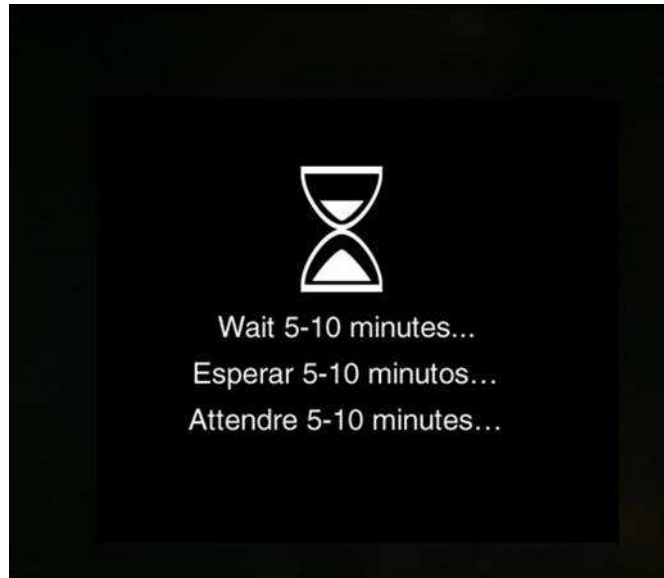
Fig. 3
Wait Screen

3. The “wait” screen (Fig. 3) will appear multiple times during the update.
