# Technical Bulletin

### MIB2 PQ Discover Media and MIB2 PQ Composition Media Radio Malfunctions

This procedure resolves the concern(s) specified above by updating the MIB2 PQ radio software to the latest level **0245**.

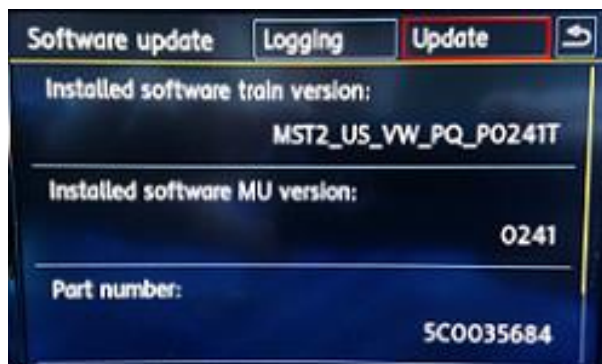
- Insert the applicable software update SD card into the SD card reader on the face of the radio display.
- Allow the data on the SD card to load.

- Press “Update” on the touch screen menu.

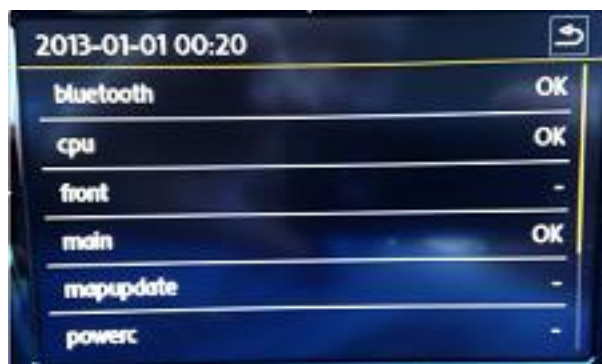
- This screen will be displayed once the update process is complete.
- Press the back arrow key on the touch screen display to return to the main menu.
