SERVICE BULLETIN

Classification: AT17-001d	Reference: NTB17-016d	Date: November 6, 2017
------------------------------	--------------------------	---------------------------

2016 – 2017 TITAN AND TITAN XD; SHIFT SHOCK, LACK OF POWER, AND/OR RPM FLUCTUATES

- APPLIED VEHICLES:** 2017 Titan (A61)
2016-2017 Titan XD (A61)
- APPLIED ENGINE:** VK56VD (Gasoline V8)
- APPLIED TRANSMISSION:** 7AT - RE7R01B

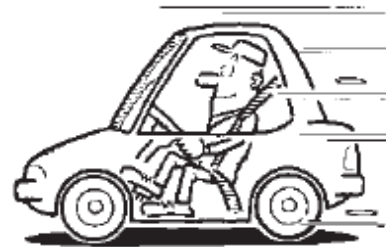
Figure A

- Take the vehicle for a 10 minute drive in order to meet the following Idle Air Volume Learn (IAVL) conditions:
 - Engine coolant temperature: 70 -100°C (158 -212°F)
 - Battery voltage: More than 12.9V (At idle)
 - Transmission: Warmed up
