Service Program Trucks

Transmission ECU Programming OBD2013, D11H, D13H, D16H VHD, VN

SP 431-021, Transmission ECU Programming

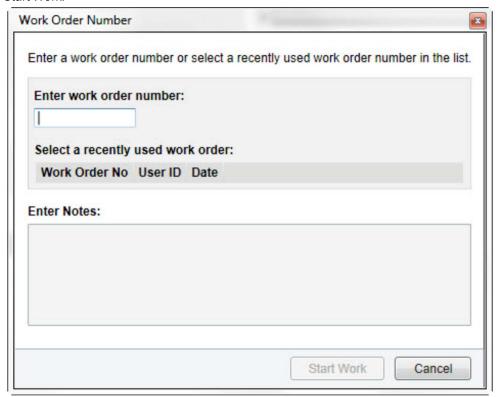
W2079940

4 Once the vehicle has been identified, enter the Work Order Number information, then click Start Work.

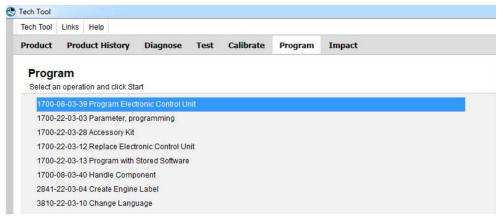
W2079941

5 From the Main Menu select Program and **then** Program Electronic Control Unit 1700-08-03-39. Then click Start.

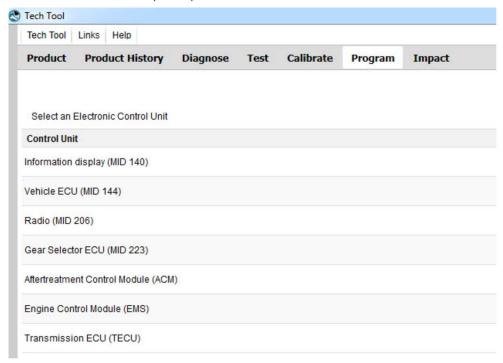
W2079943

6 Select Transmission ECU (TECU) from the list.

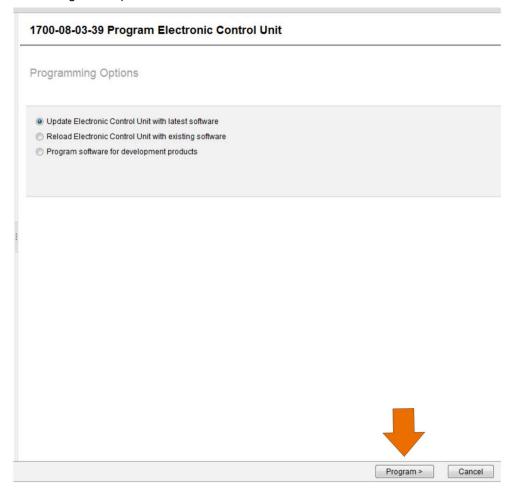
W2079942

7 Select Program to update the electronic control unit with the latest software.

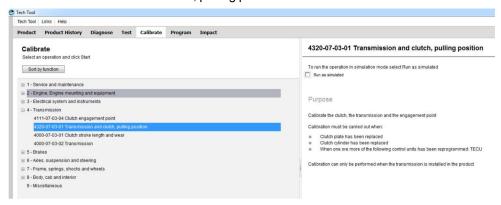
W2079944

10 Once TECU programming is complete, select Calibrate from the Main Menu. Select 4320-07-03-01 Transmission and clutch, pulling position and click on Start
