CAMPAIGN BULLETIN

Transmission Control Module Reprogram

Reference: PC604

Affected Models/Years:	Affected Population:	Dealer Inventory:	SERVICE COMM Activation date:	Stop Sale In Effect
2016-17 Titan & Titan XD(A61)	NA	11,807	December 19, 2017	NO

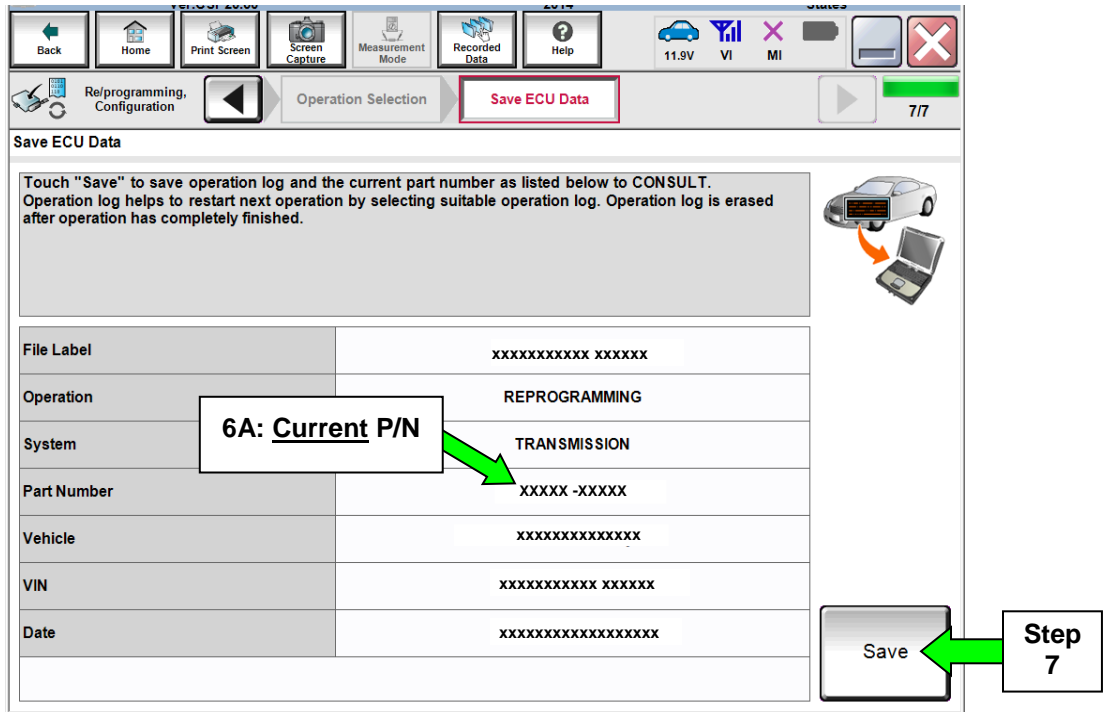
5. Follow the on-screen instructions and navigate C-III plus to the screen shown in Figure 2 below.
 6. When you get to the screen shown in Figure 2, confirm TCM reprogram applies as follows.
 - A. Find the TCM **Part Number** and write it on the repair order.
- NOTE:** This is the current TCM Part Number (P/N).

- B. Compare the P/N you wrote down to the numbers in the **CURRENT TCM PART NUMBER** column in **Table B** below.
 - If there is a match, continue with the reprogramming procedure.
 - If there is not a match, TCM reprogramming does not apply. Go to ECM reprogram on page 8.

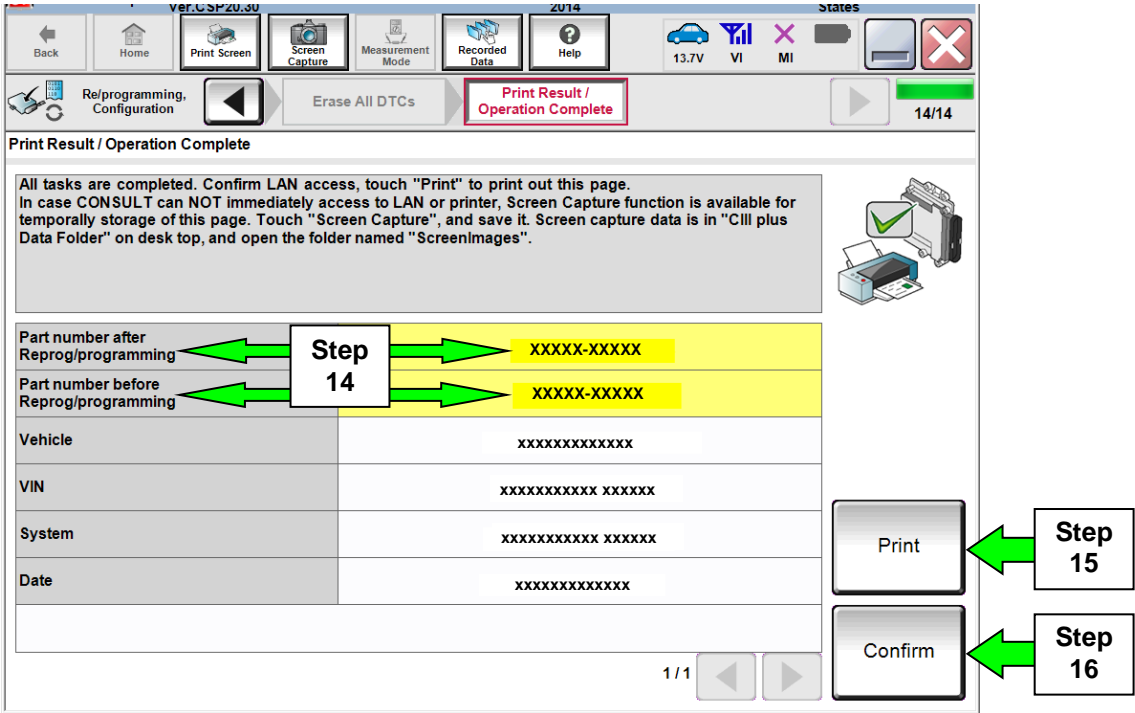
- 11. Follow the on-screen instructions to **Confirm Shift Lever Position Display**.
- 12. Follow the on-screen instructions to **Erase DTCs**.
- 13. When the entire reprogramming process is complete, the screen in Figure 8 will display.
- 14. **Verify the before and after part numbers are different.**
- 15. Print a copy of this screen (Figure 8) and attach it to the repair order for warranty documentation.

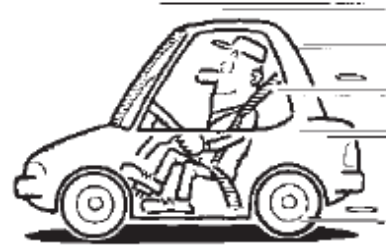
Figure A

- Take the vehicle for a 10 minute drive in order to meet the following Idle Air Volume Learn (IAVL) conditions:
 - Engine coolant temperature: 70 -100°C (158 - 212°F)
 - Battery voltage: More than 12.9V (At idle)
 - Transmission: Warmed up

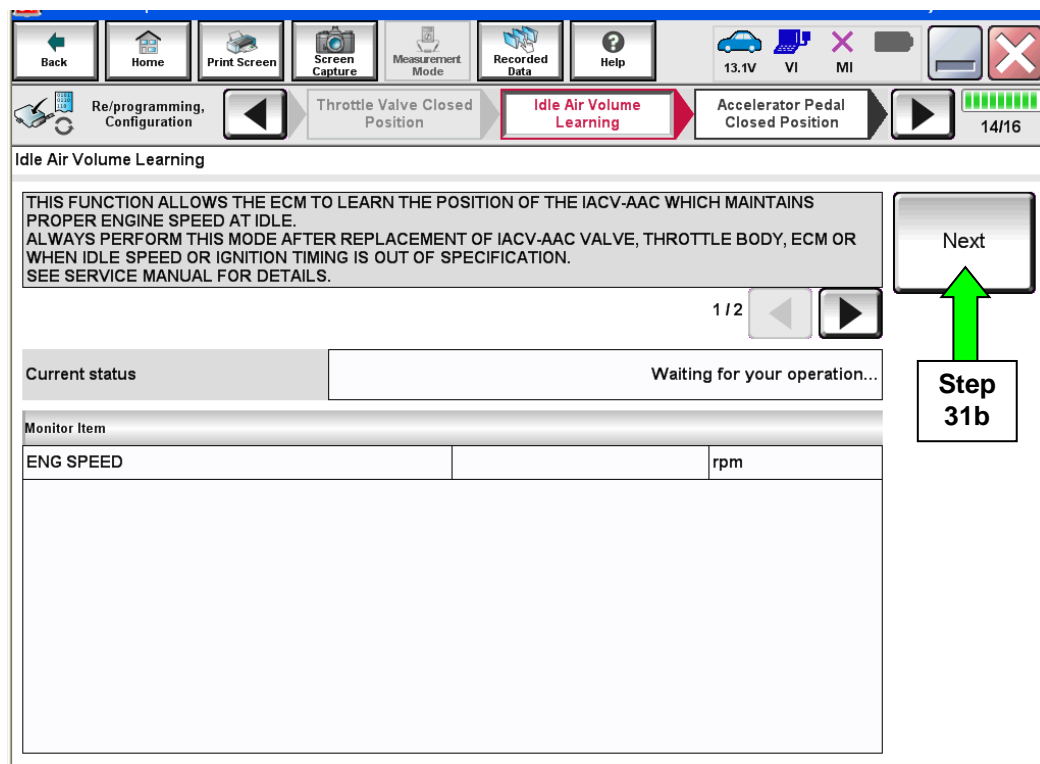
Figure 17

31. For ECM reprogramming: Perform **Idle Air Volume Learn (IAVL)** as described in Steps a through c until error occurs.

a. Turn the ignition ON (**ENGINE OFF**).

b. Select **Next**.

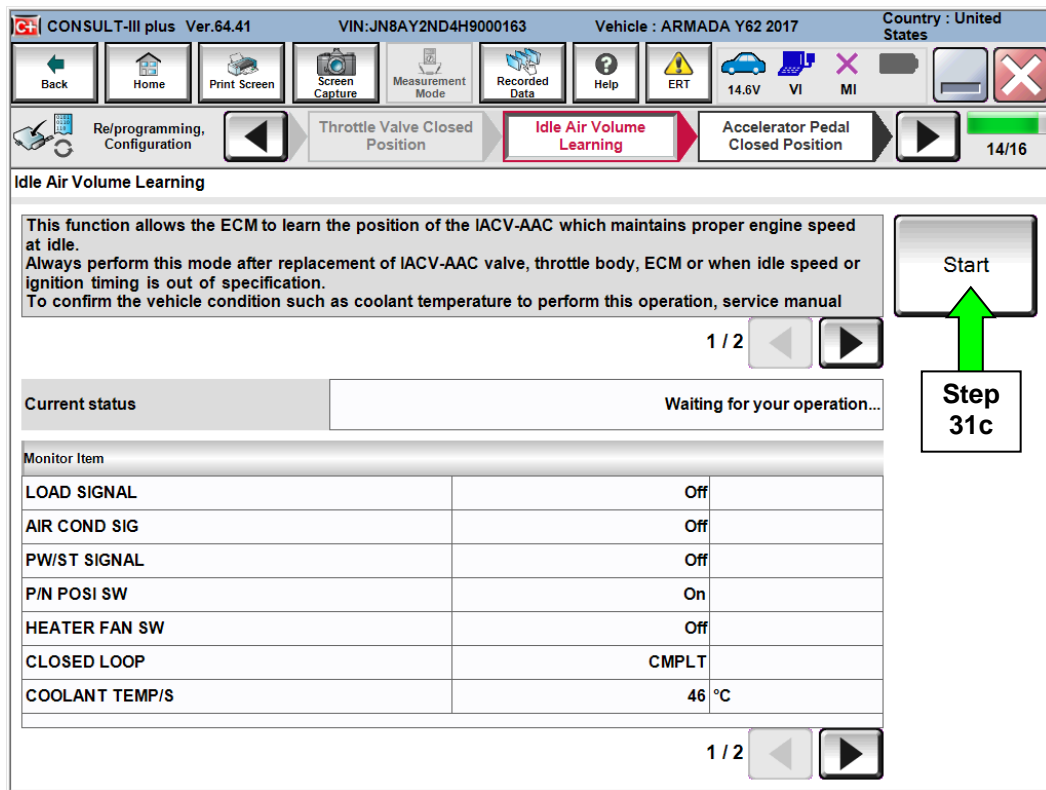
Figure 18

c. Select **Start**.

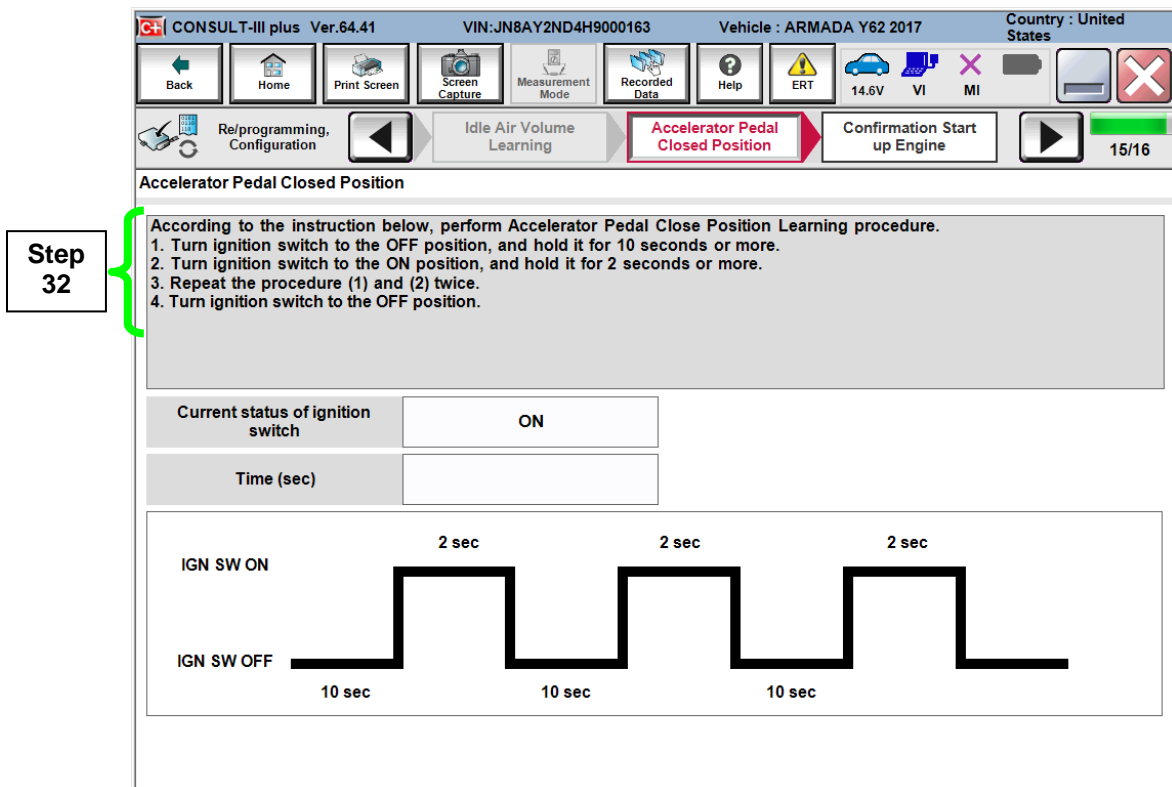
Figure 21

32. Follow the on screen instructions to complete **Accelerator Pedal Close Position Learning**.

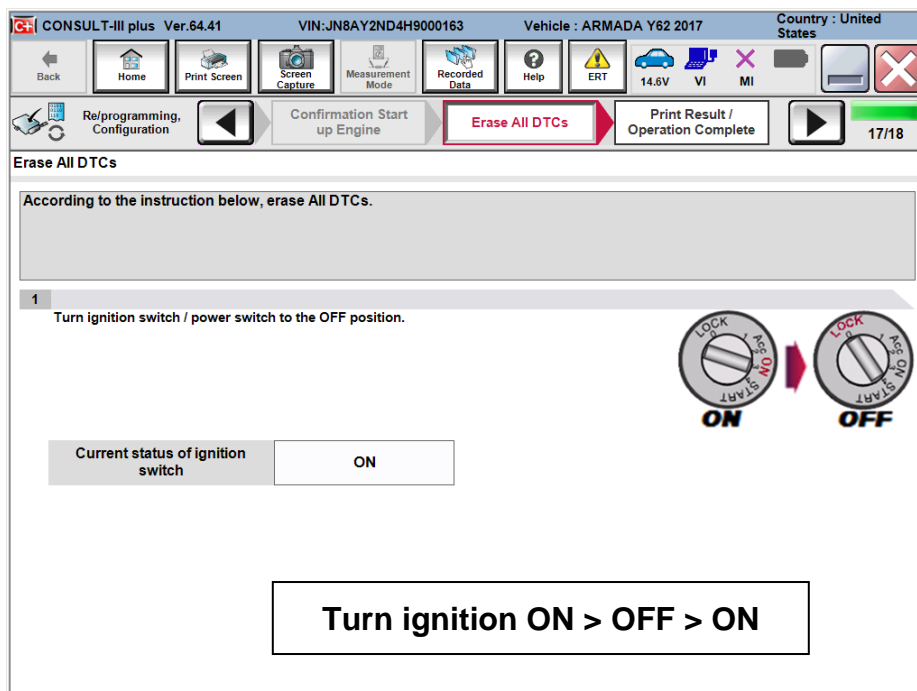
Figure 23

34. Erase all DTCs as follows:

- a. Turn the ignition OFF
- b. Turn the Ignition ON with engine off.
- c. Wait for DTC erase to complete.

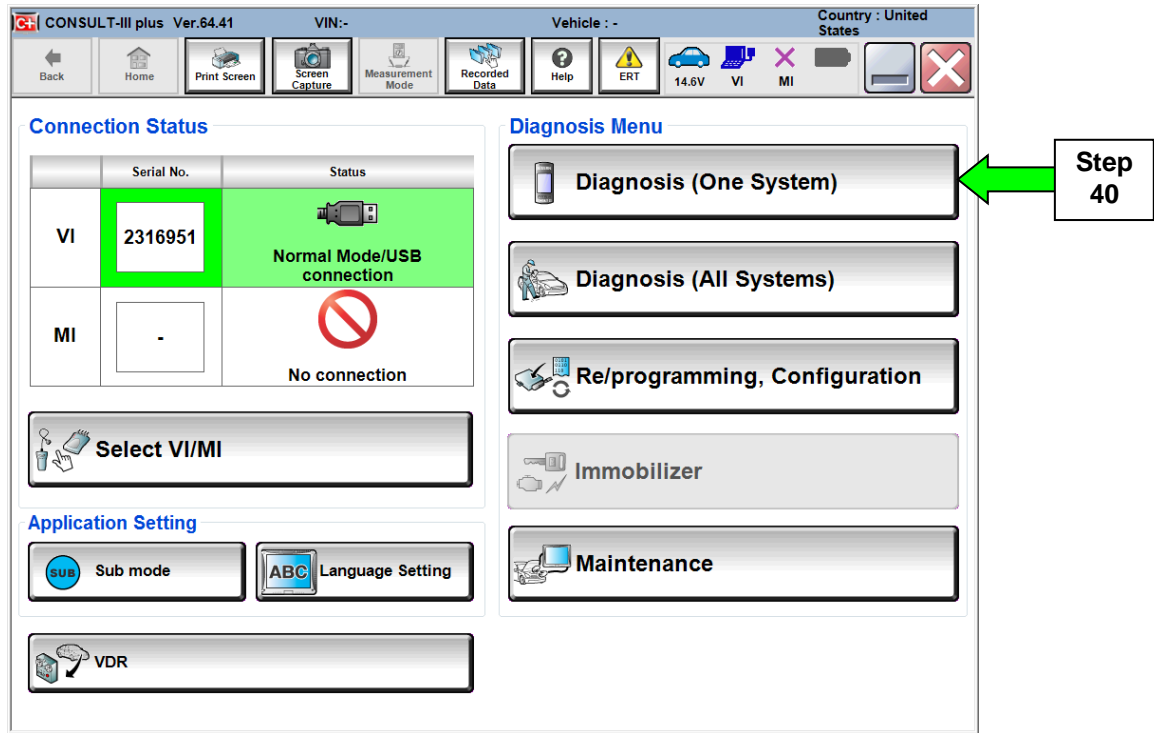
Figure 25

39. After selecting **Confirm** in the previous step, the CONSULT- III plus Home screen below will be displayed.

40. Select **Diagnosis (One System)**.

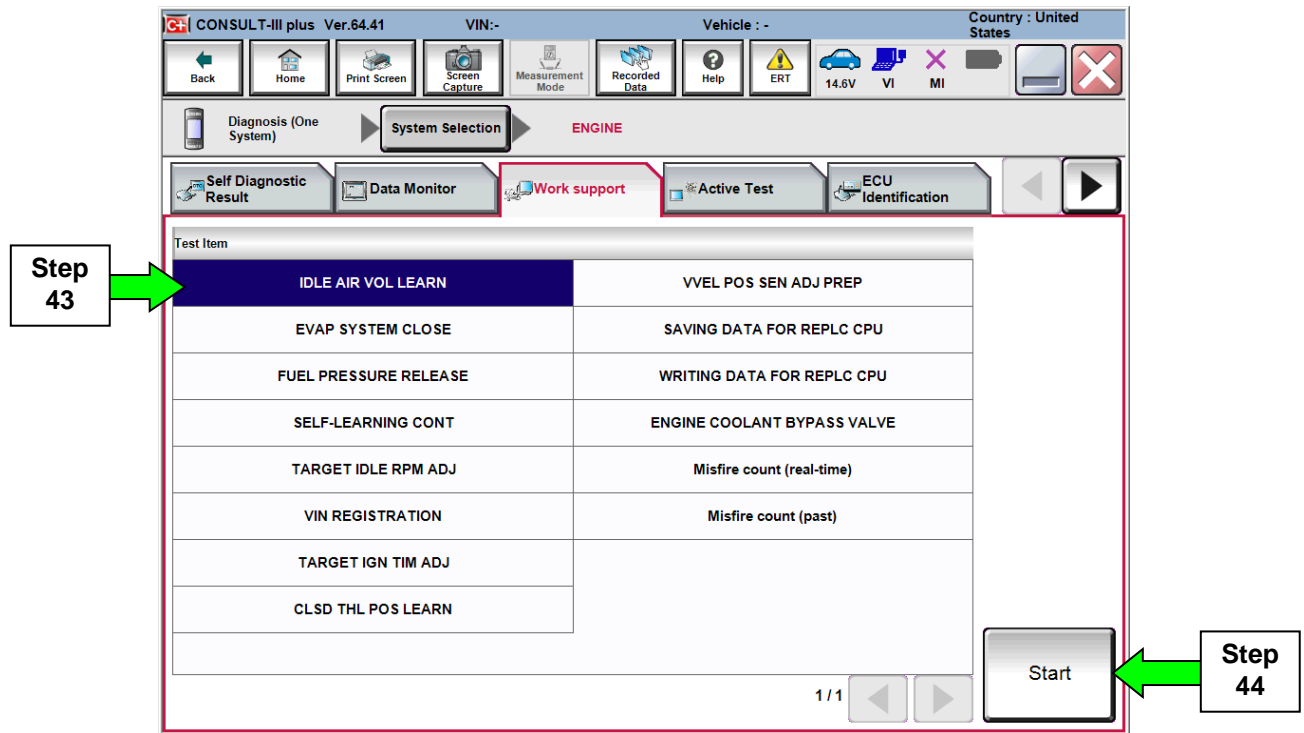
Figure 28

43. Select **IDLE AIR VOL LEARN**.

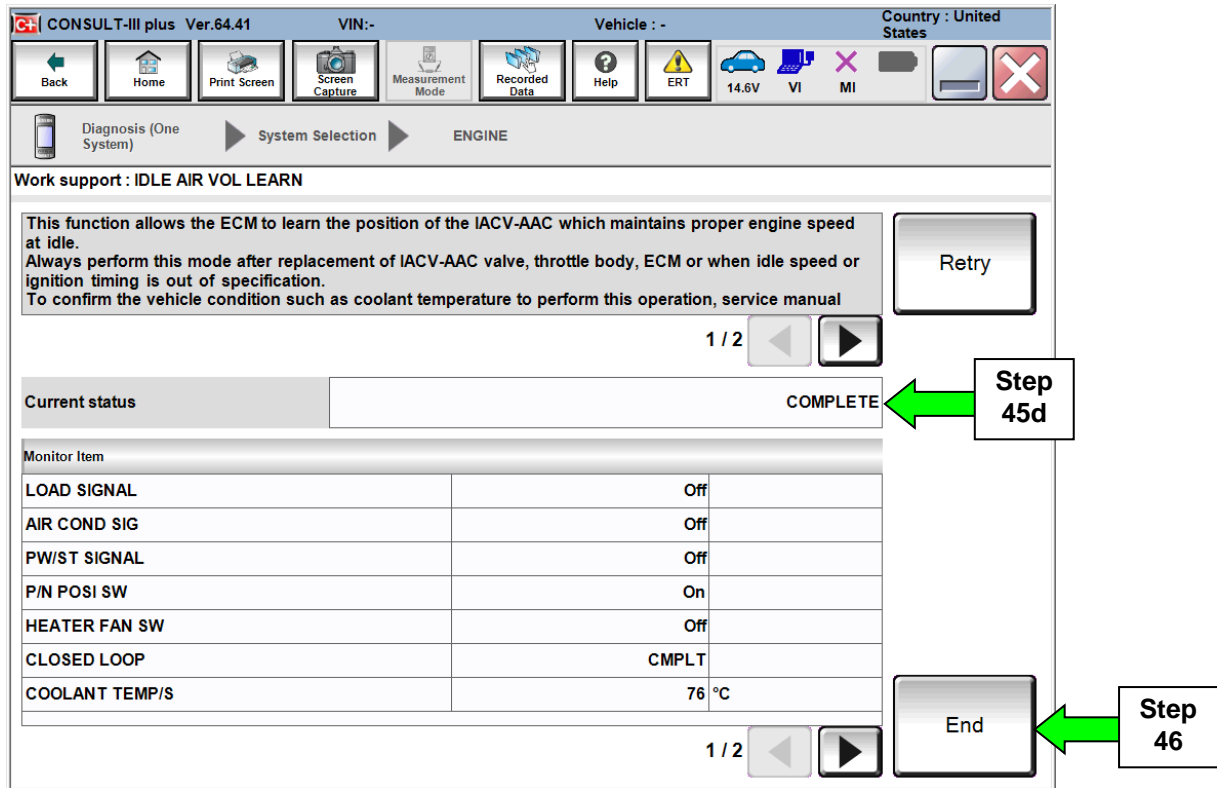
Figure 31

d. Wait for IAVL to complete.
