VOLKSWAGEN DEALERSHIP COMMUNICATION

Subject: Upcoming Update 97CH – Body Control Module Software Update
2016-2017 MY Volkswagen Golf, GTI and Golf Sportwagen

This update has been proactively released to prevent false light bulb failure detection in the instrument cluster.

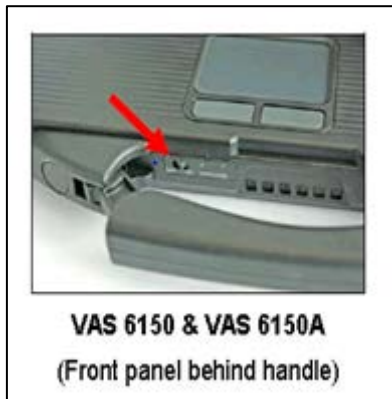
- Connect the tester to the on-line network using an Ethernet cable.
- Connect the VAS 5054A transmitter head to the VAS tester using the USB cable.
- Disable Bluetooth by physically turning the switch to the off position.

- Connect the tester using an Ethernet "hard line" cable between the tester and the on-line network. **DO NOT USE WI-FI.**
- Connect a USB cable between the transmitter head and the tester. Failure to do so may lead to errors during the flash procedure.
- **DISABLE BLUETOOTH and ensure that the tester is NOT communicating via Bluetooth as the Bluetooth protocol is not a robust data transfer environment for the flash process. DO NOT USE BLUETOOTH for flashing. Control module failures caused by flashing via Bluetooth will not be covered.**

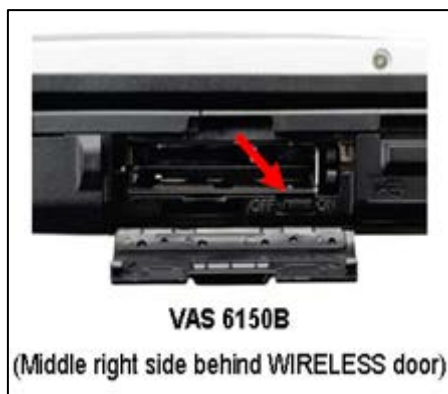
If the Bluetooth wireless VAS 5054A transmitter head is used in conjunction with a VAS tester, the transmitter head **MUST BE** connected with a USB cable to the tester.

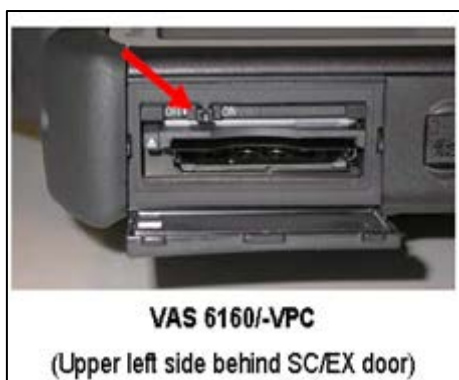
The Bluetooth function of the scan tool **MUST BE PHYSICALLY SWITCHED OFF** prior to performing this update. <See pictures>
