UPDATE Technical Bulletin

May 05, 2015

2309 UPDATE – 2.0L TDI ECM Software (FED_EMS)

Model(s)	Year	Engine Code	Trans. Code
Passat	2015	2.0L TDI (CVCA)	DSG (02E), Manual (02Q)
Jetta	2015	2.0L TDI (CVCA)	DSG (02E), Manual (02Q)
Beetle/Beetle Convertible	2015	2.0L TDI (CVCA)	DSG (02E), Manual (02Q)
Golf/Golf SportWagen	2015	2.0L TDI (CRUA)	DSG (02E), Manual (02Q)

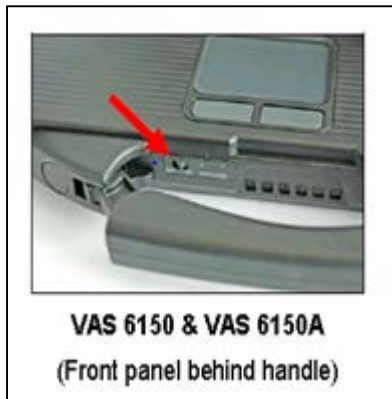
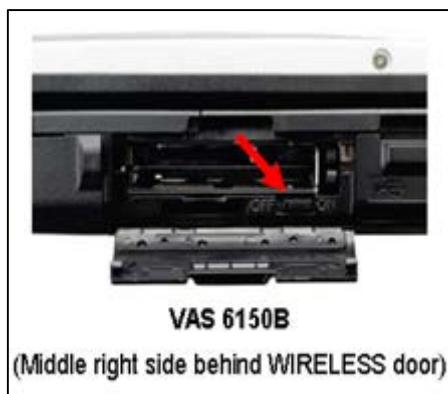
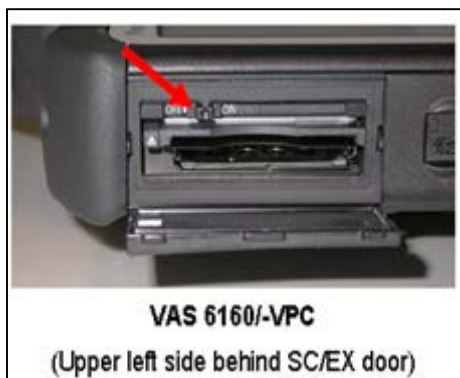
- Connect the tester to the on-line network using an Ethernet cable.
- Connect the VAS 5054A transmitter head to the VAS tester using the USB cable.
- Disable Bluetooth by physically turning the switch to the off position.

If the Bluetooth wireless VAS 5054A transmitter head is used in conjunction with a VAS tester, the transmitter head **MUST BE** connected with a USB cable to the tester.

The Bluetooth function of the scan tool **MUST BE PHYSICALLY SWITCHED OFF** prior to performing this update. <See pictures>

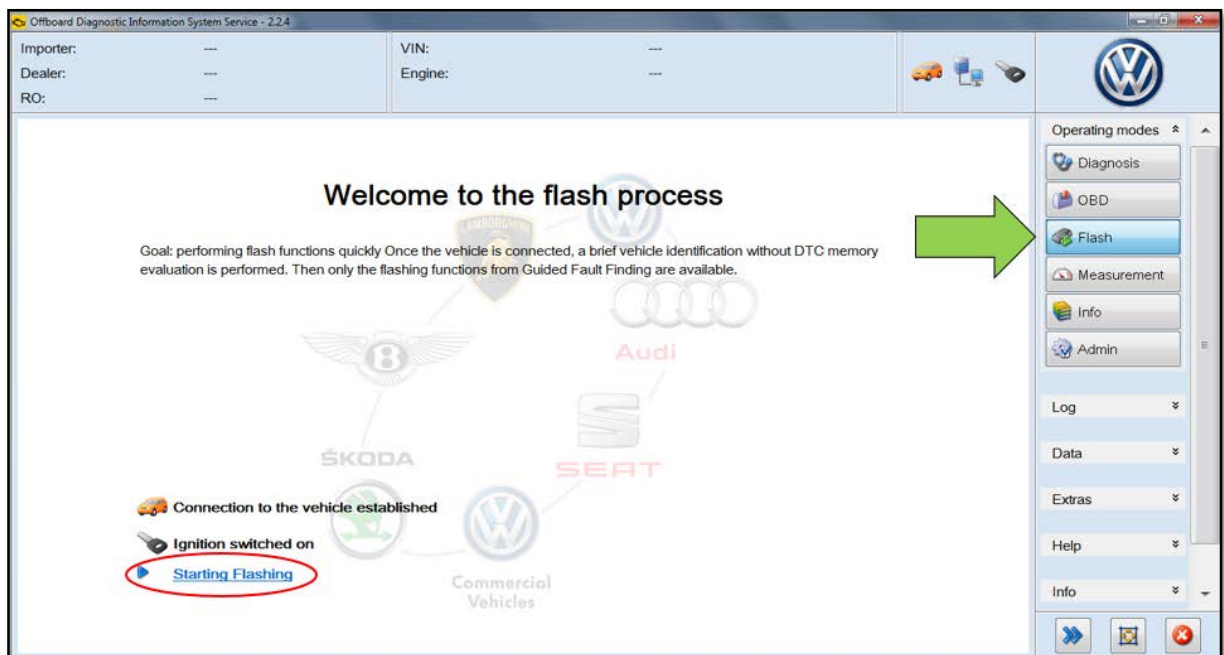
- Select the "Flash" operating mode <arrow>.
- Select "Starting Flashing" <circle>.
- Follow the on-screen directions.

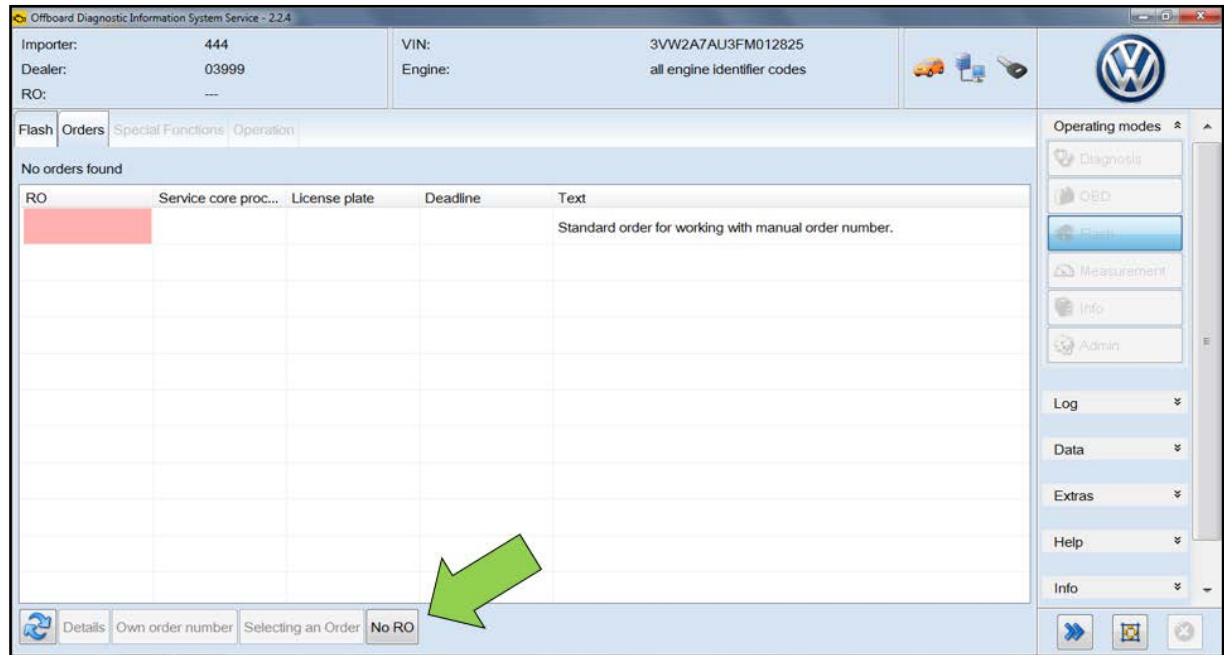
- Select "No RO" <arrow>.

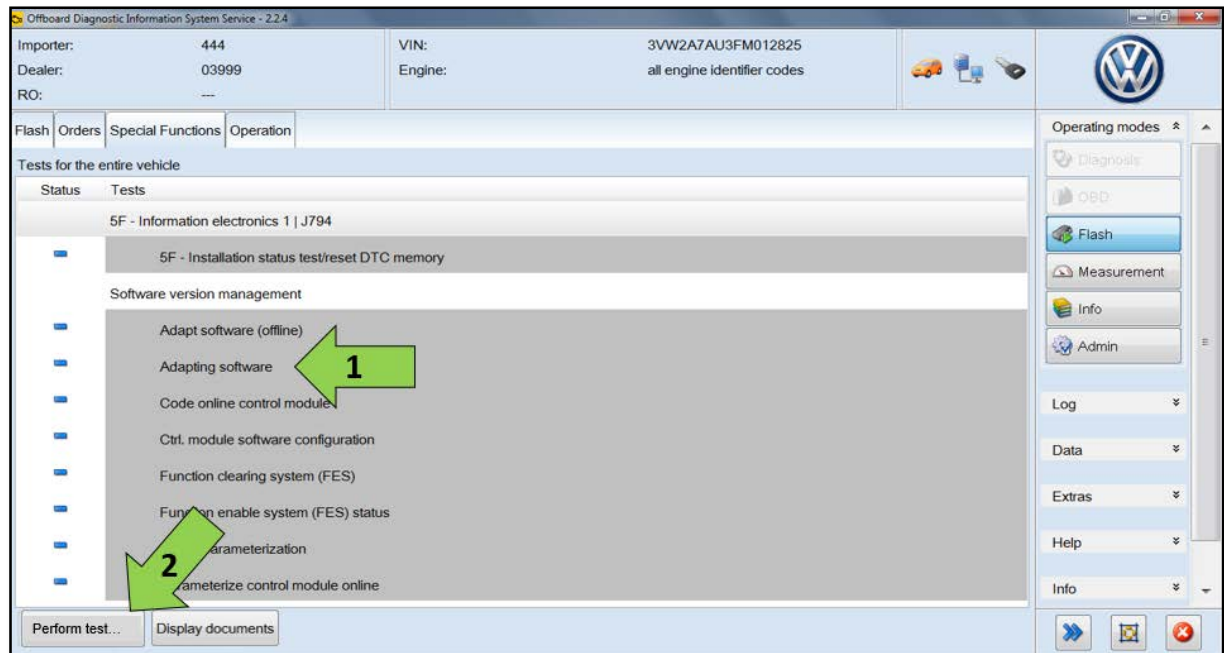
- Select "Adapting Software" <arrow 1>.
- Select "Perform Test" <arrow 2>.

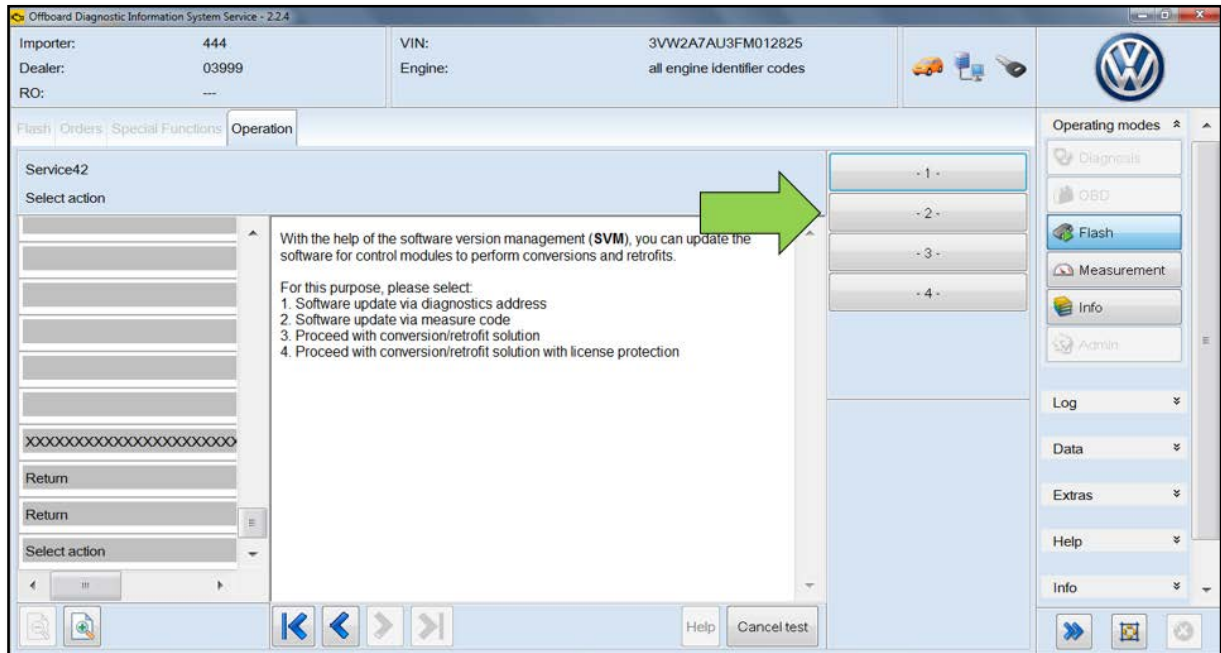
- Select “Software update via measure code” <arrow>.

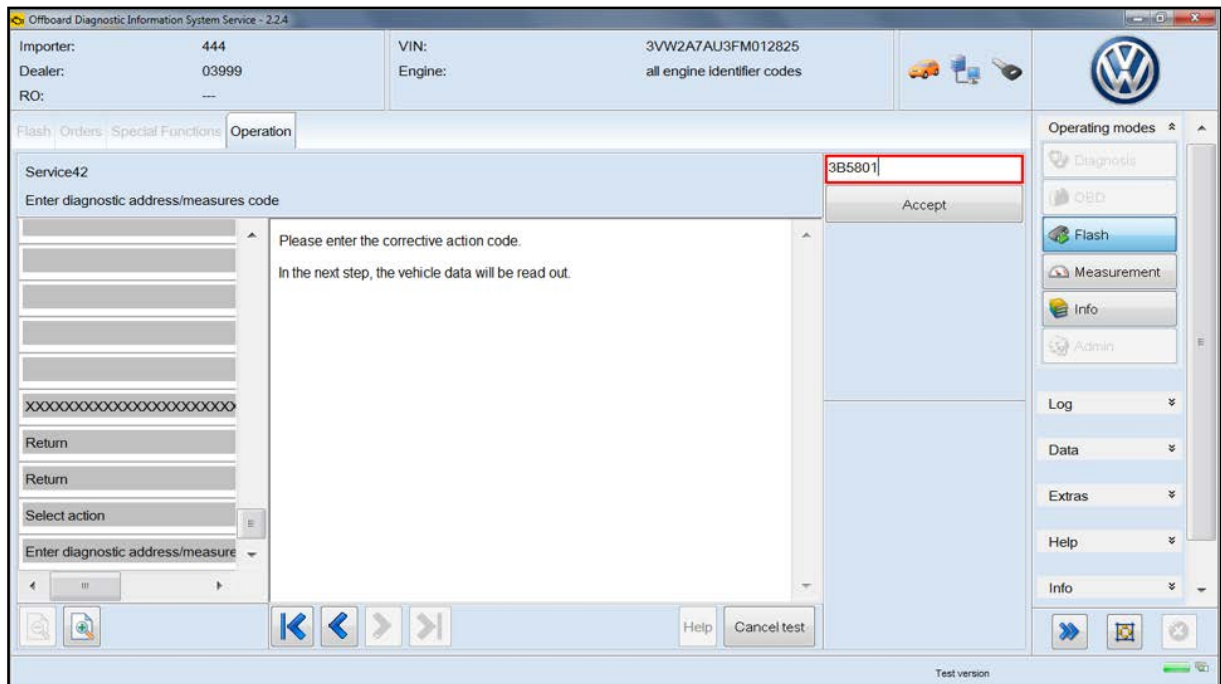
- When prompted, enter SVM code “3B5801” <as shown>.

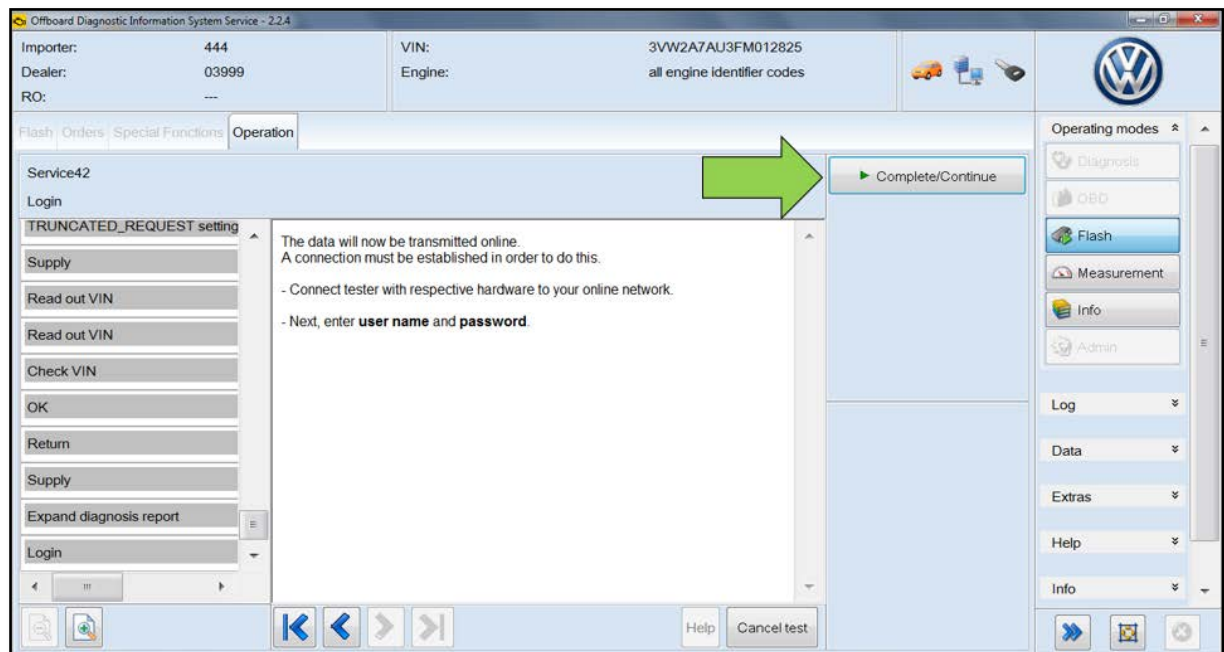
- Select “Complete/Continue” <arrow>.
- When prompted, enter your Geko ID and password.
- Follow the on-screen directions and complete the ECM software update.
- Reference the chart below for applicable Part Number and Software Level information.
