CAMPAIGN BULLETIN

Electronic Power Steering (EPS) Retailer Inventory

Reference: P8301

P8301 2018 Q60 (CV37) ELECTRONIC POWER STEERING (EPS) REPROGRAMMING

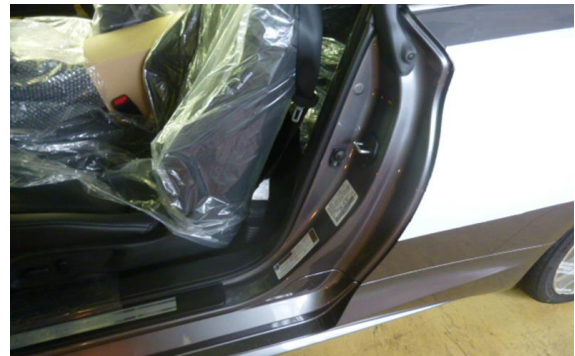
Figure 1

1. Open the Driver Door.

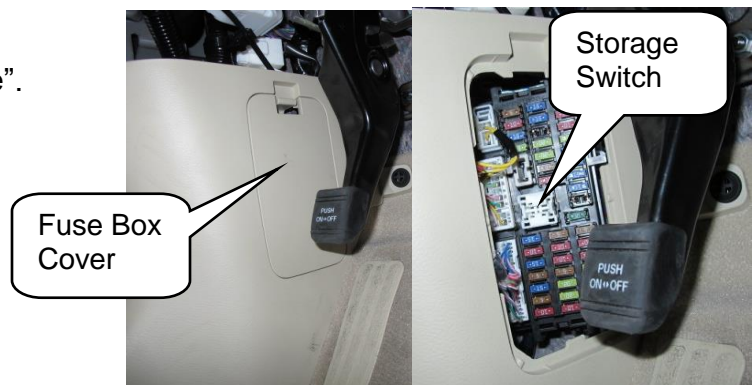
Figure 2

2. Verify the vehicle is out of “Shipping Mode”.

- Remove the fuse box cover on the Driver kick panel.
- **Push-in** the Storage Switch (White Square Button).

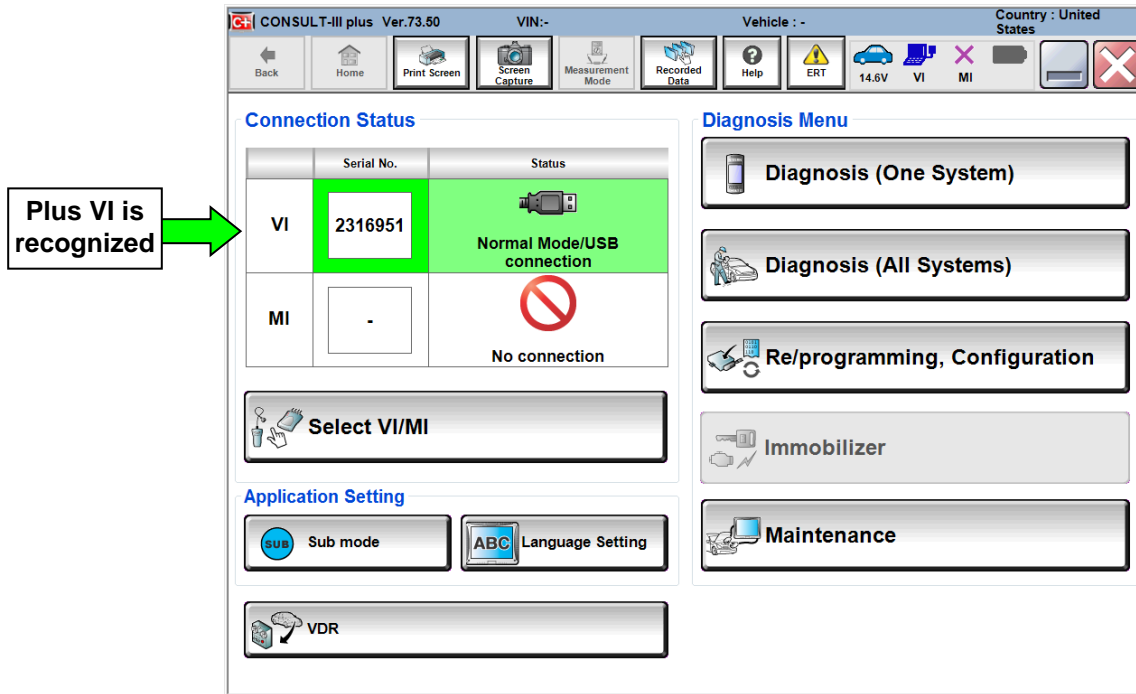
Figure 3

11. Wait for the plus VI to be recognized / connected.

- Serial number will display when the plus VI is recognized / connected.

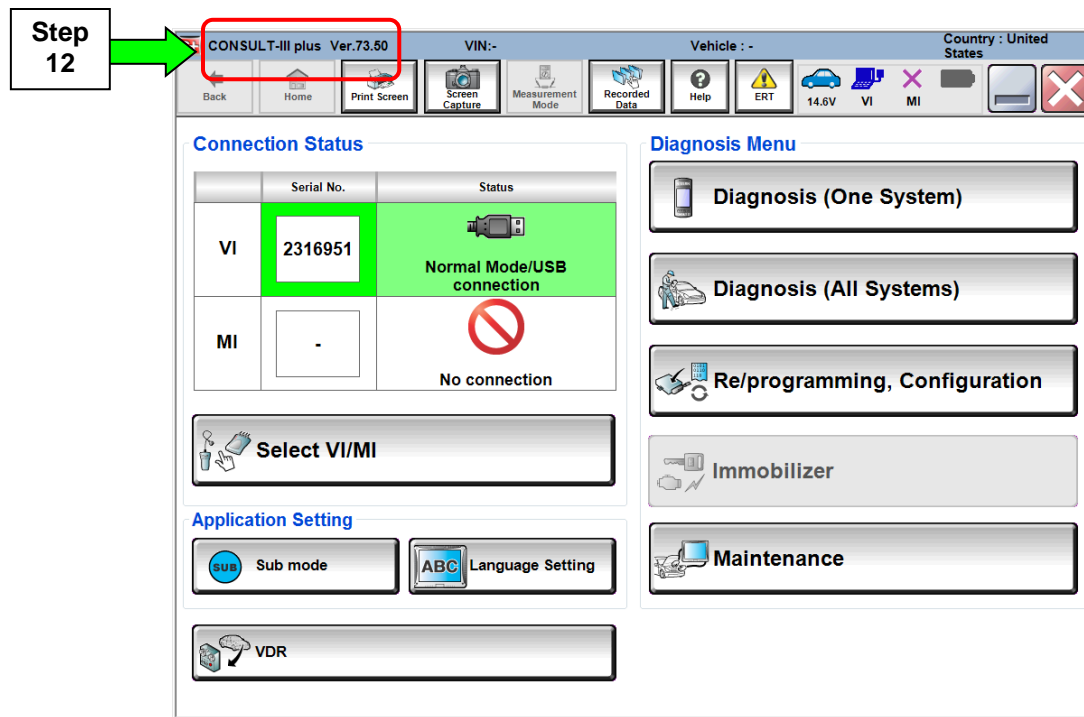
Figure 4

12. Verify CONSULT-III plus is updated to version **73.50** or higher.

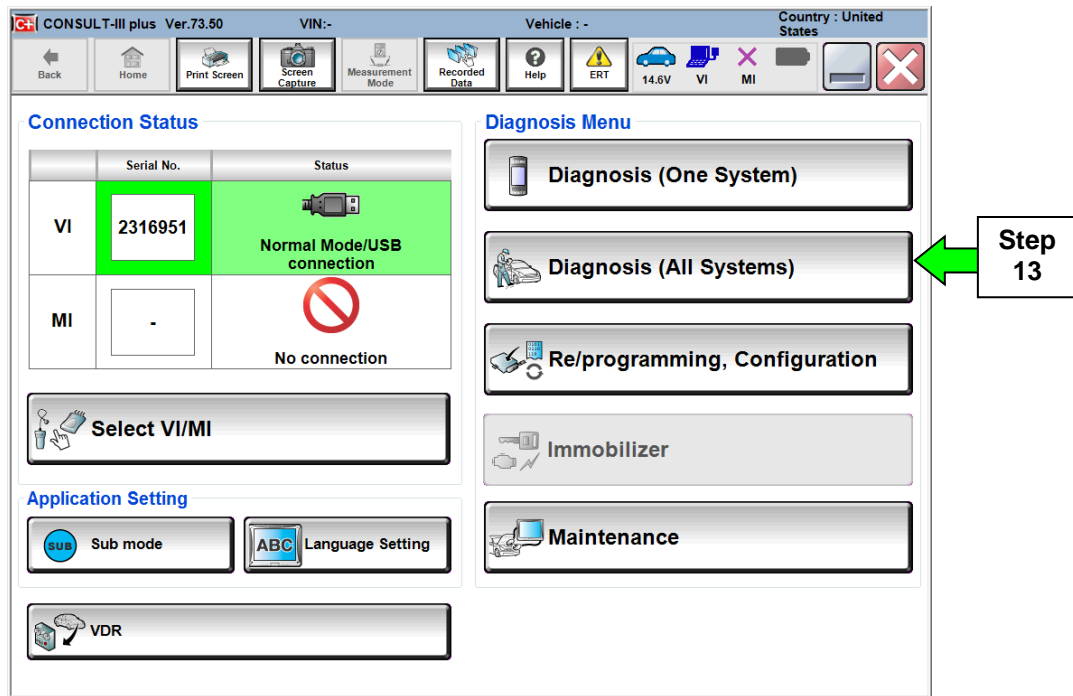
Figure 5

13. Check for DTC's. Select **Diagnosis (All Systems)**.

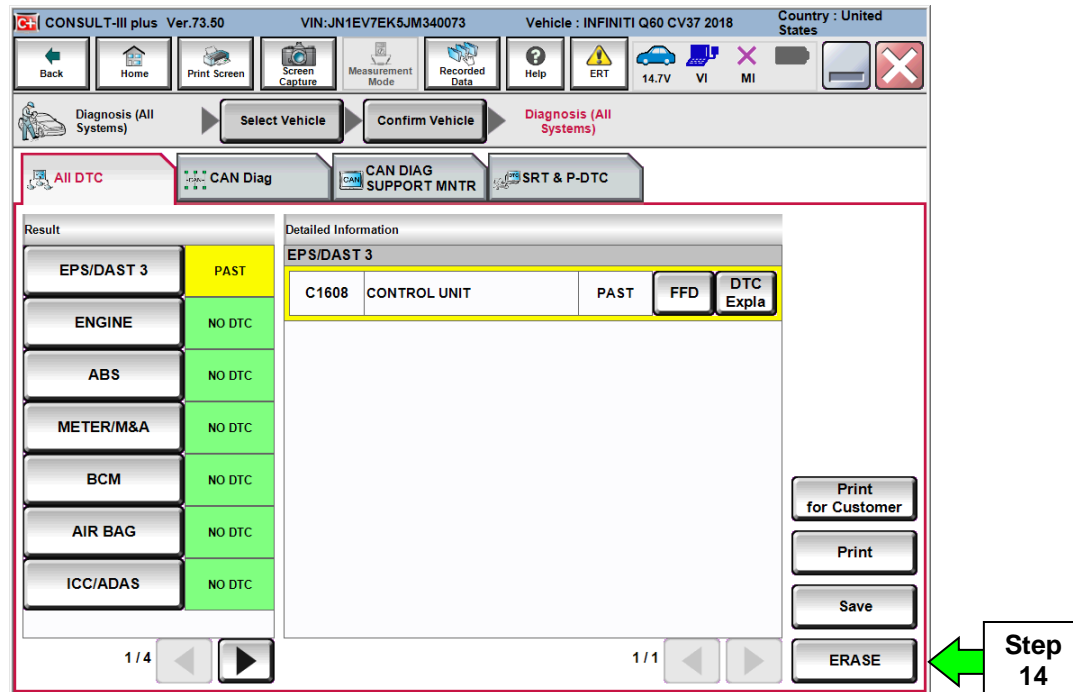
Figure 6

14. Erase any DTC's. Select **ERASE**.

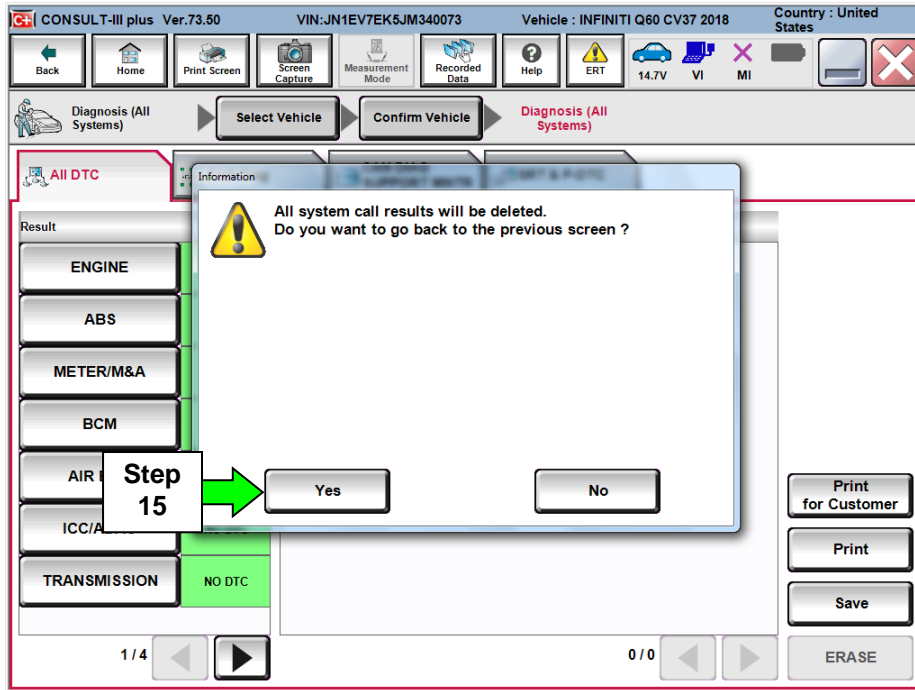
Figure 7

15. Select **Yes** to complete system call. Once the system call is complete the screen shown in Figure 8 will be displayed.

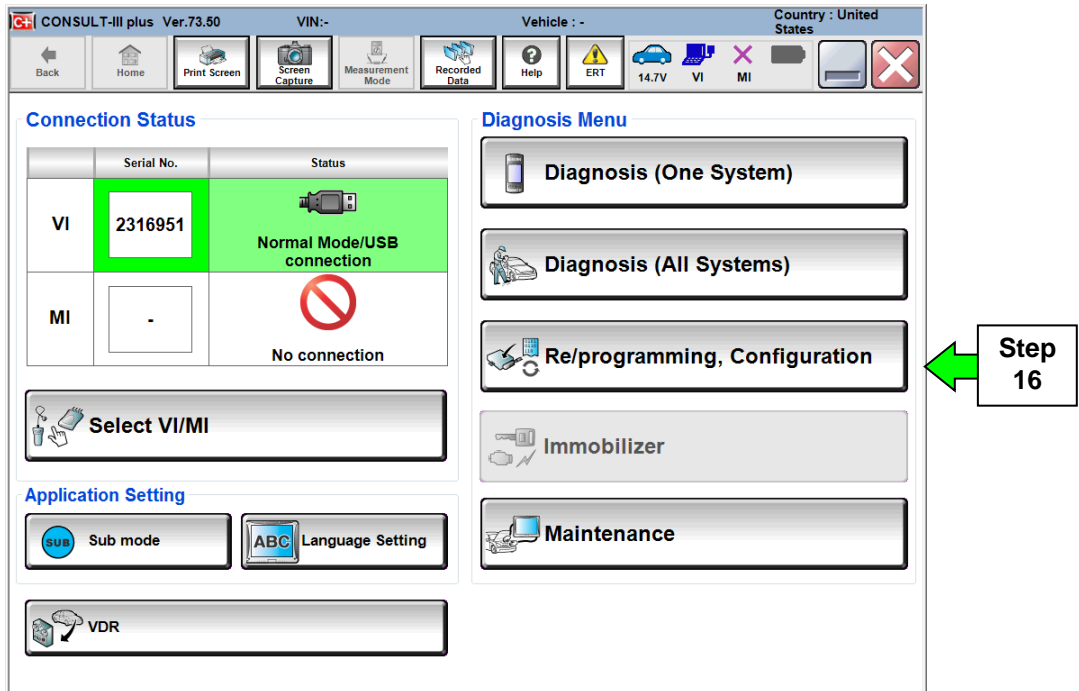
Figure 8

16. Select **Re/programming, Configuration**.

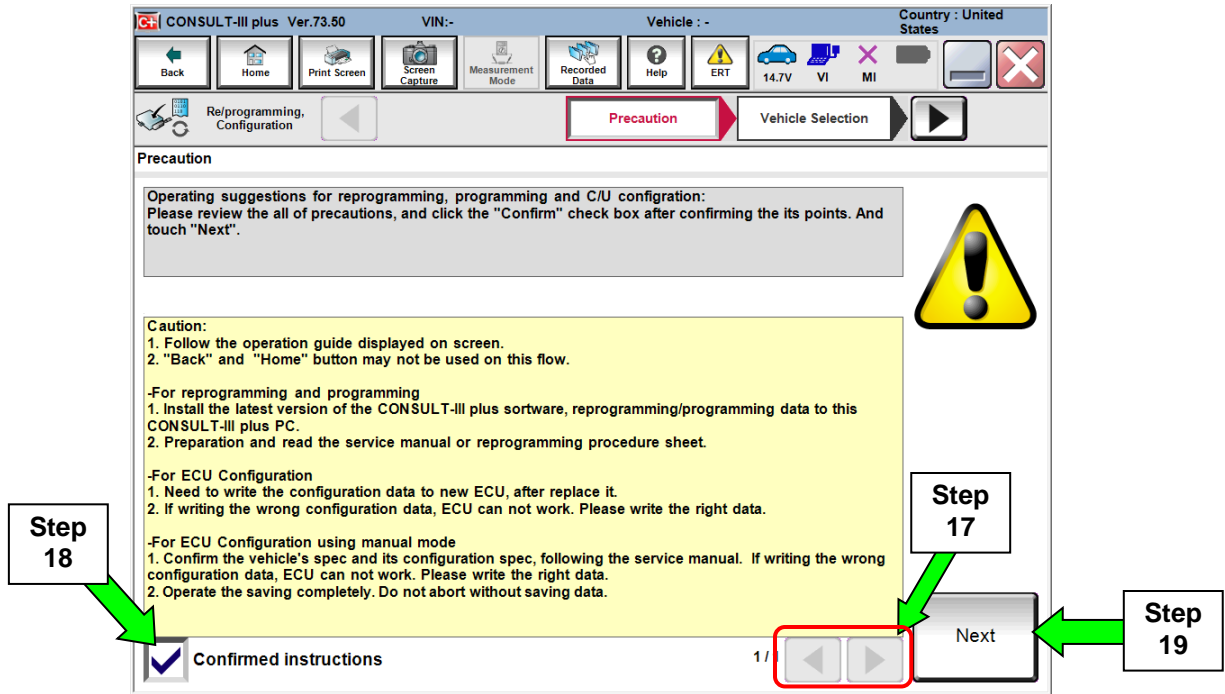
Figure 9

17. Use arrows (if needed) to view and read all precautions.
18. Check the box confirming the precautions have been read.
19. Select **Next**.

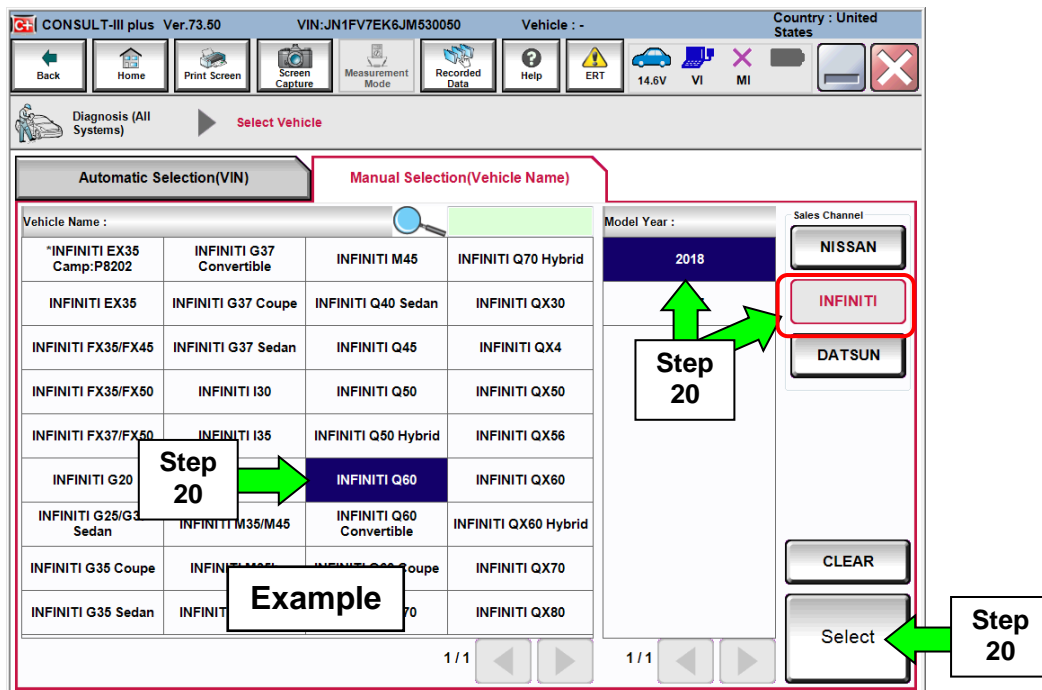
Figure 10

20. Use **Automatic Selection (VIN)** tab to select the vehicle (the screen in Figure 11 will display when complete).

NOTE: If the vehicle is not automatically identified, then use **Manual Selection(Vehicle Name)** tab. Select **Infiniti**, **Vehicle Name (INFINITI Q60)**, and then the correct **Model Year (2018)**. Click **Select**.

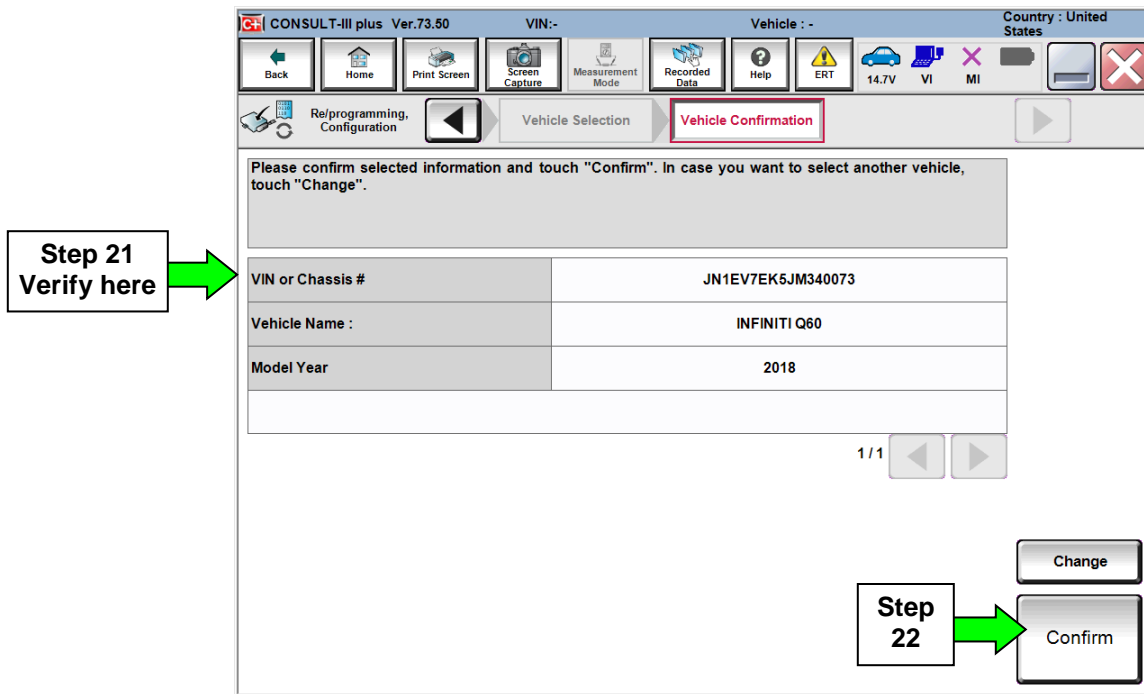
Figure 11

21. Make sure **VIN or Chassis #** matches the vehicle's VIN.

22. If the correct VIN is displayed, select **Confirm**.

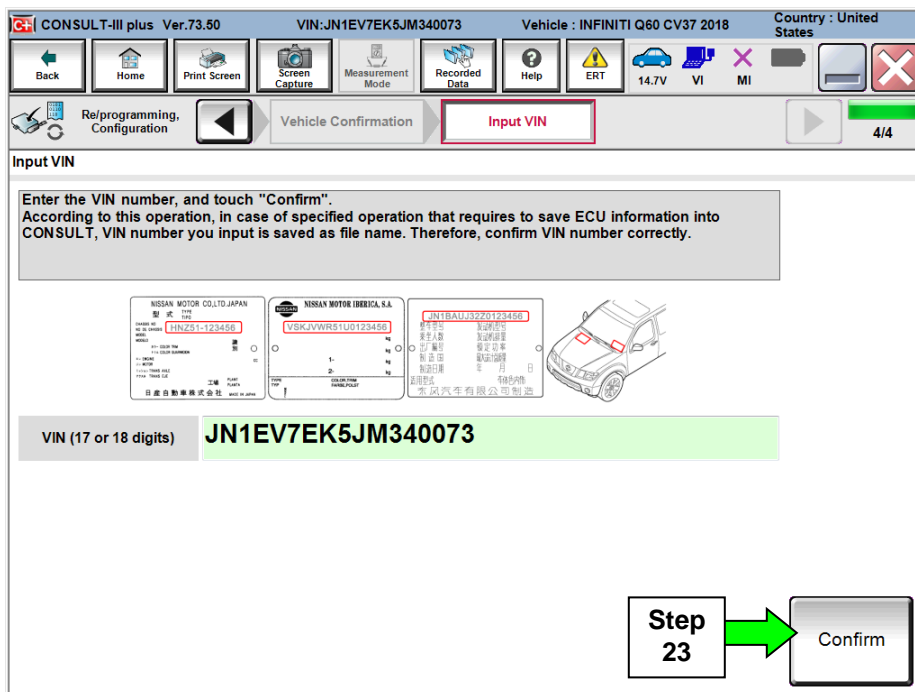
Figure 12

23. Select **Confirm**.

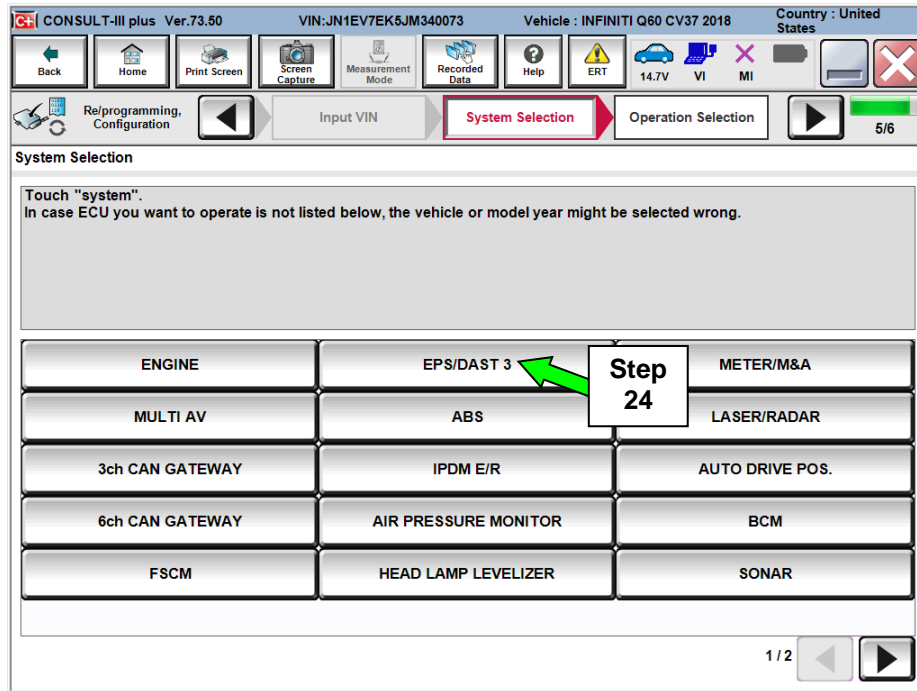
Figure 13

24. Select **EPS/DAST 3**.

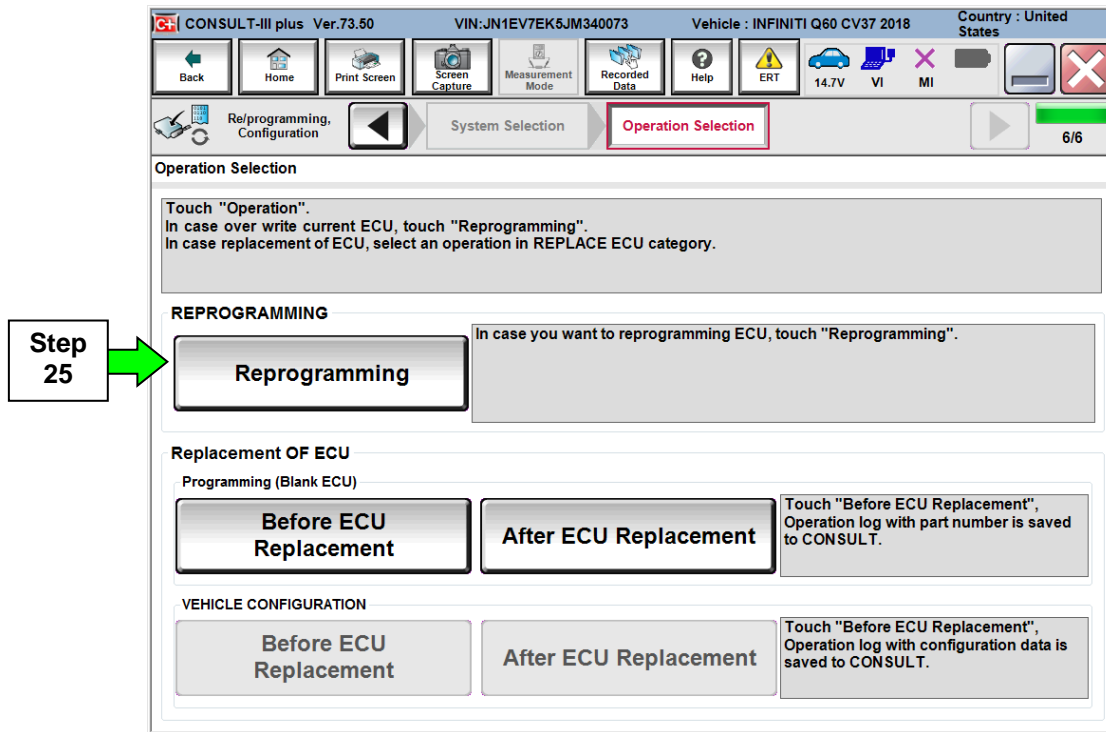
Figure 14

25. Select **Reprogramming**.

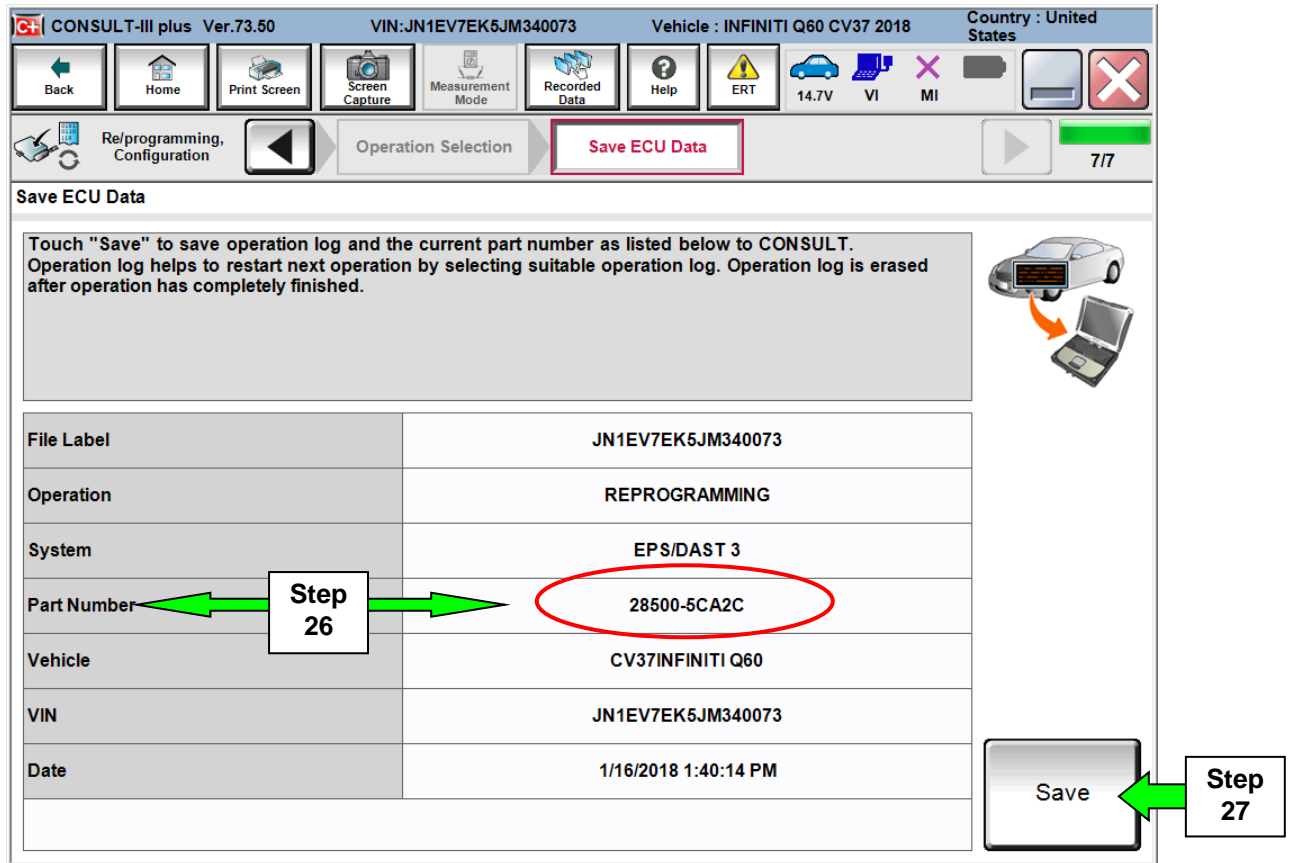
Figure 15

26. When you get to the screen shown in Figure 15, confirm this bulletin applies as follows:

A. Find the EPS **Part Number** and write it on the repair order.

NOTE: This is the current Part Number (P/N).

B. Compare the P/N you wrote down to the numbers in the **Current EPS Part Number** column in **Table A** below.

- If there is a match, this bulletin applies. Continue with the reprogramming procedure.
- If there is not a match, this bulletin does not apply. Close C-III plus and refer to Asist for further diagnostic information.

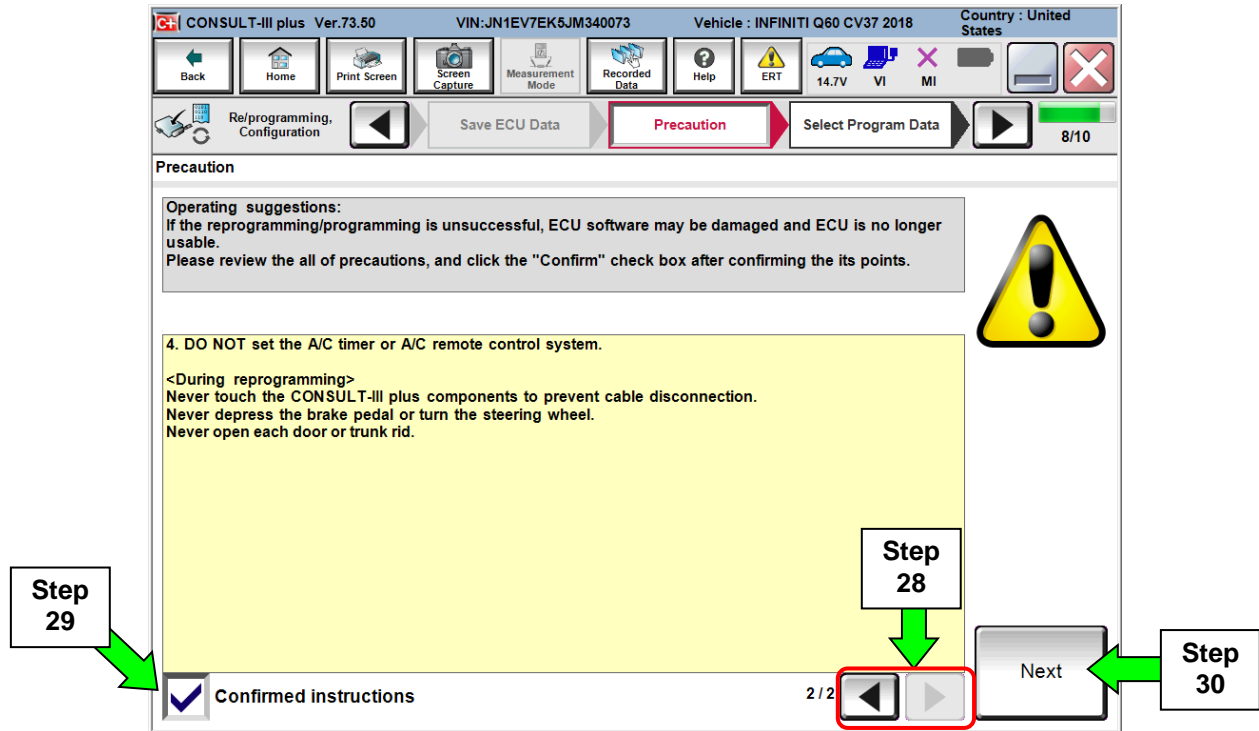
Figure 16

28. Use arrows (if needed) to view and read all precautions.
29. Check the box confirming the precautions have been read.
30. Select **Next**.

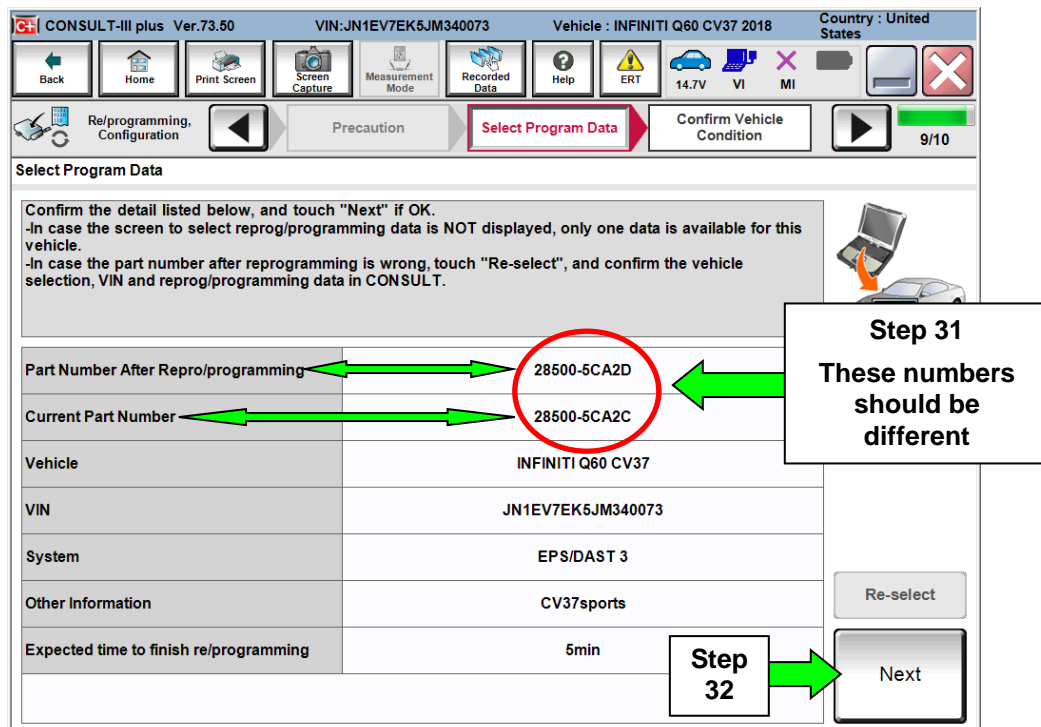
Figure 17

31. Read the **Current Part Number** and **Part Number After Reprogramming**. They should be different.
32. Select **Next**.

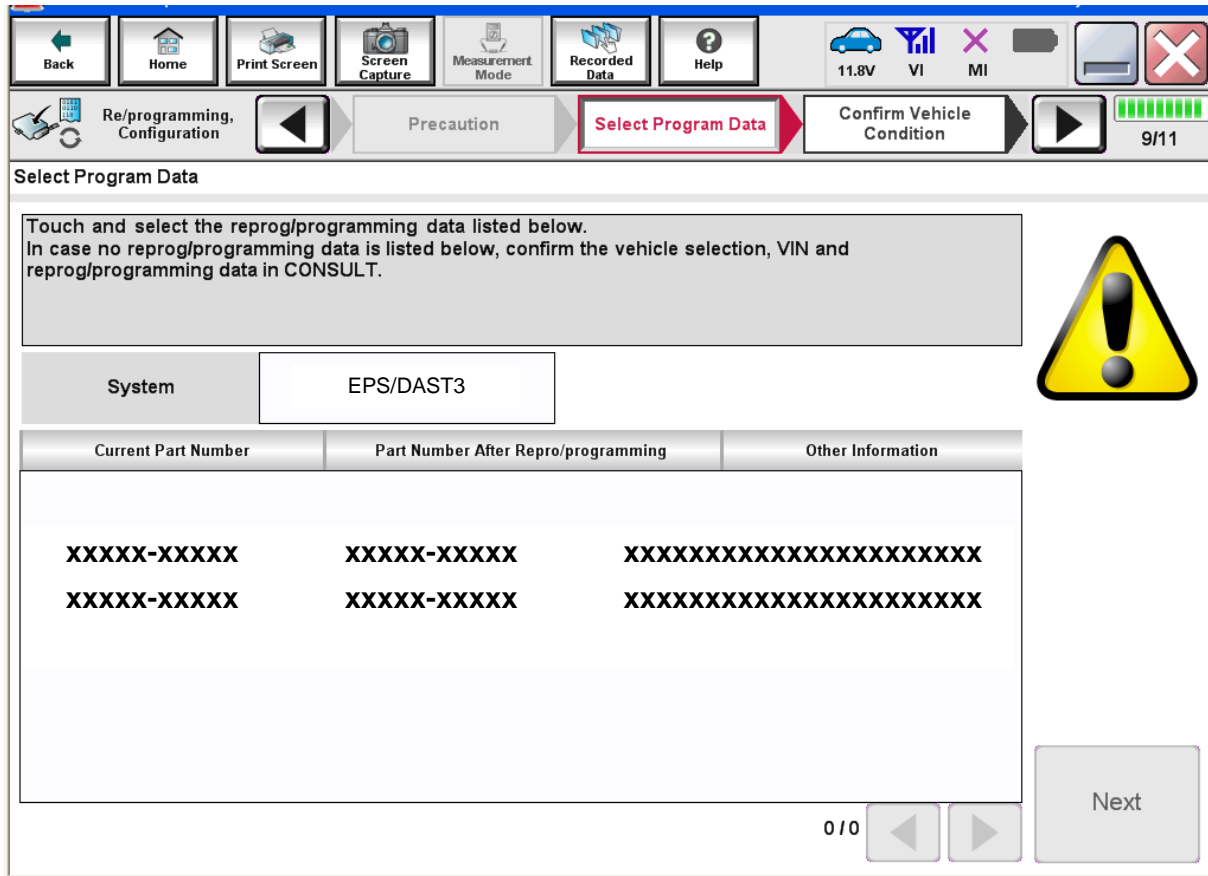
Figure 18

IMPORTANT:

If you get this screen and it is blank (no reprogramming listed), it means there is no matching EPS reprogramming available for this vehicle (**EPS Reprogram is Not Needed**).

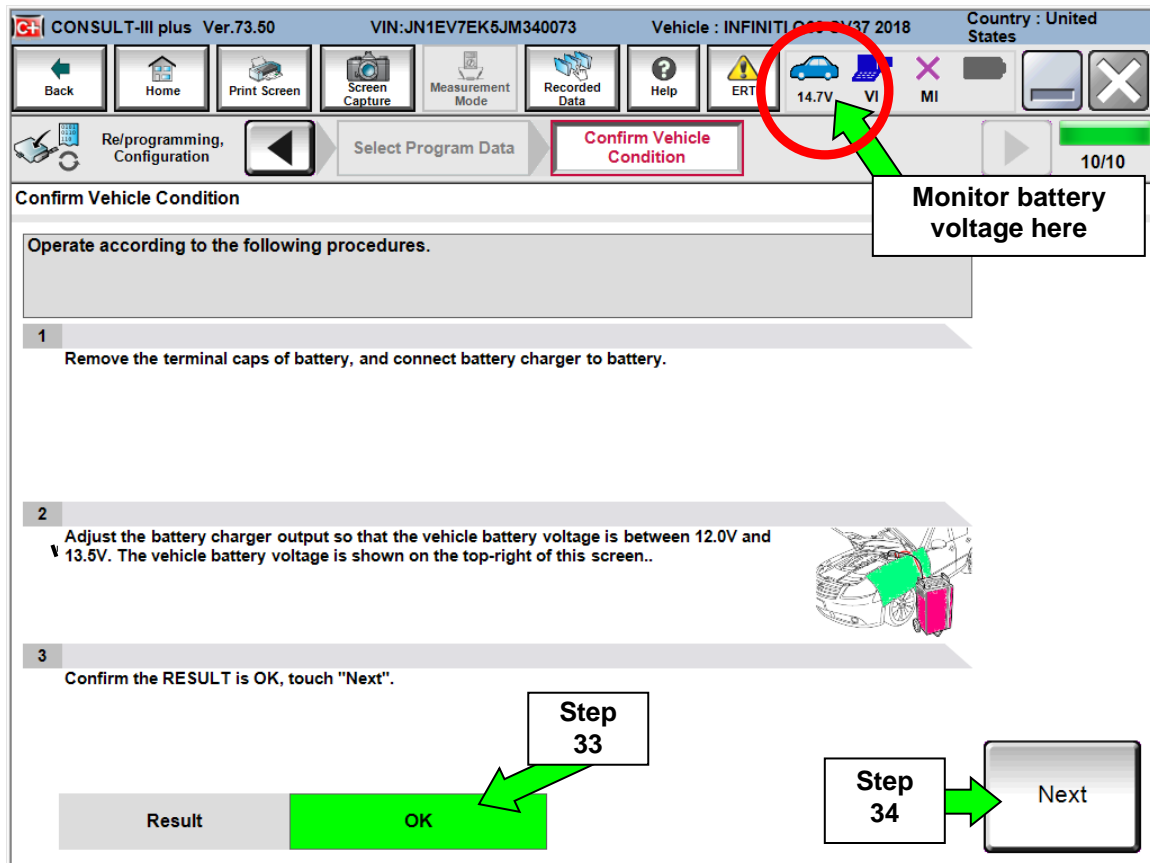
Figure 19

33. Make sure **OK** is highlighted **green** (battery voltage must be between **12.0 and 15.5 Volts**).

34. Select **Next**.

IMPORTANT: Battery voltage must stay between **12.0 and 15.5 Volts** during reprogramming or EPS reprogramming may be interrupted and EPS may be damaged.

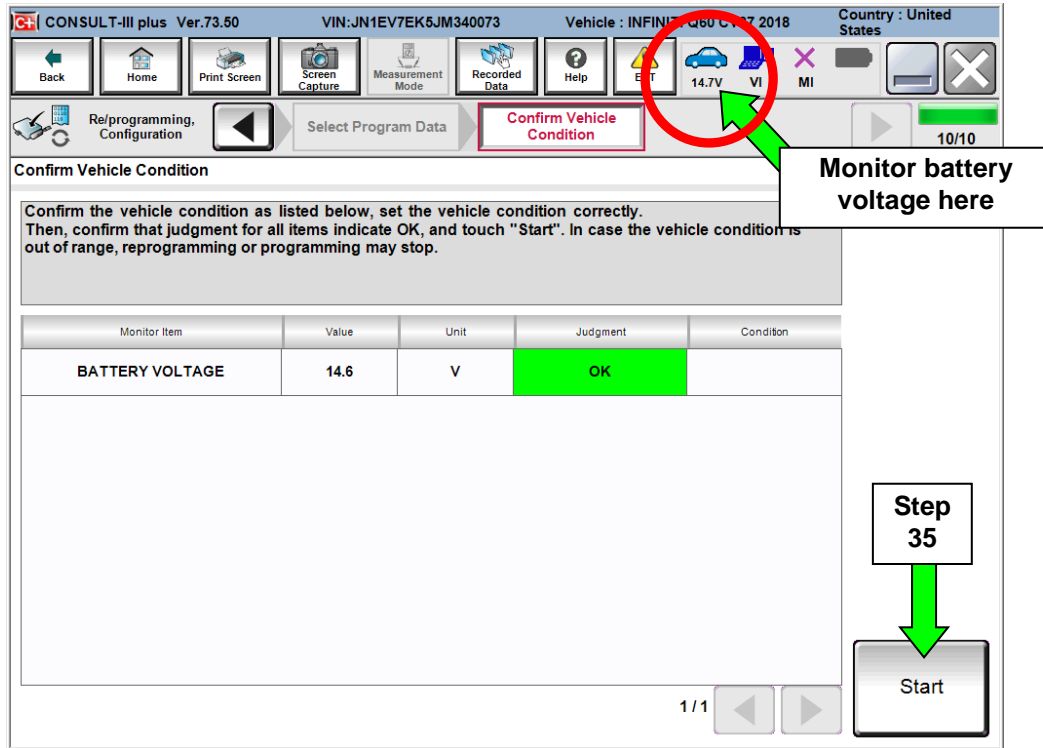
Figure 20

NOTE: In the next step, the reprogramming process will begin when **Start** is selected.

35. Make sure **OK** is highlighted **green** for all Judgements then select **Start**.

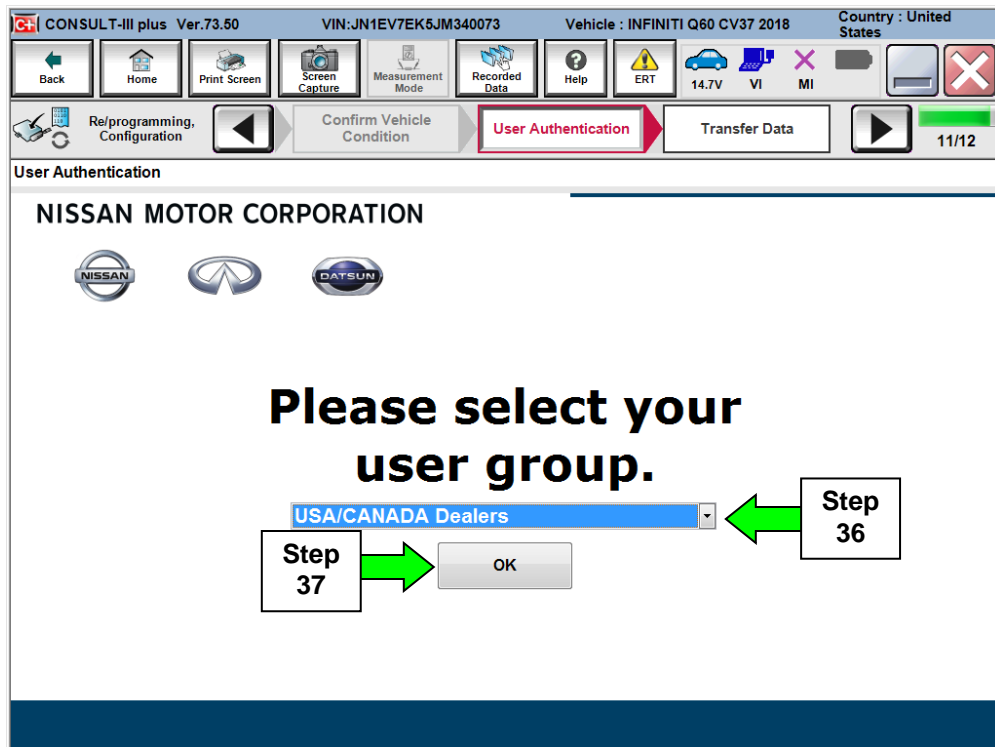
Figure 21

36. Select the user group **USA/CANADA Dealers** using drop down menu.

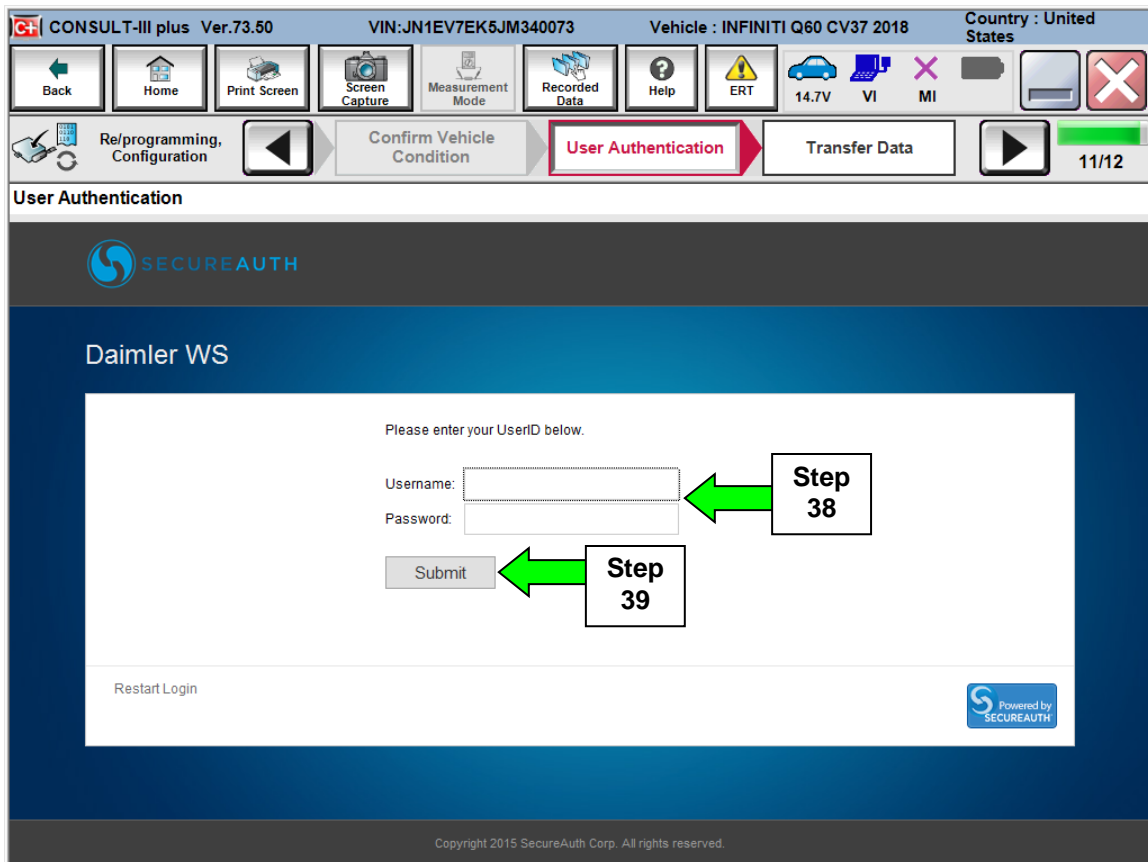
Figure 22

38. Enter Username and Password.

- Before reprogramming will start, you will be required to enter your User Name and Password.
 - The CONSULT PC must be connected to the Internet (Wi-Fi or cable).
 - If you do not know your User Name and Password, contact your Service Manager.

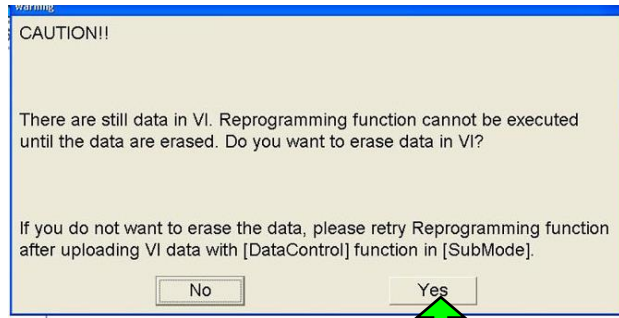
NOTE: If the message shown in Figure 24 appears, there is data stored in the plus VI. Select **“Yes”** to proceed with reprogramming.

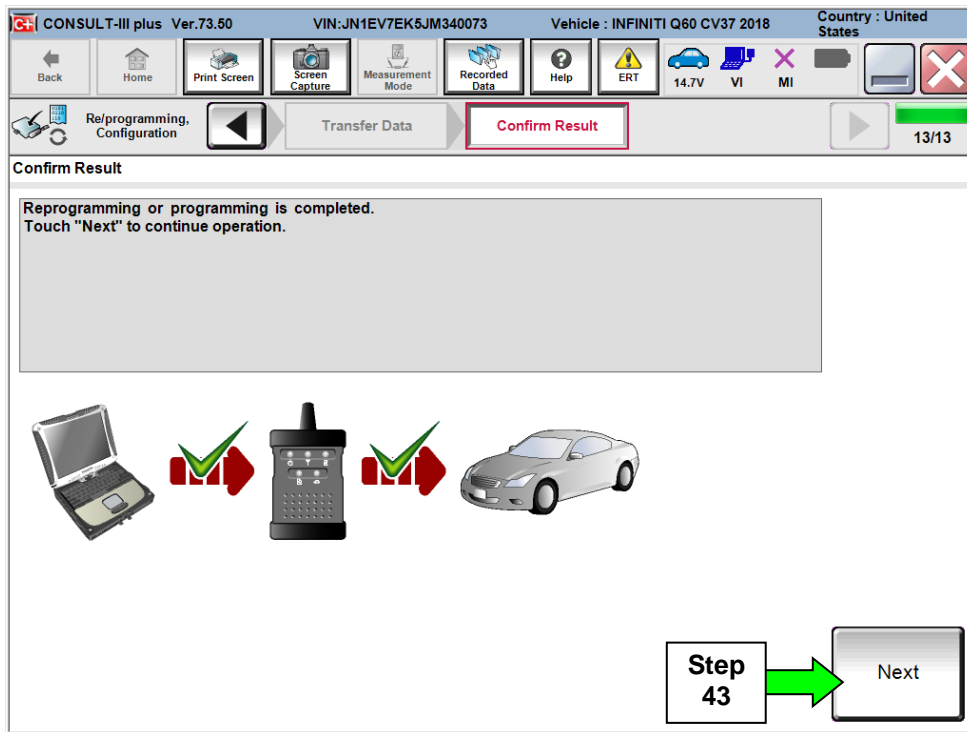
41. When the screen in Figure 25 displays, the reprogramming is complete.

NOTE: If the screen in Figure 25 does not display (reprogramming does not complete), refer to the information on the next page.

NOTE: Additional steps/operations are required before C-III plus will provide the final reprogramming confirmation report (Proceed to Step 44).

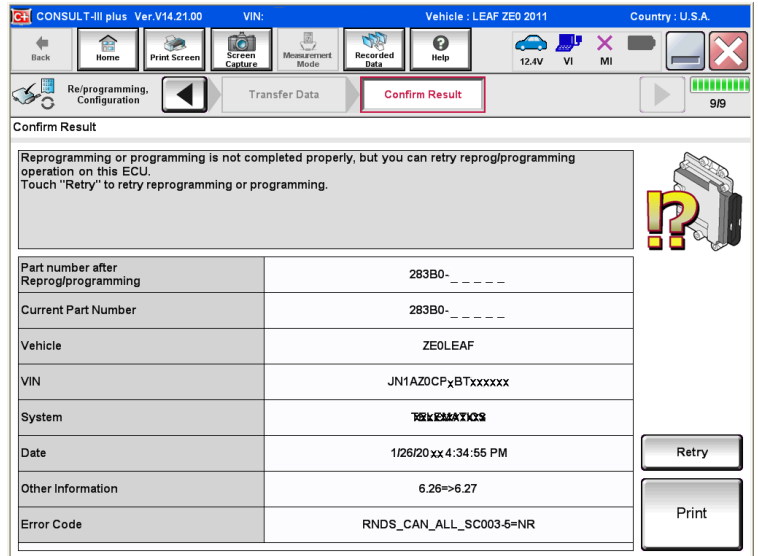
Figure 26

If reprogramming does not complete and the “!?” symbol displays as shown in Figure 26:

- Check battery voltage (12.0 – 15.5V).
- Ignition is ON.
- External Bluetooth® devices are OFF.
- All electrical loads are OFF.
- **Select Retry and follow the on screen instructions.**

NOTE: Retry may not go through on first attempt and can be selected more than once.

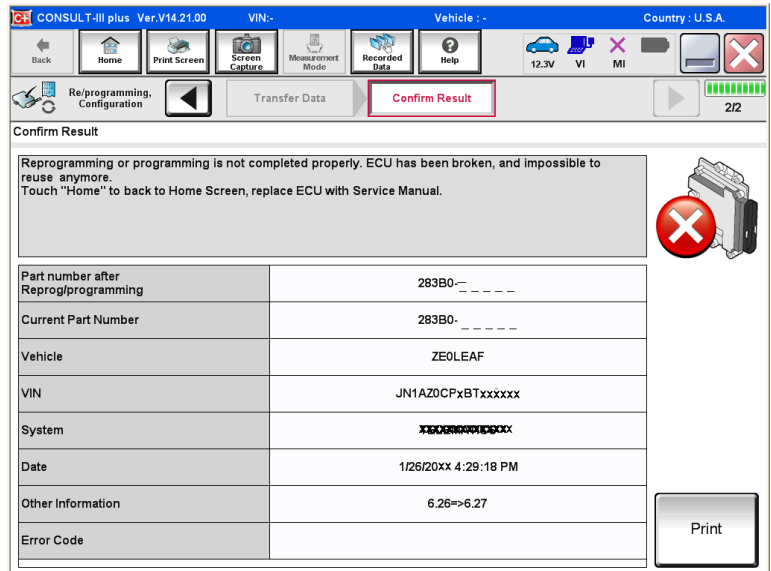
Figure 27

If reprogramming does not complete and the “X” symbol displays as shown in Figure 27:

- **Do not disconnect the plus VI or shut down C-III plus if reprogramming does not complete.**
- Check battery voltage (12.0 – 15.5V).
- CONSULT A/C adapter is plugged in.
- Ignition is ON.
- Transmission in Park.
- All C-III plus / plus VI cables are securely connected.
- All C-III plus updates are installed.
- **Select Home, and then restart the reprogram procedure from the beginning.**

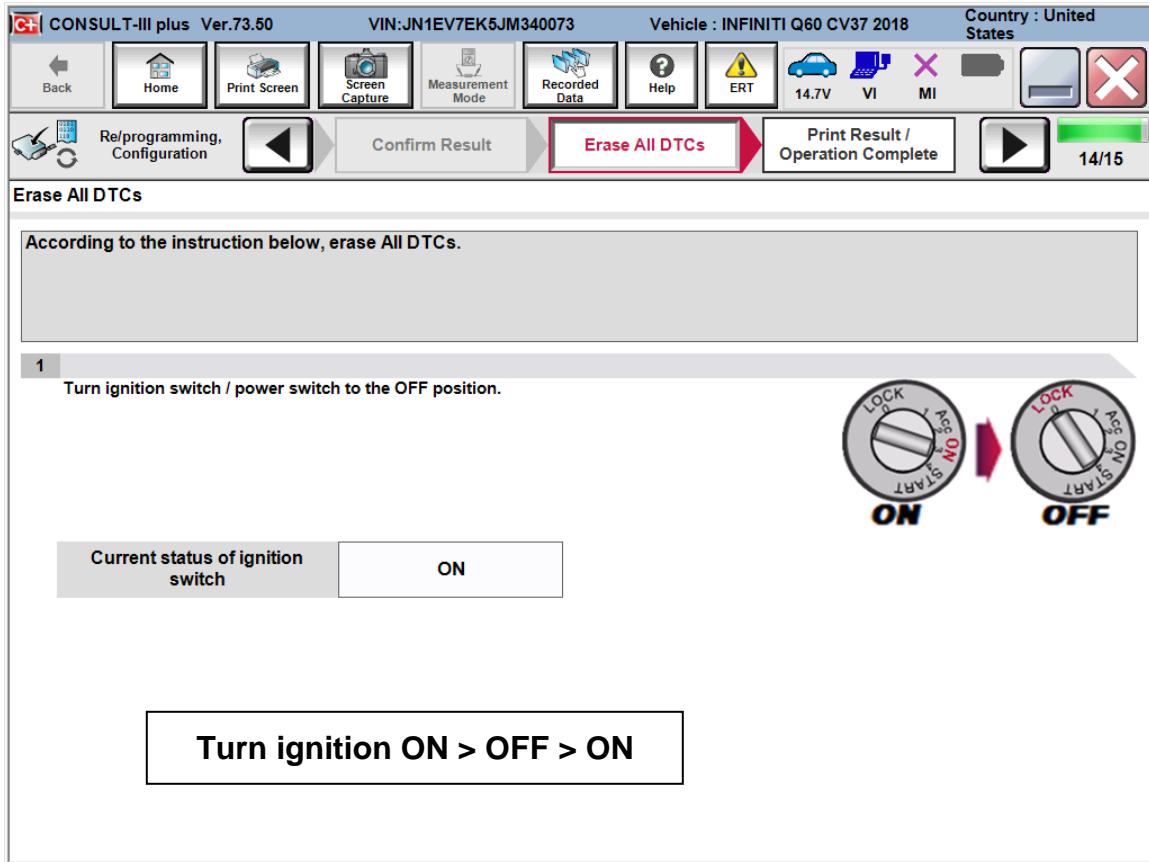
Figure 28

44. **Erase all DTCs** as follows:

- a. Turn the ignition OFF
- b. Turn the Ignition ON.
- c. Wait for DTC erase to complete.
