Surge, Hesitation, or Judder on Light Acceleration from a Stop

(Supersedes 13-053, dated August 28, 2013, to revise the information marked by the black bars)

The continuously variable transmission (CVT) needs hardware and software updates.

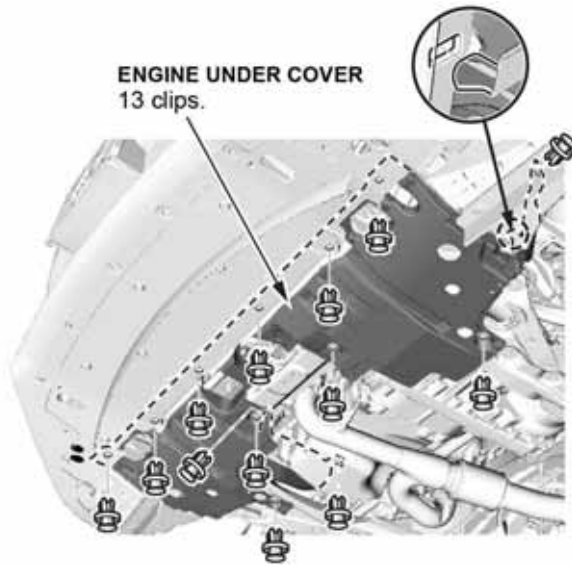
1. Raise the vehicle on a lift.
2. Remove the engine under cover.

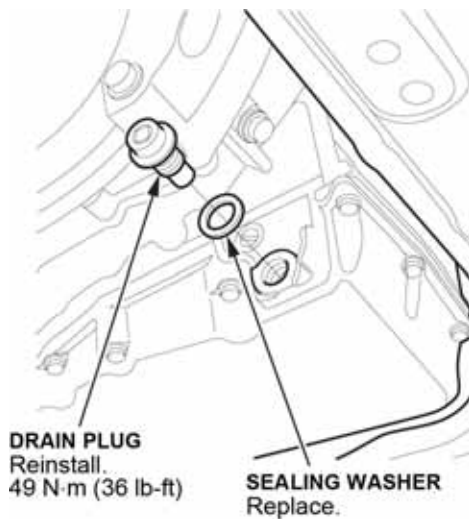
3. Remove the transmission drain plug, and drain the CVT fluid.

NOTE: Clean and remove any metal particles from the magnetic drain plug.

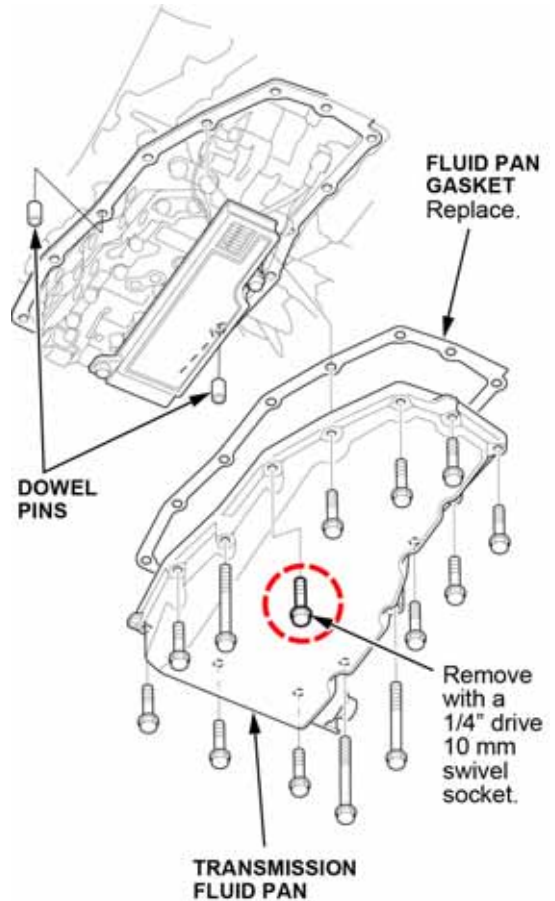
5. Remove the transmission fluid pan, then remove the dowel pins. Remove the transmission fluid pan gasket; it will not be reused.

NOTE: One fluid pan bolt is partially obstructed by the subframe; remove it using a 1/4" drive 10 mm swivel socket.

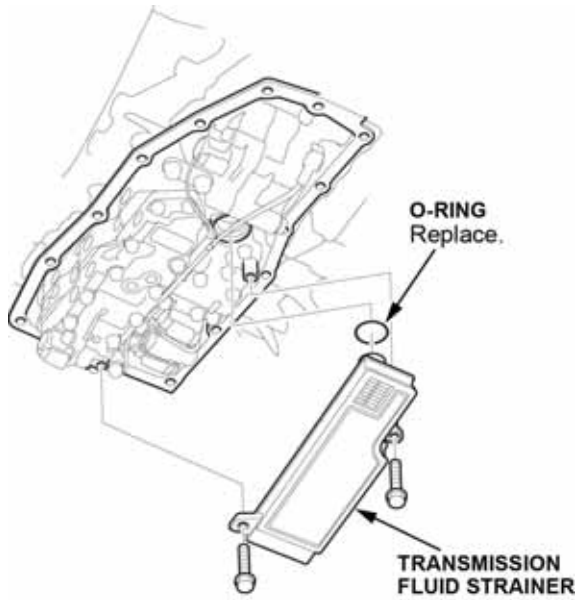
6. Remove the transmission fluid strainer and the O-ring.

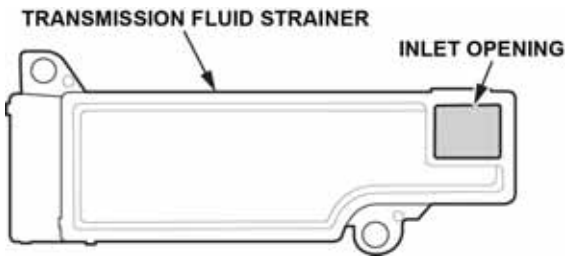
7. Inspect and clean the inlet opening of the transmission fluid strainer as needed. Replace it if it is clogged or damaged.

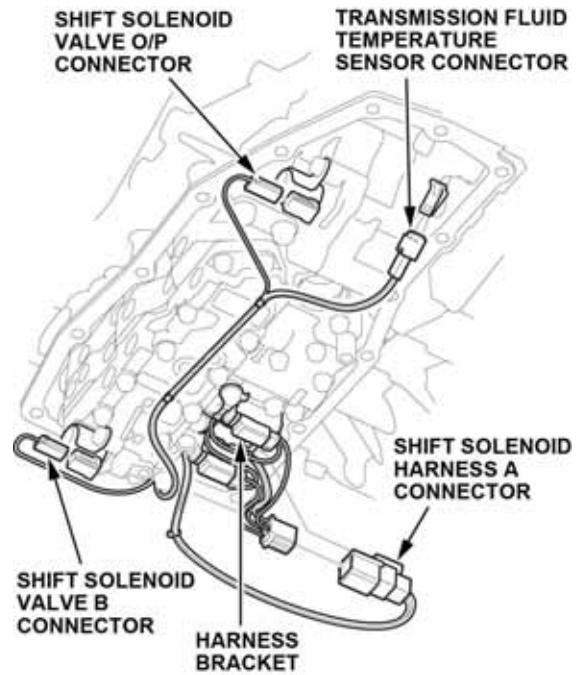
8. Remove the transmission fluid temperature sensor connector. Remove the shift solenoid harness A connector from the harness bracket. Disconnect the following connectors:

- Shift solenoid harness A connector
- Shift solenoid valve B connector
- Shift solenoid valve O/P connector

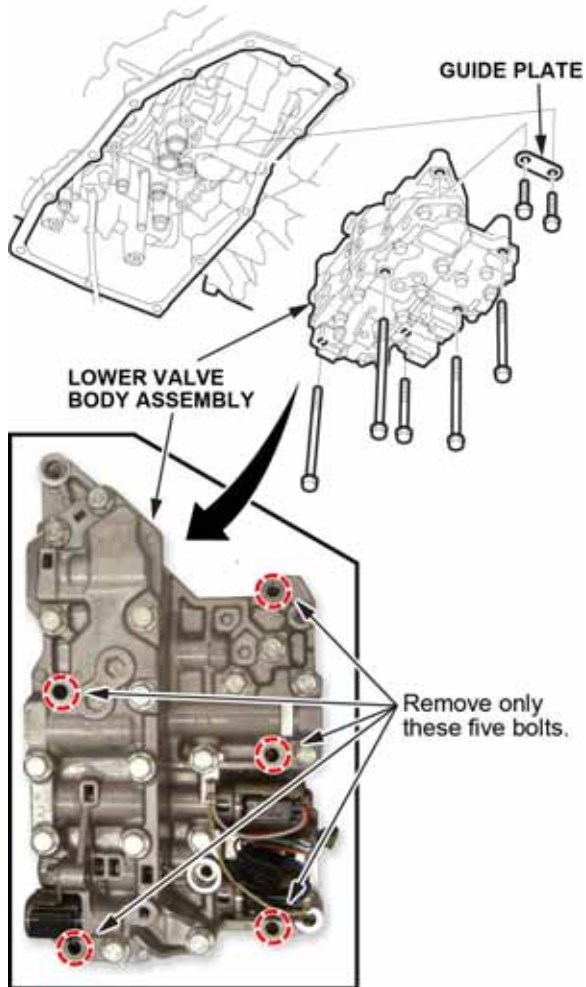
- Remove the guide plate, then remove the lower valve body assembly.

- When removing the valve body assembly, do not damage solenoid wire harnesses A and B.
- Remove only the five valve body bolts and the two guide plate bolts shown. If an incorrect bolt is removed, you may be unable to remove the valve body.

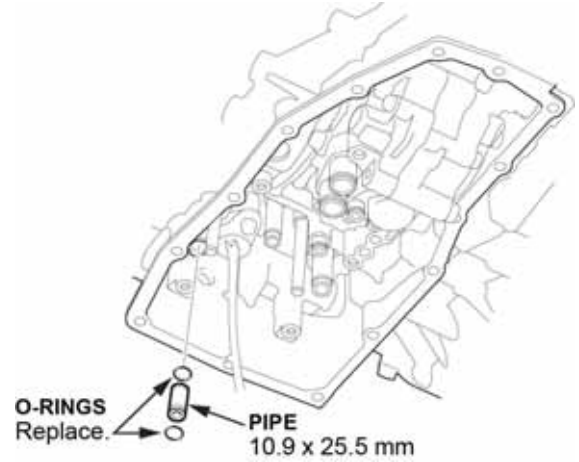
- Remove the 10.9 mm x 25.5 mm pipe and the O-rings.

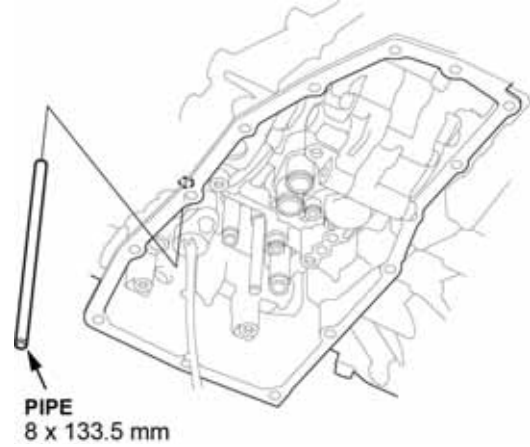
- Remove the 8 mm x 133.5 mm pipe.

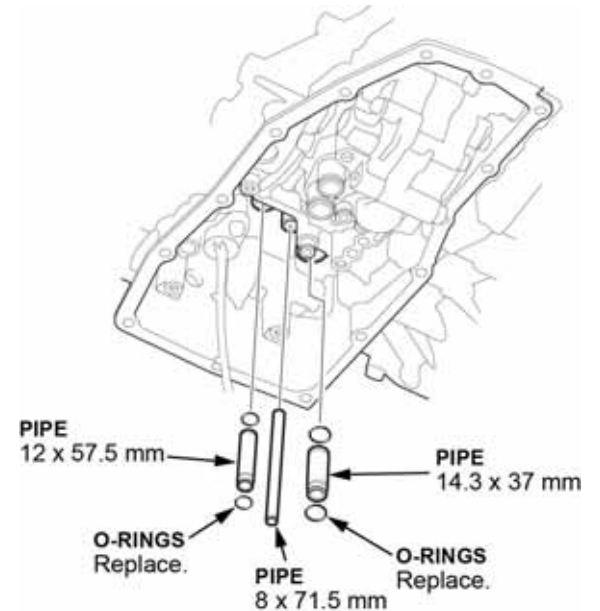
- Remove the 12 mm x 57.5 mm pipe and the O-rings.

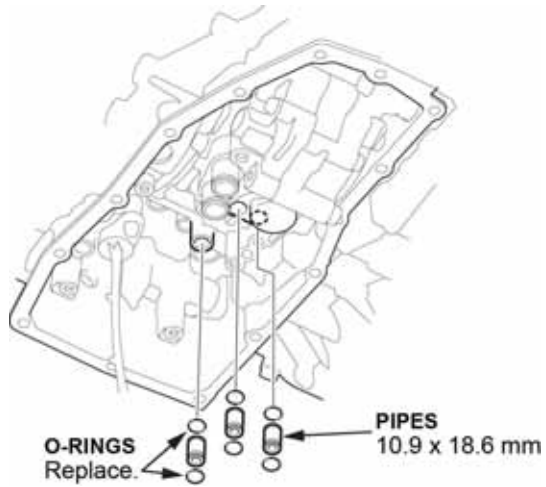
13. Remove the 8 mm x 71.5 mm pipe.
14. Remove the 14.3 mm x 37 mm pipe and the O-rings.
15. Remove the three 10.9 mm x 18.6 mm pipes and the O-rings.

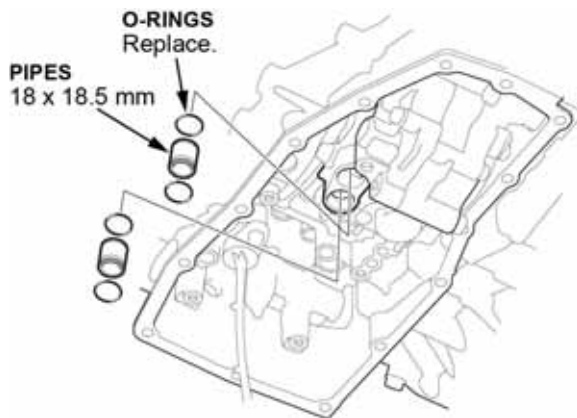
16. Remove the two 18 mm x 18.5 mm pipes and the O-rings.

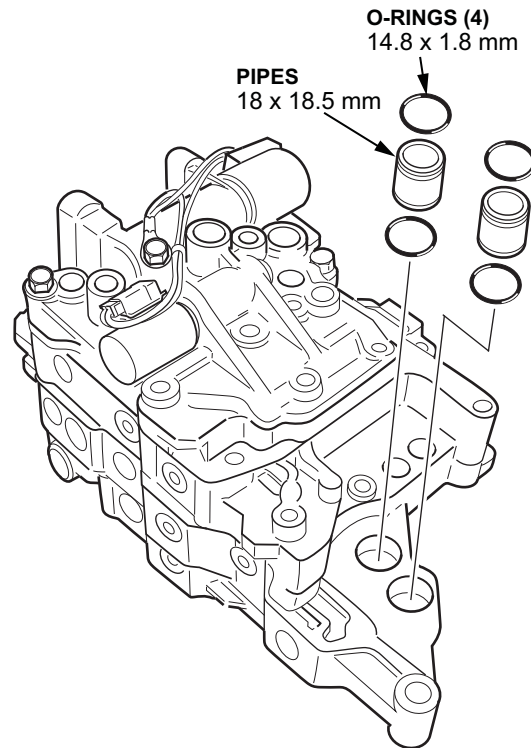
1. Transfer the 18 mm x 18.5 mm pipes with new O-rings into the new valve body.

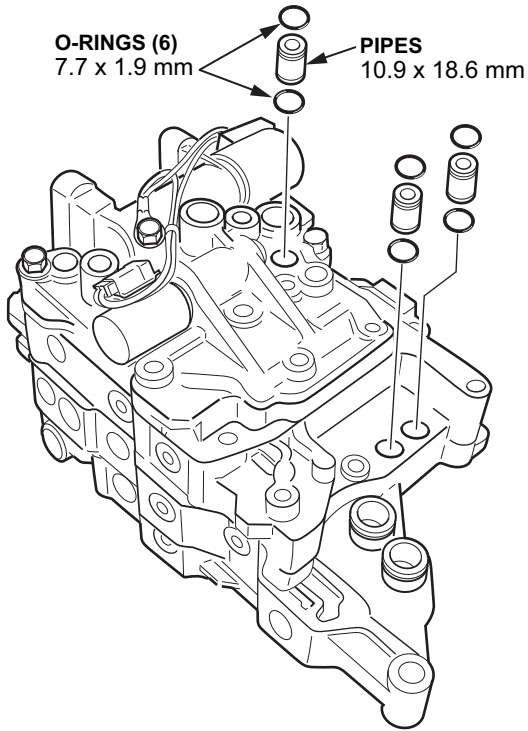
- Transfer the 10.9 mm x 18.6 mm pipes with new O-rings into the new valve body.

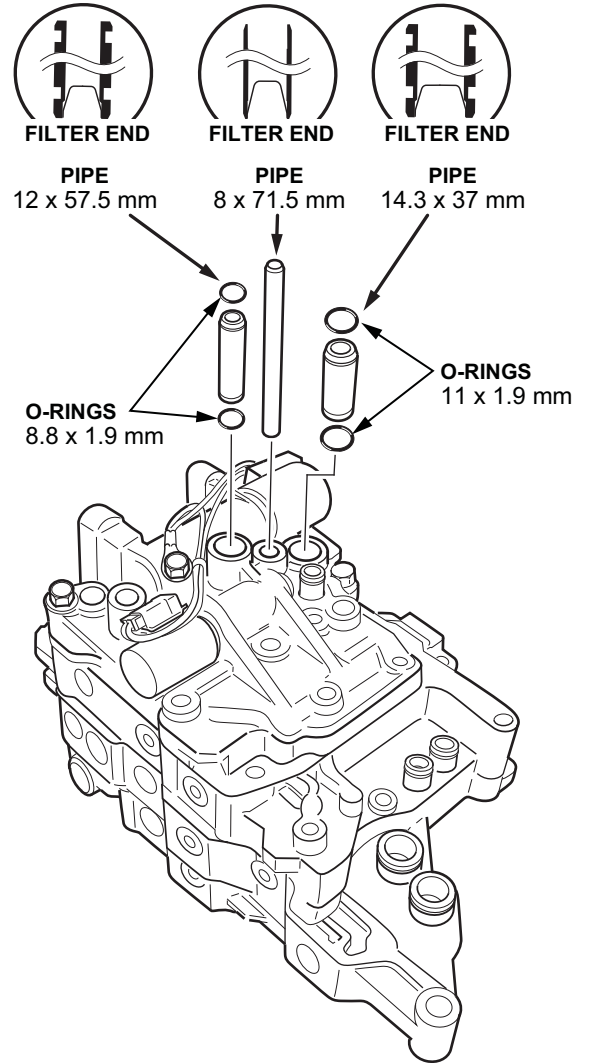
- Transfer the 14.3 mm x 37 mm pipe into the new valve body with new O-rings and with the filter end facing the valve body assembly.

- Transfer the 8 mm x 71.5 mm pipe into the new valve body with the filter end facing the valve body assembly. See diagram in step 3 above.
- Transfer the 12 mm x 57.5 mm pipe into the new valve body using the new O-rings and with the filter end facing the lower valve body assembly. See diagram in step 3 above.
> 8.8 mm x 1.9 mm O-ring (2)

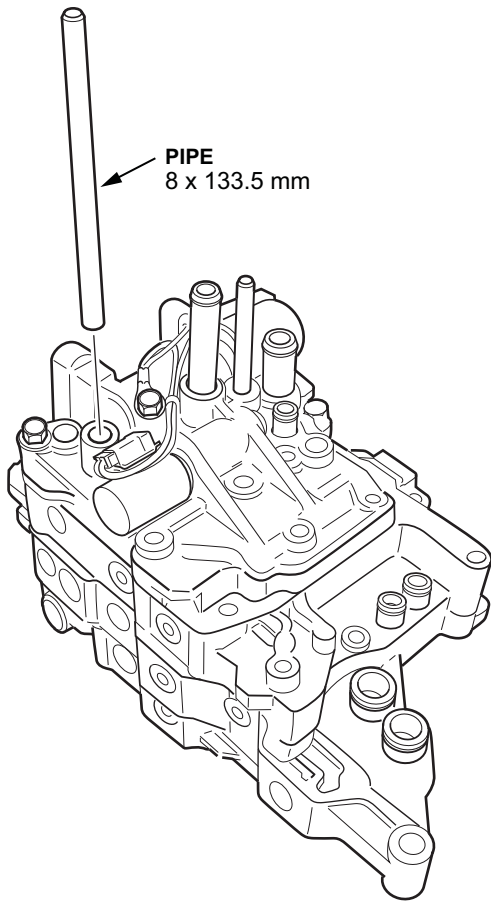
6. Transfer the 8 mm x 133.5 mm pipe into the new valve body.

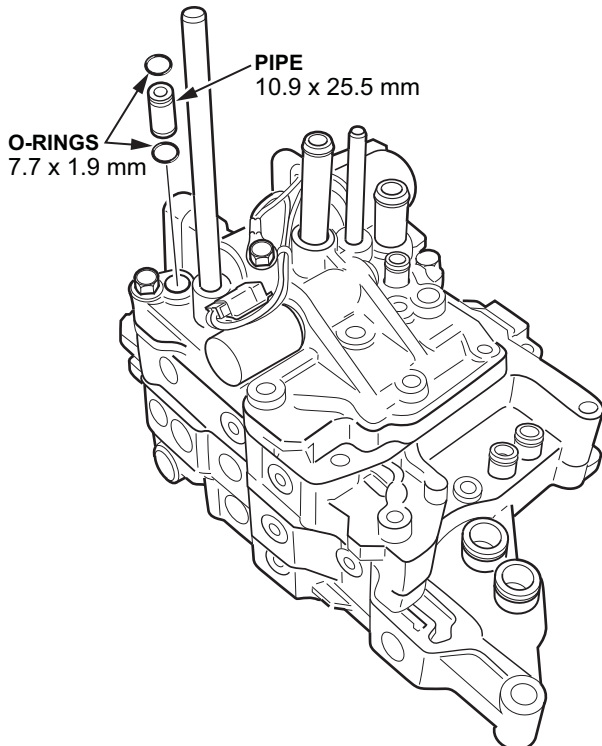
7. Transfer the 10.9 mm x 25.5 mm pipe into the new valve body with new O-rings.

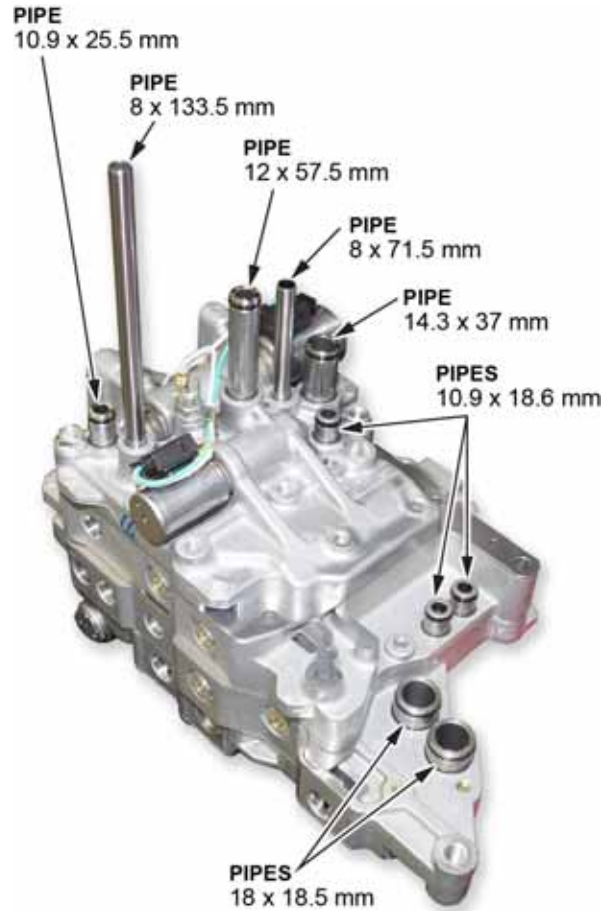
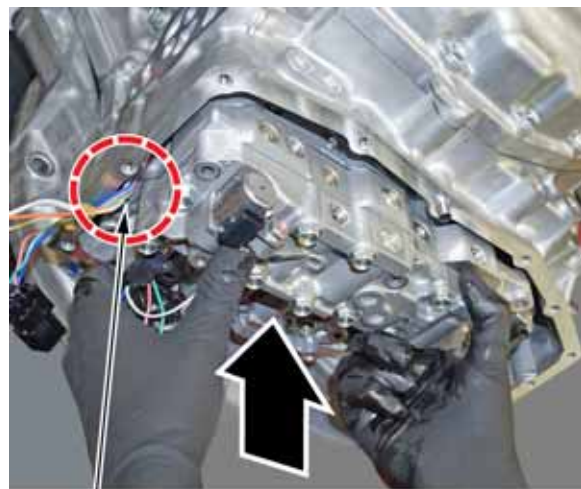
8. Install the new lower valve body assembly and the bolts. Tighten them in a crisscross pattern in at least two steps

- Do not pinch or damage the solenoid wire harnesses.
- While installing the new valve body assembly, be careful not to damage the pipes or the O-rings.

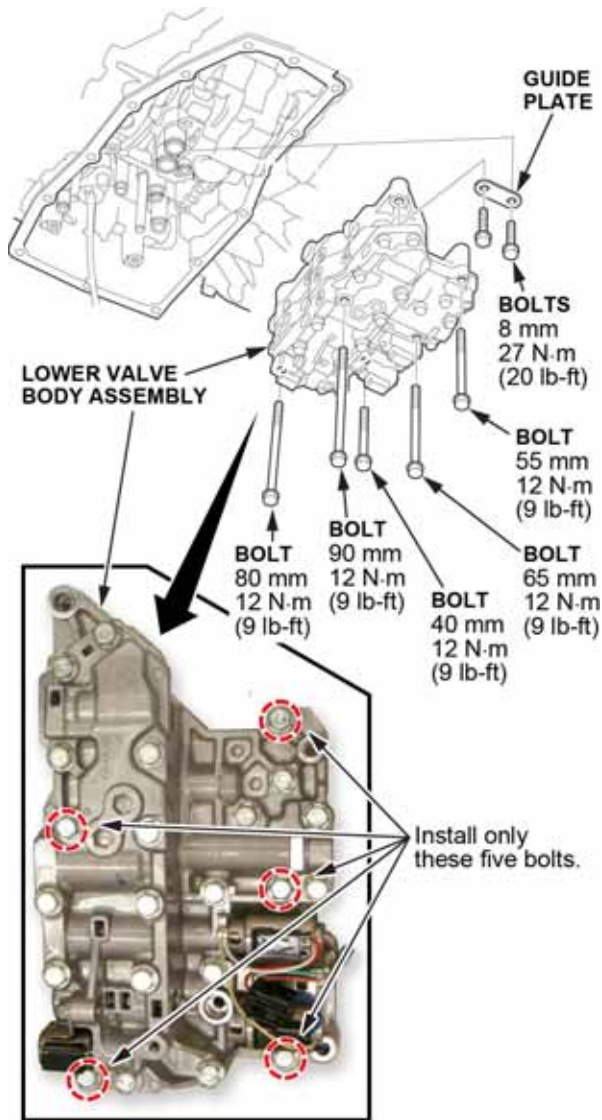
Be careful not to pinch these wires as the valve body is pushed upward.

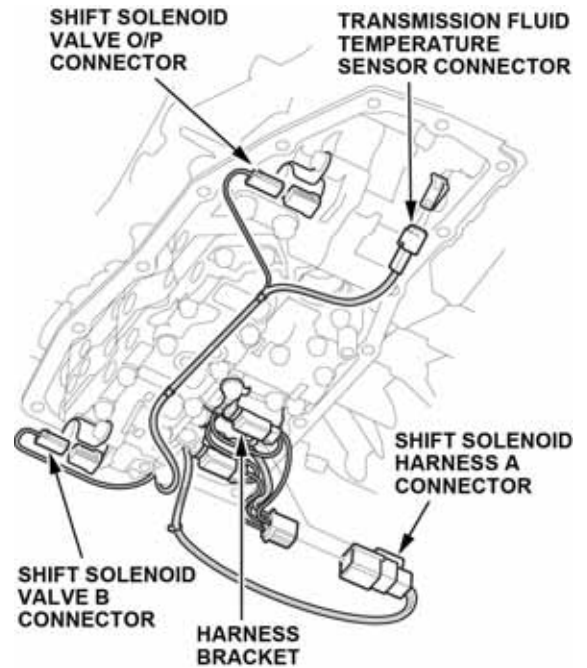
9. Install the guide plate.

10. Connect the following connectors:

- Shift solenoid harness A connector
- Shift solenoid valve B connector
- Shift solenoid valve O/P connector

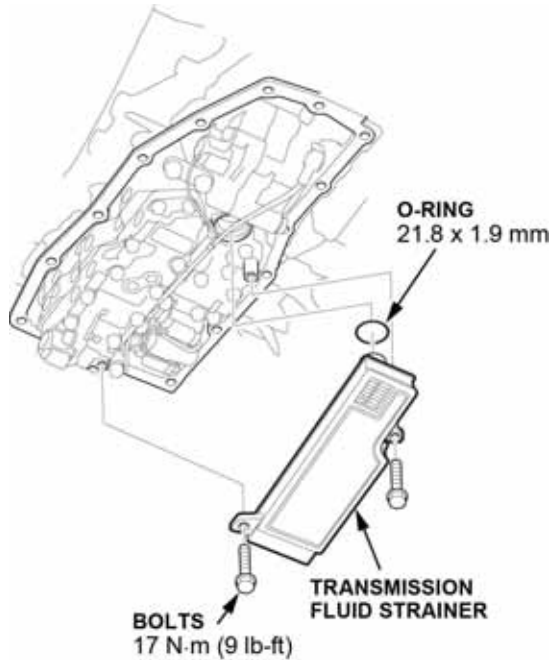
13. Install the transmission fluid strainer with a new O-ring.

- To prevent O-ring damage, carefully install the transmission fluid strainer.
- Do not pinch the solenoid wiring harness.

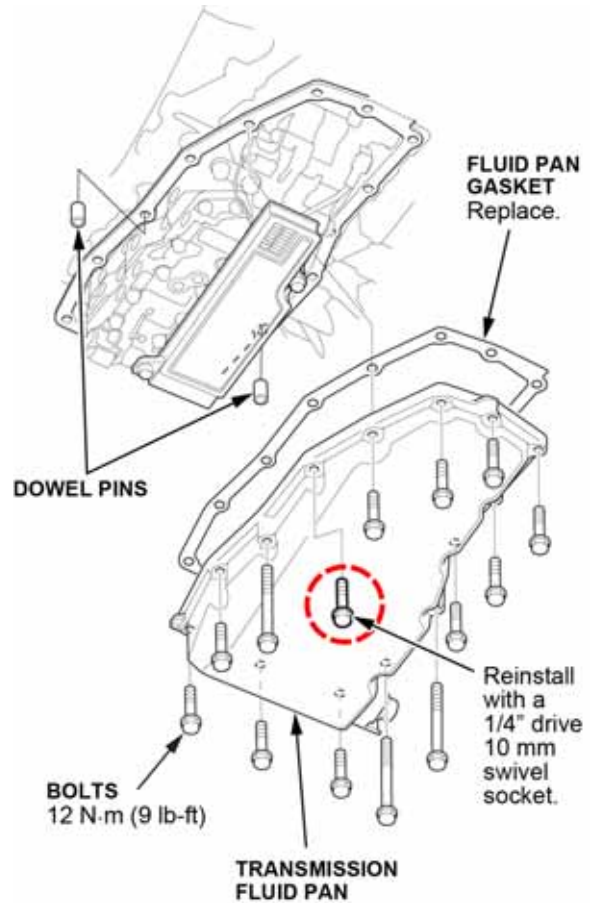
14. Thoroughly clean the fluid pan and magnets (do not remove the magnets). Install the dowel pins, then install the transmission fluid pan with a new gasket. Tighten the bolts in a crisscross pattern in at least two steps.

- Do not pinch or crimp the solenoid wiring harnesses.
- One fluid pan bolt is partially obstructed by the subframe; reinstall and torque it using a 1/4" drive 10 mm swivel socket.

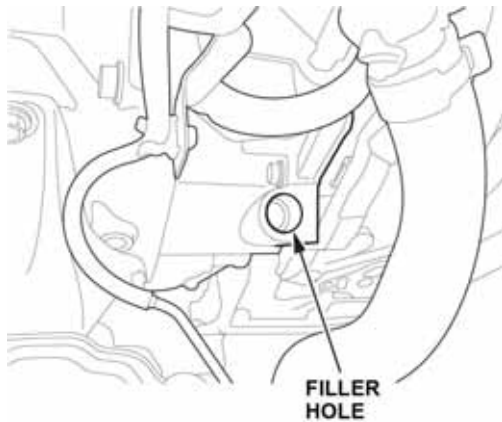
15. Refill the transmission with only Honda HCF-2 CVT Fluid.

- If you use an incorrect fluid, you will damage the transmission.
- **Do not** remove the check bolt before or while refilling the CVT.

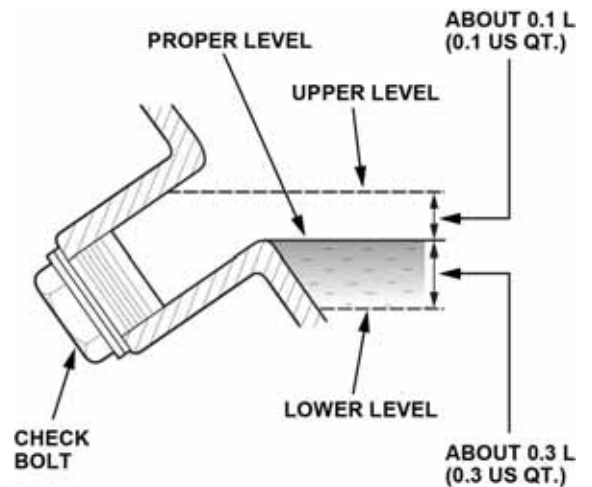
16. Check the CVT fluid level.

NOTE: When checking the CVT fluid level at the check bolt, it is normal for the CVT fluid to be between the upper or lower level. A slow drip of CVT fluid indicates proper fluid level.

- Do the CVT fluid level check immediately after following the procedure below.
 - Apply the parking brake.
 - Start the engine in Park.
 - While pressing the brake pedal firmly, move the shift lever through all selector positions. Wait for at least 3 seconds in each position.
 - Move the shift lever back to Park.
 - Turn off the engine.
 - Remove the check bolt.
 - Check the transmission fluid level.
 - If necessary, add the proper fluid.

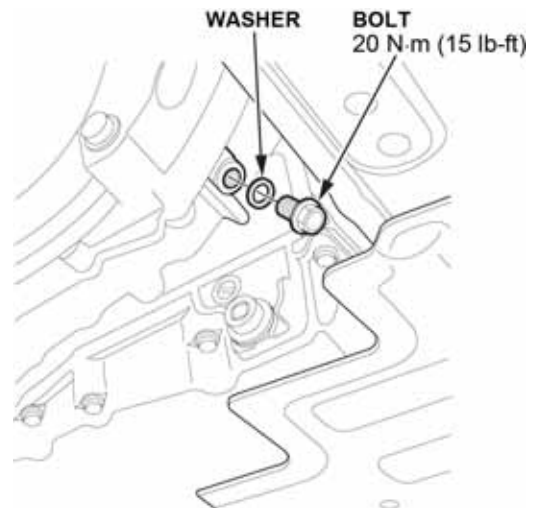
17. Reinstall the check bolt with a new sealing washer.
