07974 Version 4

MIL Comes On with DTC P0430 (Front Bank Catalyst System Efficiency Below Threshold [Bank 2])

Supersedes 17-034, dated October 12, 2017; to revise the information highlighted in **yellow**

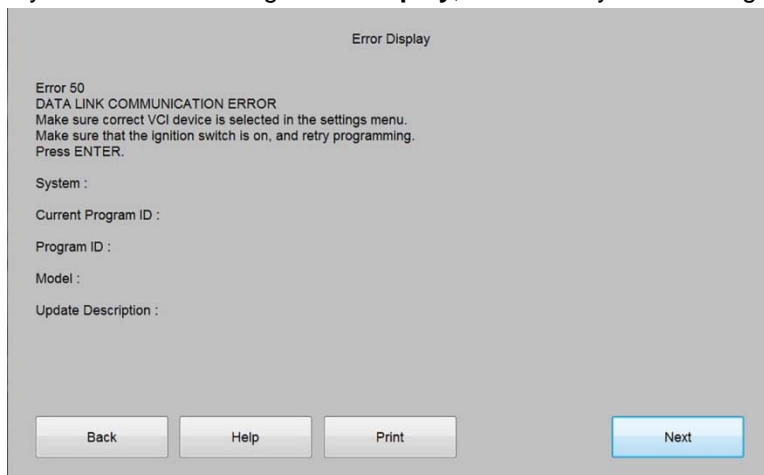
- You cannot update the vehicle using the MVCI as a standalone tool.
- **Do not** use the MongoosePro VCI tool.
- Make sure the 12-volt battery is fully charged before starting an update.
- Connect a fully charged jumper battery to the vehicle, and leave it connected during the entire procedure to maintain steady voltage.
- Never turn the ignition to OFF or ACCESSORY during the update. If there is a problem with the update, leave the ignition turned to ON.
- To prevent PCM damage, do not operate anything electrical (headlights, audio system, brakes, A/C, power windows, door locks, etc.) during the update.
- If you see the following **Error Display**, check that you are using the correct tool (MVCI or DST-i) with the i-HDS.

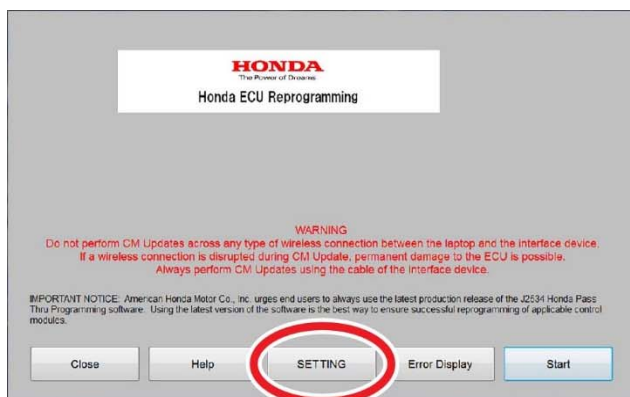
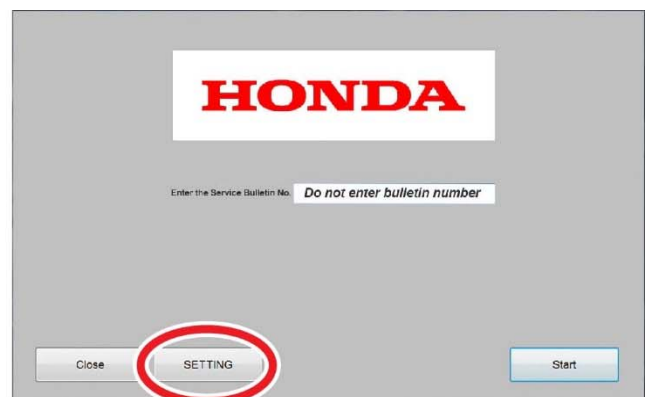
To change this, click on either of the **SETTING** selection buttons at the bottom of the J2534 initial screens as shown.

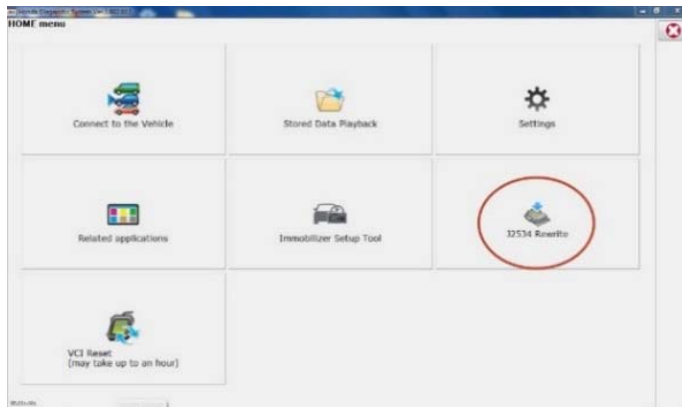
2. Select **J2534 Rewrite**.

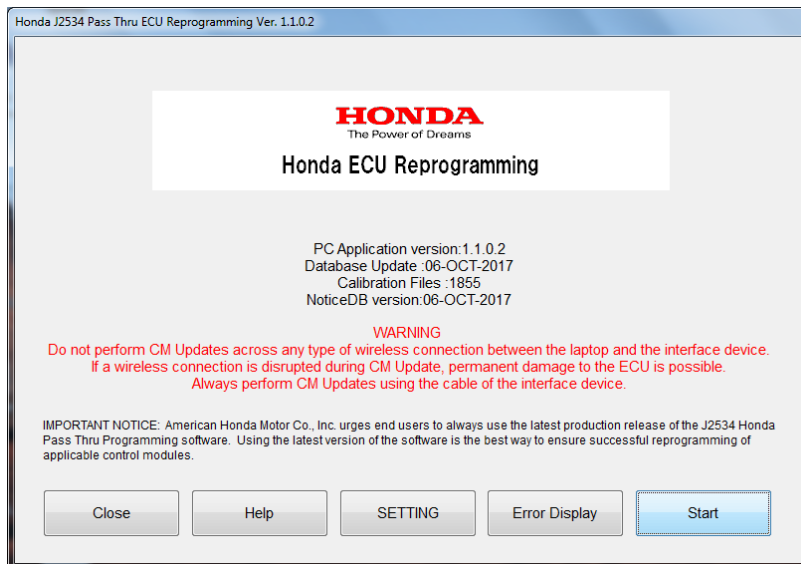
3. Confirm the software is the same **or later** as listed in SOFTWARE INFORMATION.

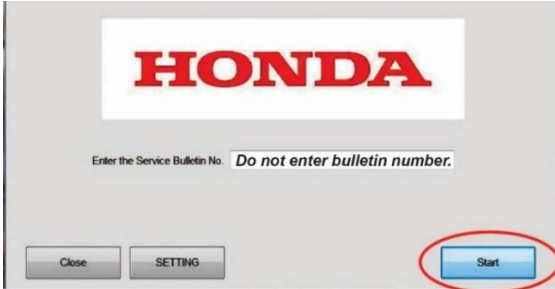
- Select **Start**, then follow the screen prompts.

- Do not enter a bulletin number.

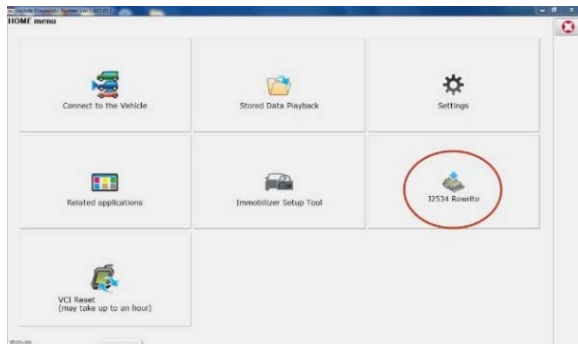
- Select **J2534 Rewrite**.

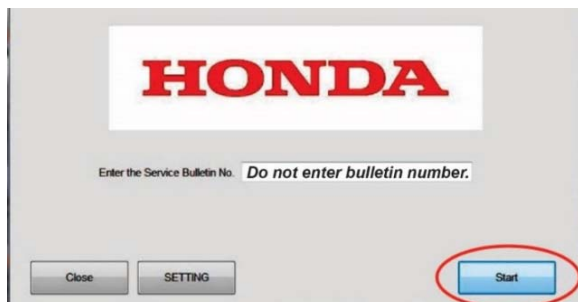
- Select **Start**.

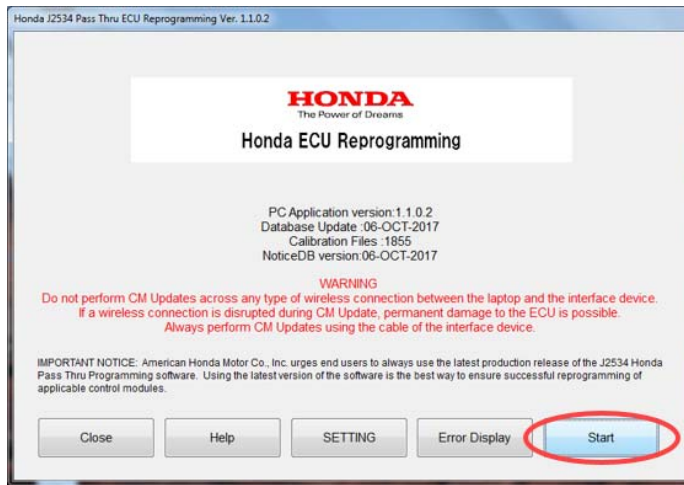
3. Select **Start**.

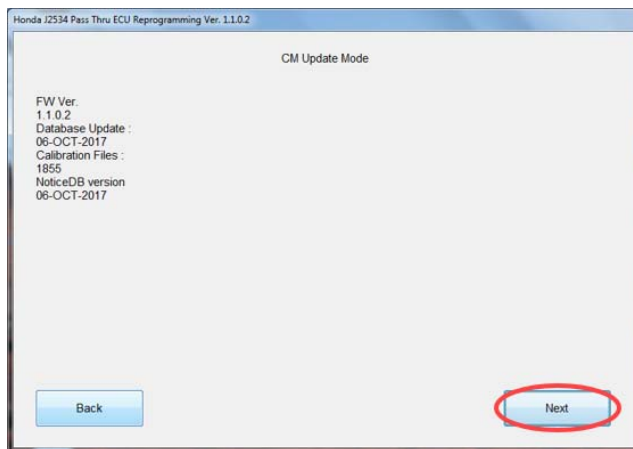
4. Select **Next**.

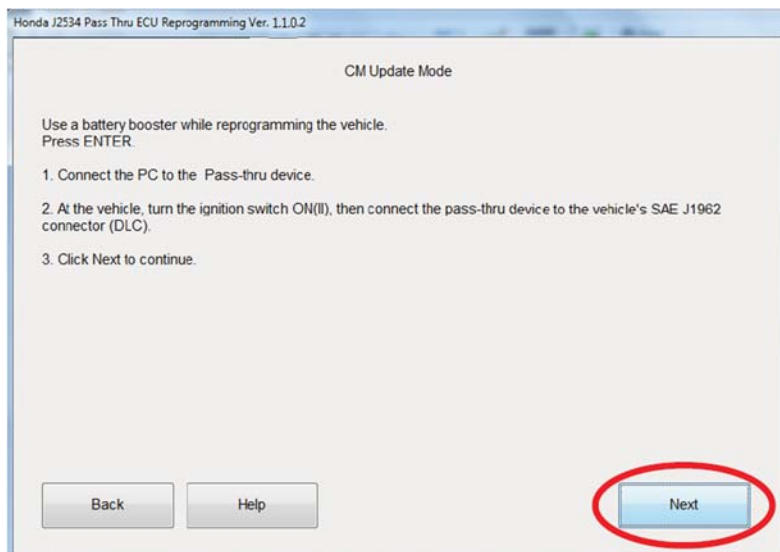
5. Select **Next**.

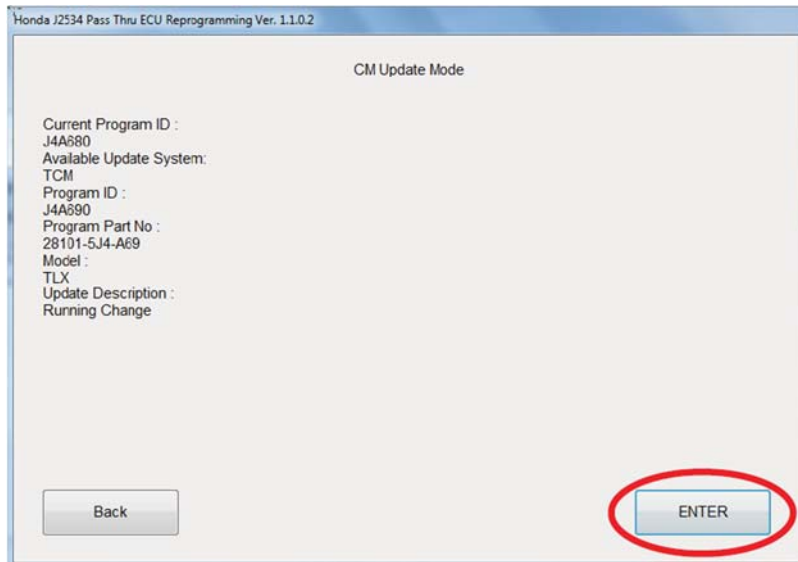
7. Check if **TCM** appears under **System Selection**.

Does TCM appear under System Selection?

Yes – Select **Select** then **ENTER** on the next screen to update the TCM software.

No – The TCM software is up to date.
