February 27, 2018

08335 Version 3

## 2013–17 Accord: Judder from the Torque Converter Lock-Up Clutch (Snapshot Upload Required)

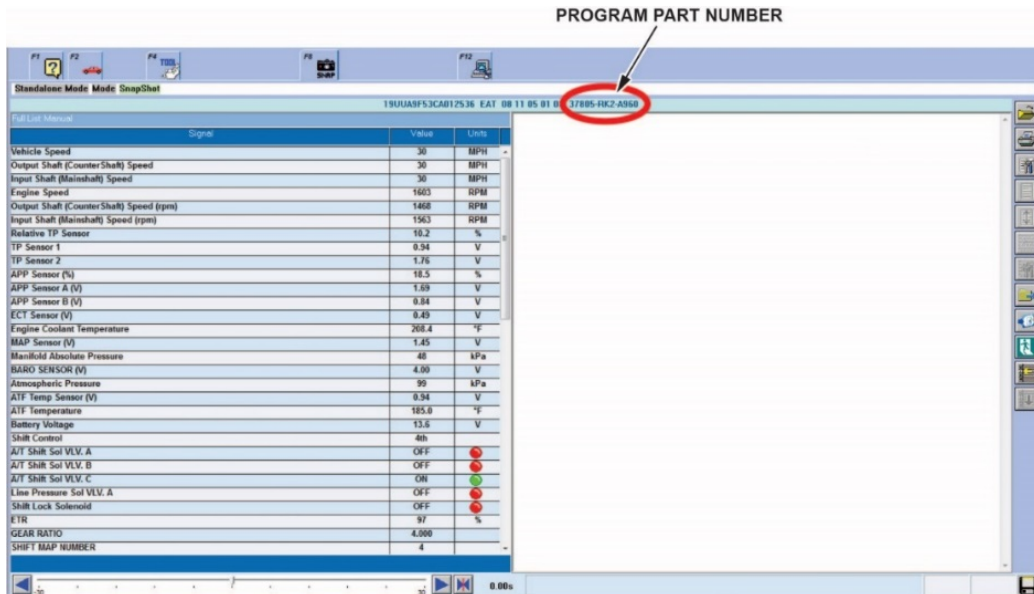
1. Connect the i-HDS, and go to the A/T Data List. Check to see if the software has been updated by comparing the program P/N against the table below.

- If the program P/N is listed below (or later), the vehicle has been updated. Go to service bulletin 17-018 2013–17 Accord: Judder from the Torque Converter Lock-Up Clutch After Software Update.

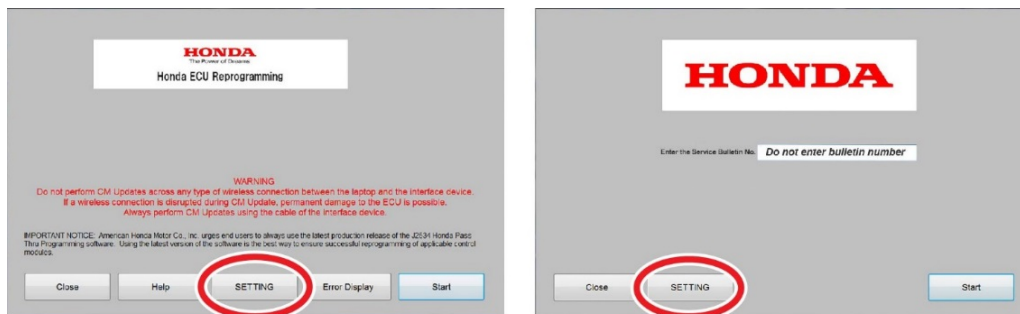
To change this, click on either of the SETTING selection buttons at the bottom of the J2534 initial screens as shown.

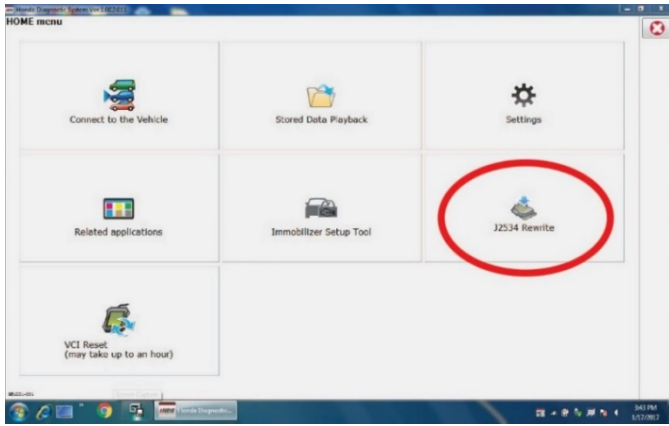
2. Select **J2534 Rewrite**.

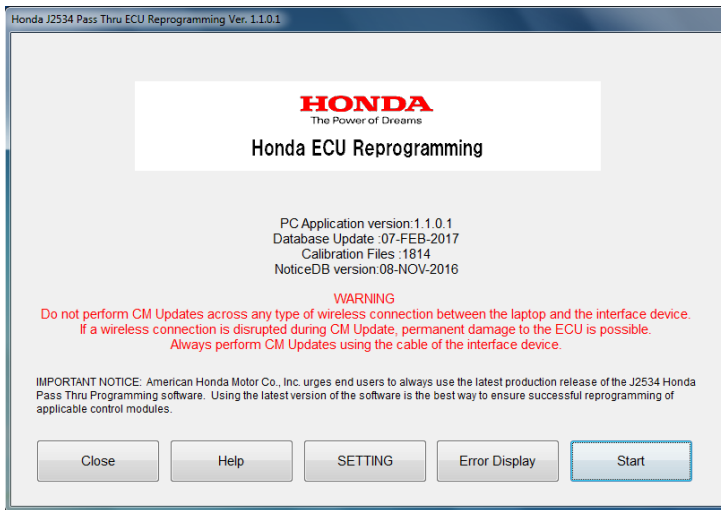
3. Confirm the software is the same **or later** as listed in SOFTWARE INFORMATION.

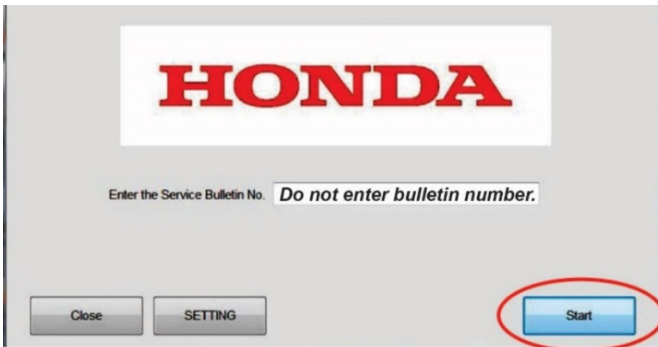
4. Select **Start**, then follow the screen prompts.

- **Don't enter a bulletin number.**
