**February 24, 2018**

Version 1

## 2012-13 Odyssey: Judder from the Torque Converter Lock-Up Clutch (Snapshot Required)

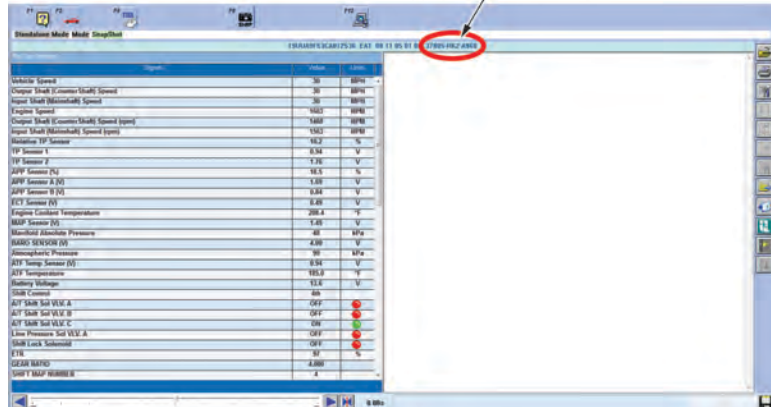
PROGRAM PART NUMBER

1. Connect the i-HDS, and go to the **A/T Data List**. Check the program P/N.
  - If the software program P/N starts with **37805**, it is a Continental PCM. There is no software available at this time. Go to VERIFICATION PROCEDURE.
  - If the software program P/N starts with **37806**, it is a Keihin PCM. Check if the PCM has been updated by comparing the program P/N against the table below.

Parameter	Value	Unit
Vehicle Speed	30	MPH
Change Switch (Continental Lock) Speed	30	MPH
Input Shift (Keihin/Continental) Speed	30	MPH
Engine Speed	1020	MPH
Change Switch (Continental Lock) Speed (Input)	1020	MPH
Input Shift (Keihin/Continental) Speed (Input)	1020	MPH
Maximum T/P Sensor	16.2	V
T/P Sensor 1	5.36	V
T/P Sensor 2	5.28	V
JWP Sensor (S)	16.5	V
JWP Sensor (R)	5.85	V
JWP Sensor (D)	5.84	V
JCT Sensor (S)	2.49	V
Engine Coolant Temperature	206.4	V
MAP Sensor (S)	1.81	V
Manifold Absolute Pressure	48	MPa
BAROS SENSOR (S)	4.88	V
Atmospheric Pressure	98	MPa
JTF Voltage Sensor (S)	5.96	V
JTF Temperature	165.9	V
Battery Voltage	13.3	V
GM Control	06	
A/T Shift Sol VLV A	OFF	
A/T Shift Sol VLV B	OFF	
A/T Shift Sol VLV C	ON	
Lock Pressure Sol VLV A	OFF	
Shift Lock Solenoid	OFF	
ETM	87	
GEAR MATES	4.880	
GM V MAP SENSOR	1

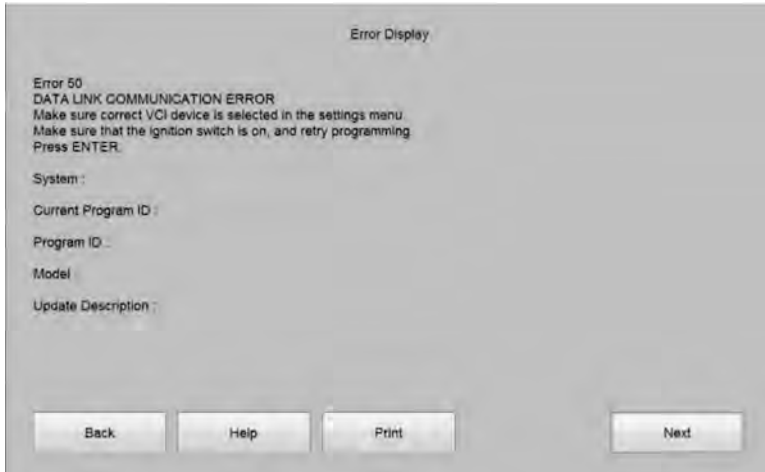
- Do not use the MongoosePro VCI tool.
- Make sure the 12-volt battery is fully charged before starting an update.
- Connect a fully charged jumper battery to the vehicle, and leave it connected during the entire procedure to maintain steady voltage.
- Never turn the ignition to OFF or ACCESSORY during the update. If there is a problem with the update, leave the ignition turned to ON.
- To prevent PCM damage, do not operate anything electrical (headlights, audio system, brakes, A/C, power windows, door locks, etc.) during the update.
- If you see the following **Error Display**, check that you are using the correct tool (MVCI or DST-i) with the i-HDS.

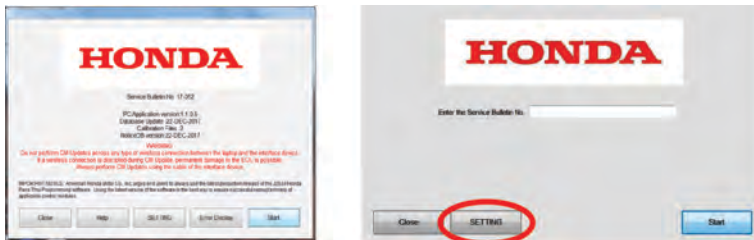
To change this, click on either of the **SETTING** selection buttons at the bottom of the J2534 initial screens as shown.

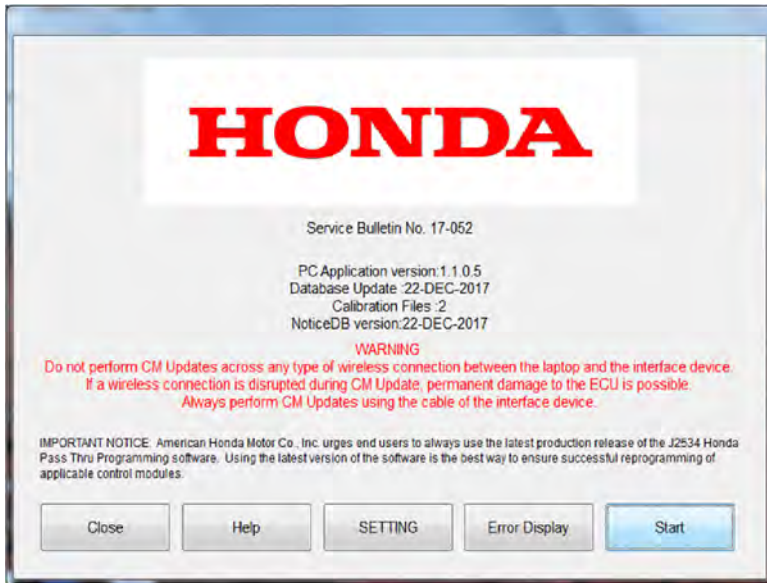
3. Confirm the software is the same or later as listed in SOFTWARE INFORMATION, then select **Start**.

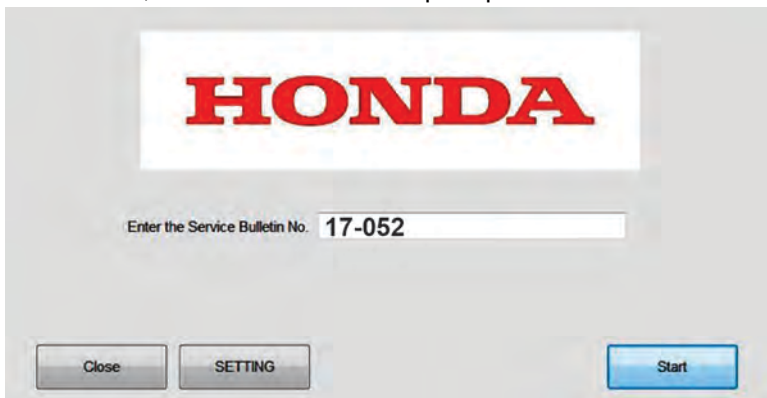
4. Enter the bulletin number **17-052**.
5. Select Start, then follow the screen prompts.
