## **FSB 284-064 Engine Control Module (ECM) and Aftertreatment Control Module (ACM), Reprogramming**

Software updates with enhancements are available for the engine control module (ECM) and aftertreatment control module (ACM) for MACK MP7, MP8 and MP10 engines on OBD2015 vehicles built from January 1, 2015 to December 31, 2015.

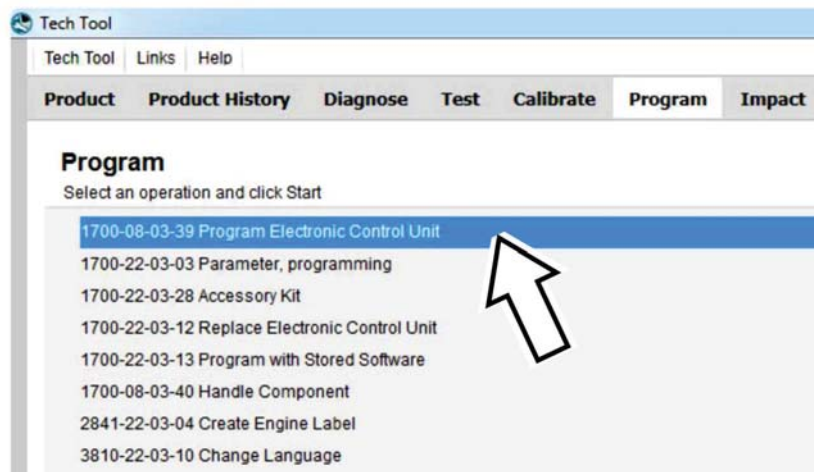
W2115478

- 9 From the Main Menu select Program and **then** Program Electronic Control Unit 1700-08-03-39. Then click Start.
