January 12, 2018

08020 Version 2

2013–17 Accord: Judder from the Torque Converter Lock-Up Clutch

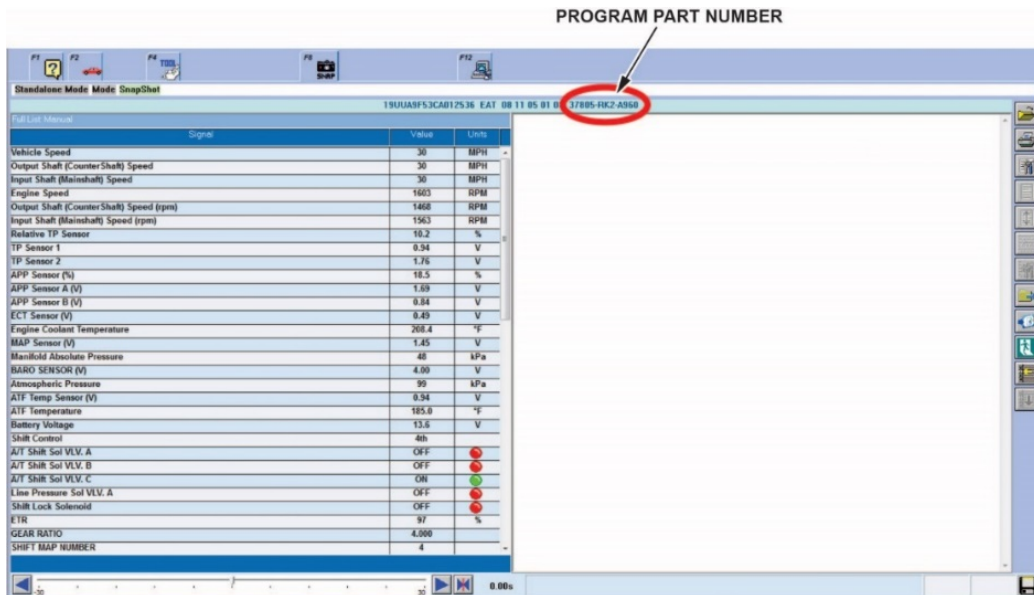
1. Connect the i-HDS, and go to the A/T Data List. Check to see if the software has been updated by comparing the program P/N against the table below.

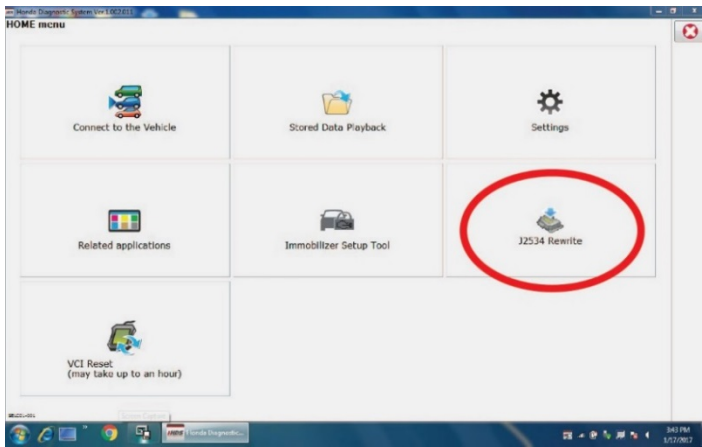
2. Select **J2534 Rewrite**.

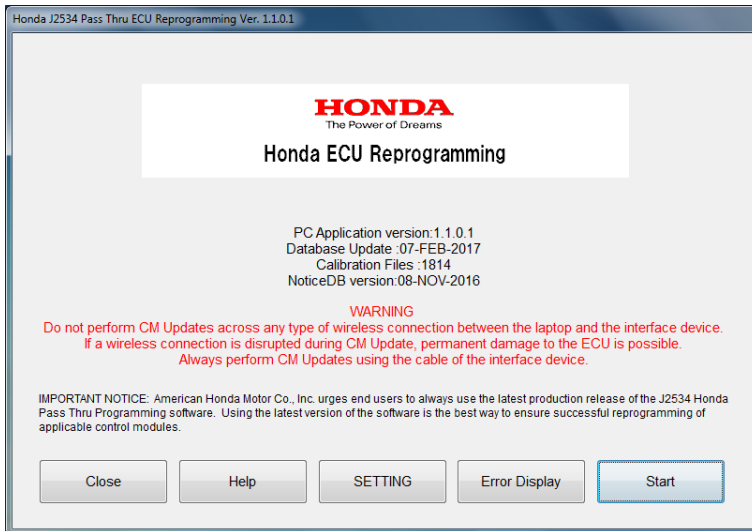
3. Confirm the software is the same **or later** as listed in SOFTWARE INFORMATION.

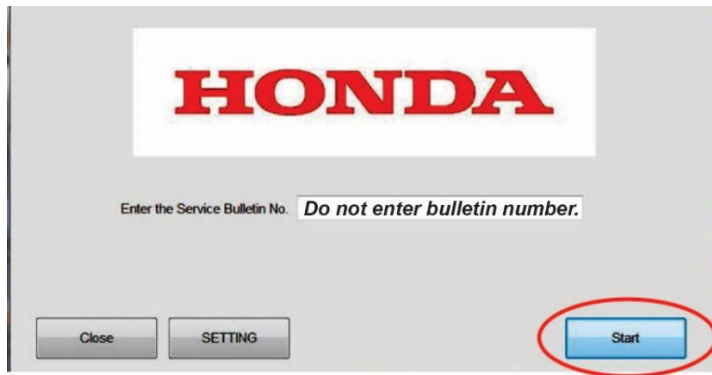
4. Select **Start**, then follow the screen prompts.

- **Don't enter a bulletin number.**
- If you receive a message that the vehicle has been already updated or that no update is available, check the transmission data list. The header should indicate one of the following numbers (or later).
