SERVICE BULLETIN

2016-2017 TITAN XD WITH CUMMINS 5.0L; IDLE FLUCTUATION DURING LOW TEMPERATURE WARM-UP

APPLIED VEHICLES: 2016-2017 Titan XD (A61)

APPLIED ENGINE: Cummins 5.0L V8 Diesel

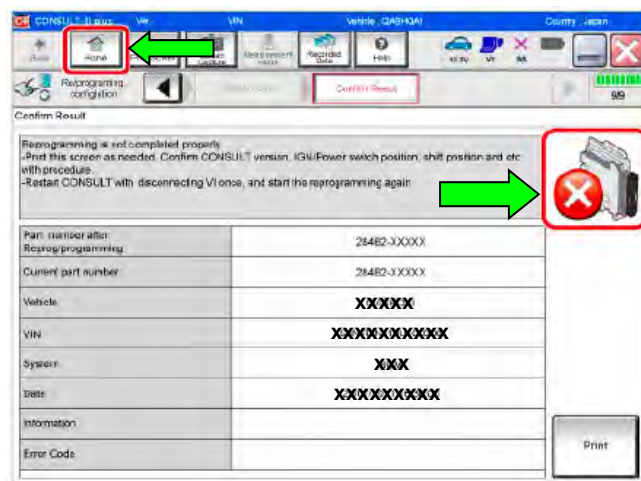
Figure 6

If reprogramming does not complete and the “X” icon displays as shown in Figure 6:

- Check battery voltage (12.0 - 15.5 V).
- CONSULT A/C adapter is plugged in.
- Ignition is ON, engine OFF.
- Transmission is in Park.
- All C-III plus / VI cables are securely connected.
- All C-III plus updates are installed.
- **Select Home, and restart the reprogram procedure from the beginning.**

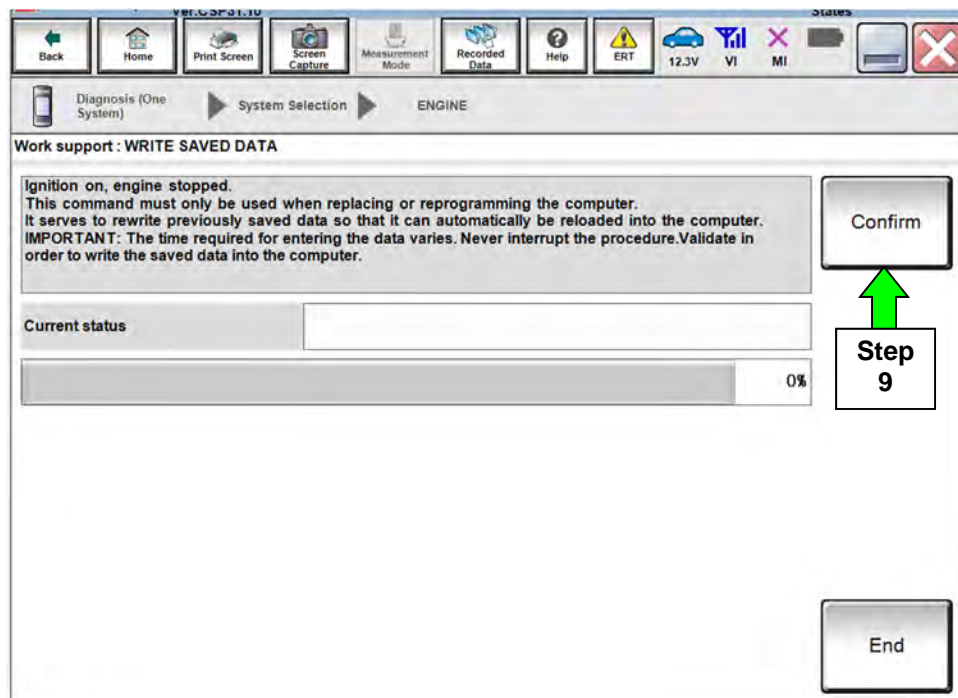
Figure 3A

8. Make sure the ignition is ON and the engine is OFF (engine not running).
9. Select **Confirm**.
