# Emissions Service Action

Code: 2306

**Subject: Certain 2010-2014 Volkswagen Vehicles with 2.0L TDI® Clean Diesel Engine  
ECM Software Update**

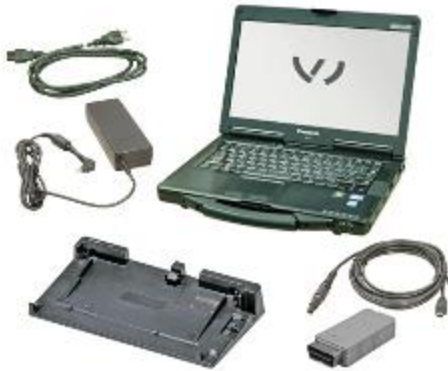
- VAS 6150C Scan Tool (or equivalent)

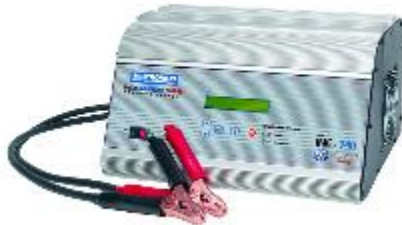
- INC-940 Battery Charger (or equivalent)

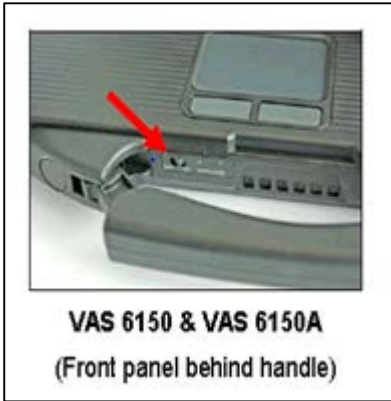
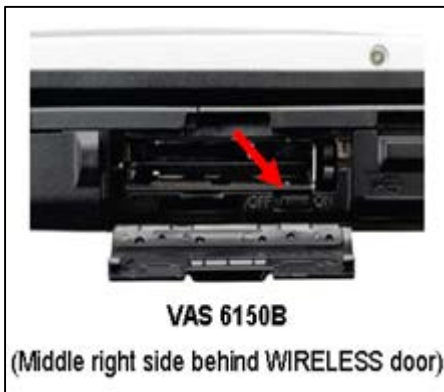
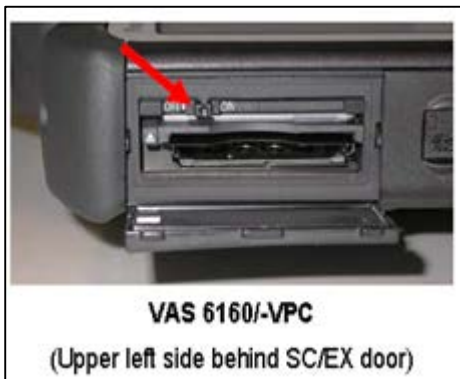
- Switch the ignition OFF.
- Switch off the headlights, radio, HVAC, and all other battery consumers.
- Open the hood.
- If necessary, open/remove the battery cover.
- Connect the battery charger to the vehicle.
- Connect the VAS tester to the online network using an Ethernet cable.
- Connect the VAS 5054A transmitter head to the VAS tester using the USB cable.
- Disable the Bluetooth by physically turning the switch to the "off" position.

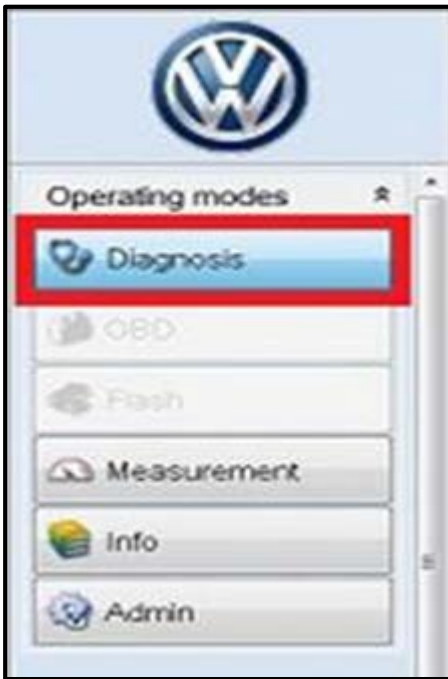
- Switch the ignition on.
- Apply the parking brake.
- Switch the headlights off.
- Attach an appropriate VAS tester to the vehicle.
- Start the ODIS program.
- ⇐ Upon ODIS startup, verify the “Diagnosis” operating mode is selected <as shown>.

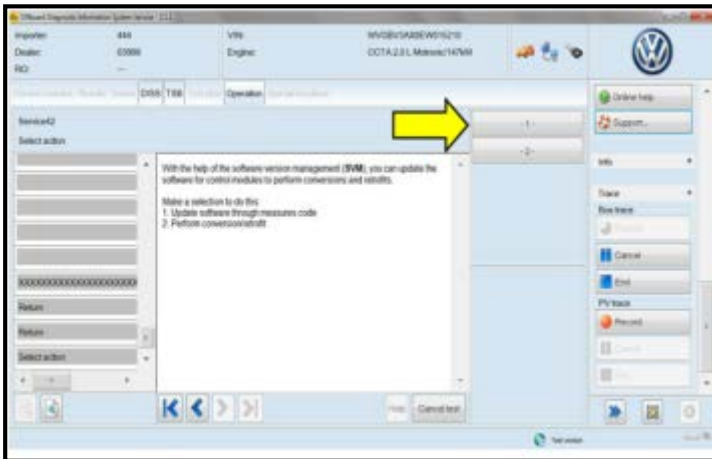
← Select the appropriate option to update “through measures code” <arrow>.

**NOTE**  
Read this screen carefully. The option to update software through measures code is **NOT** always selection #1 on this screen.
