Techstream ECU Flash Reprogramming Procedure

Service Category Engine/Hybrid System

Section Emission Control

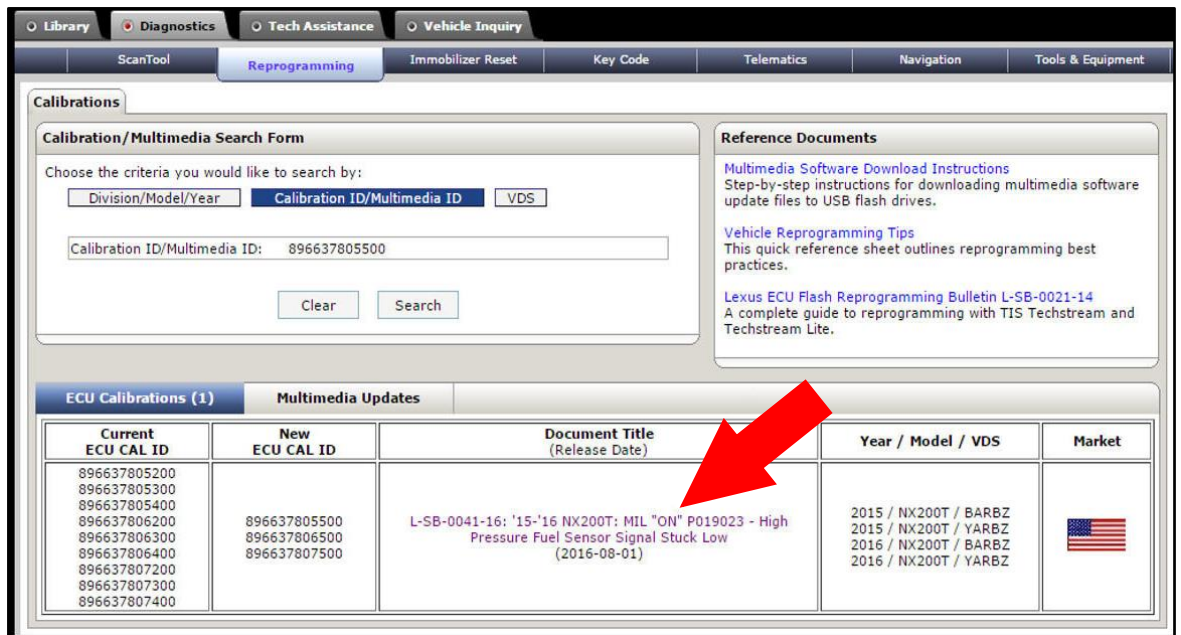
Figure 6.

- G. To review the Service Bulletin and access the calibration file, click the Service Bulletin link in the Document Title column of the calibration search result portlet.

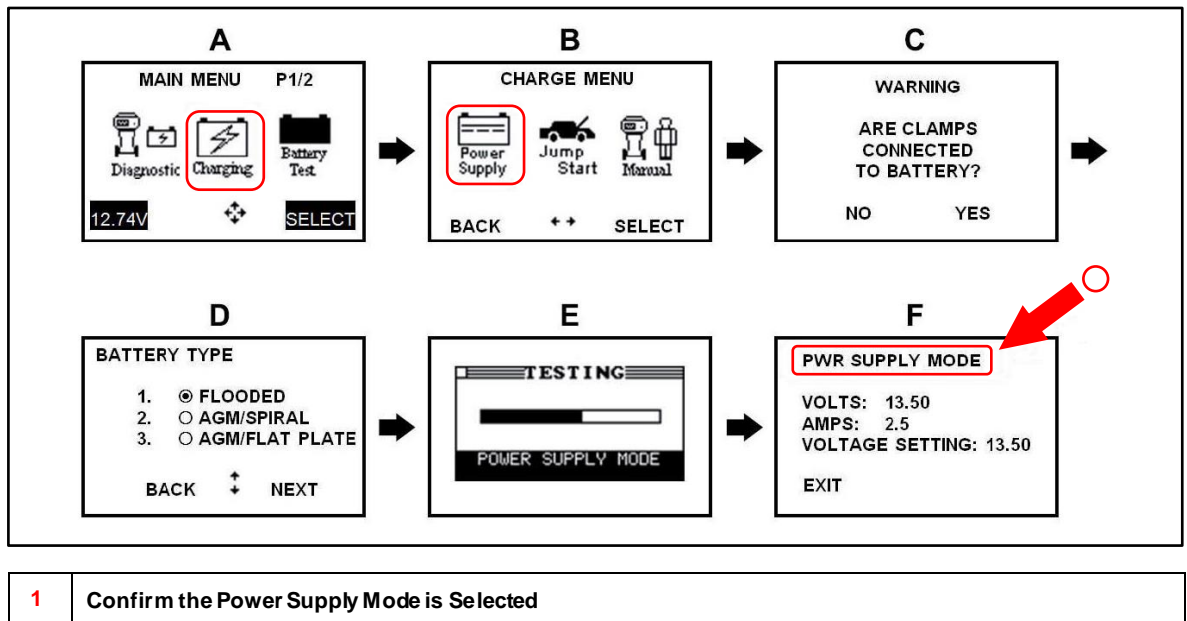
Figure 7.

B. Select *Pwr Supply Mode* by following the screen flow below.

- ECU damage may occur if the correct battery charger and mode setting is NOT used.
- Power Supply Mode is used to maintain battery voltage at 13.5V while flash reprogramming the vehicle.
- For details on how to use the GR8 Battery Diagnostic Station, refer to the [“GR8 Instruction Manual”](#) located at *TIS – Diagnostics – Tools & Equipment – Battery Diagnostics*.

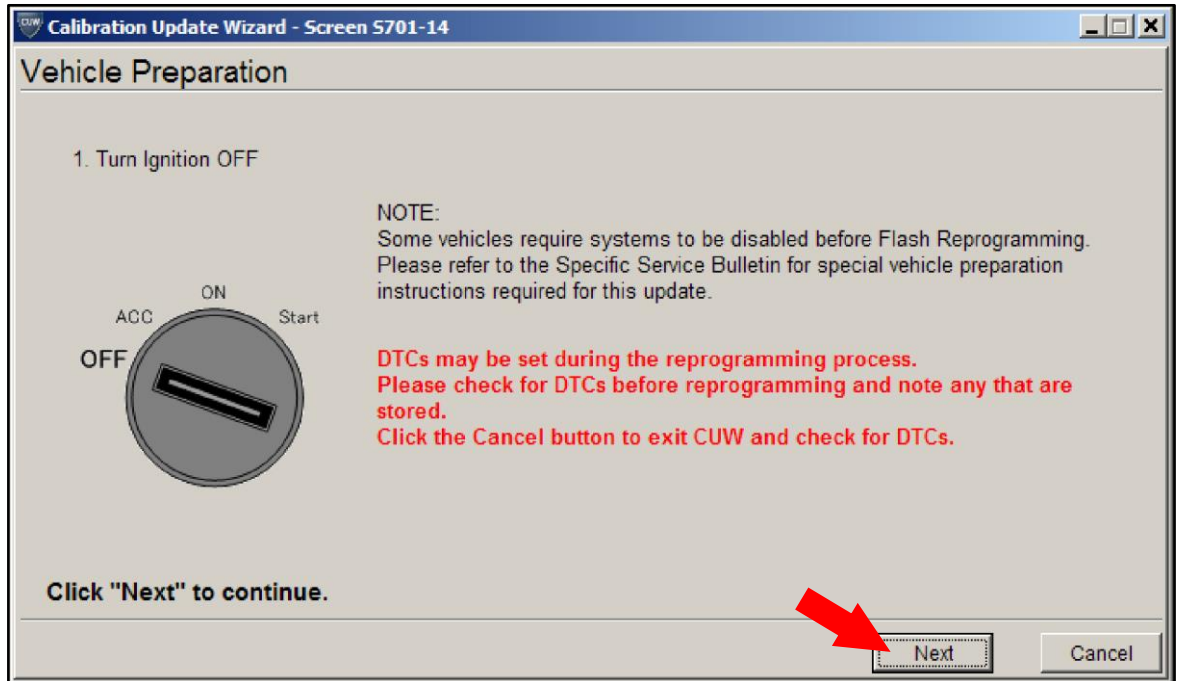
Figure 13.

F. Turn ignition OFF. Then click *Next*.

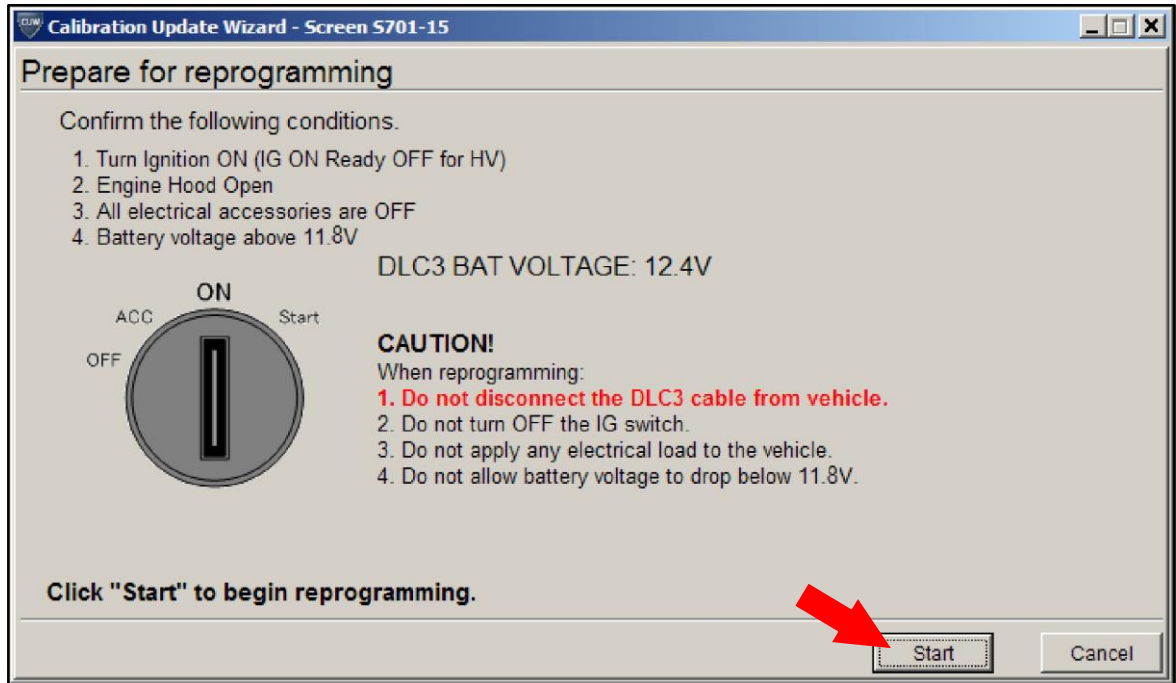
Figure 17.

- J. Turn the ignition to the ON position. Then click *Start*.

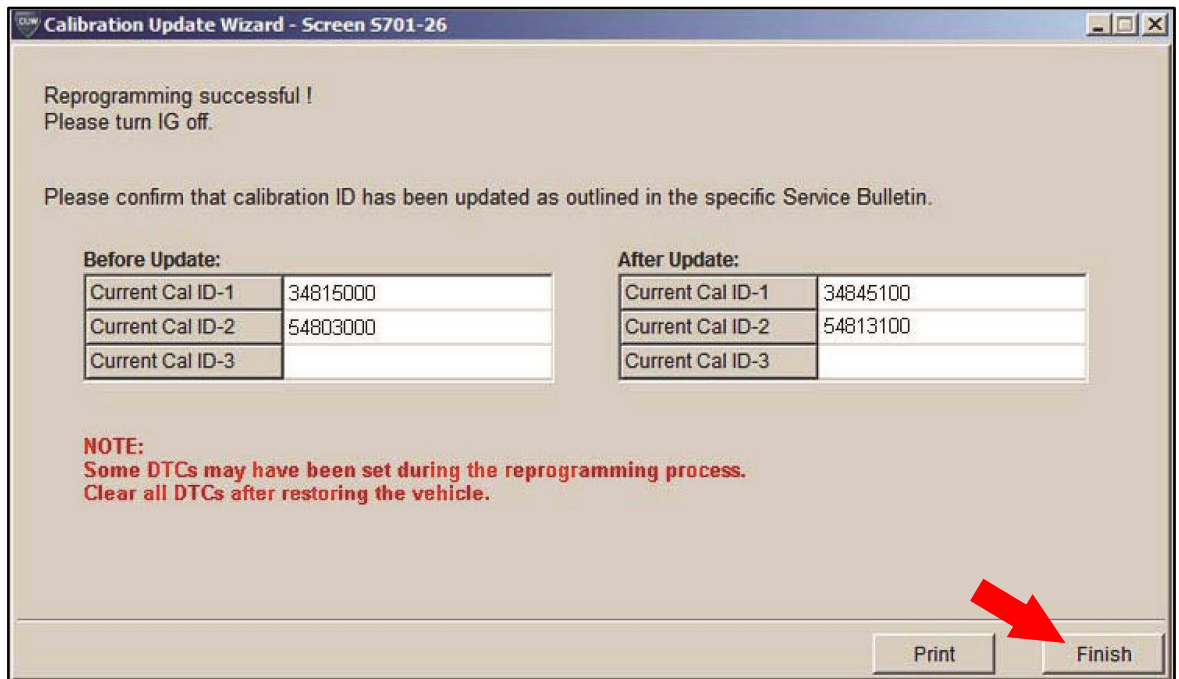
Figure 21.

- N. Confirm ALL calibrations were updated as specified in the Service Bulletin. Then click *Finish*.
