# Entune/Entune Premium Audio Head Unit Software Update (Fujitsu Ten)

YEAR(S)	MODEL(S)	ADDITIONAL INFORMATION
2014	Corolla

Some 2014 model year Corolla vehicles equipped with Entune™ (version BU.26.42) or Entune™ Premium (version AU.26.61) Audio may exhibit one or more of the following conditions:

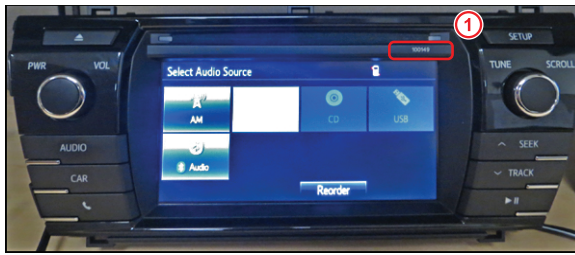
Figure 1. Entune™

1. Confirm the audio system type by checking the Panel ID printed above the top-right of the display.

<b>1</b>	<b>Panel ID: 100149</b>
----------	-------------------------

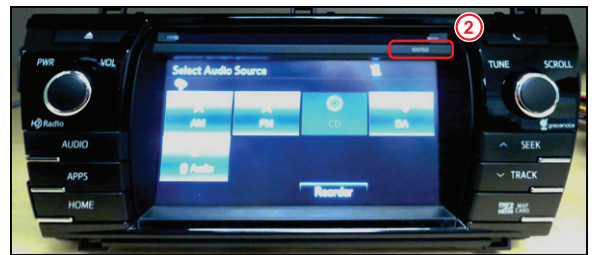
Figure 2. Entune™ Premium

<b>2</b>	<b>Panel ID: 100150</b>
----------	-------------------------

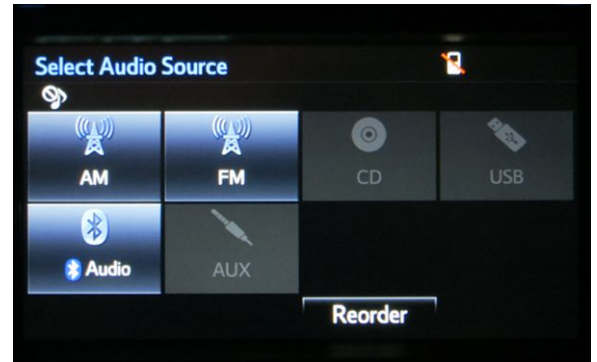
Figure 3.

2. Start the engine.
3. Wait for the *Select Audio Source* screen to be displayed.

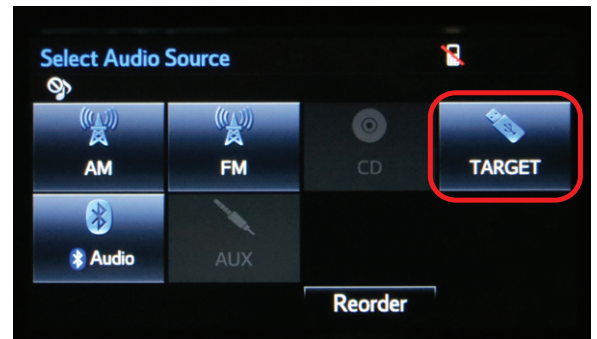
Figure 4.

4. Insert the USB Drive SST into the vehicle USB port.
5. Wait until the USB source icon highlights and displays the USB name with the icon.

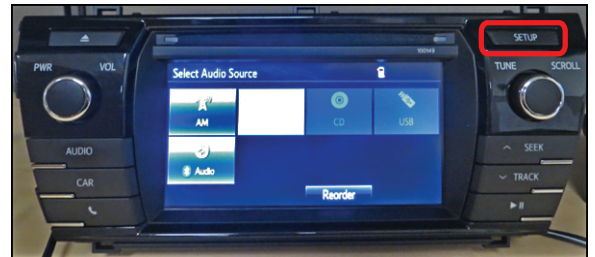
**Figure 5.**

A. For Entune (Panel ID: 100149):

Press the *SETUP* button on the right of the panel.

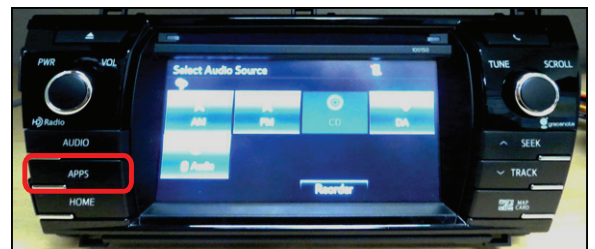
**Figure 6.**

B. For Entune Premium (Panel ID: 100150):

Press the *APPS* button on the left of the panel.

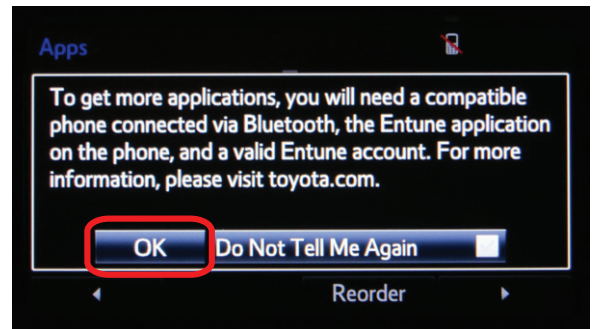
**Figure 7.**

If Entune pop-up displays, select *OK*.

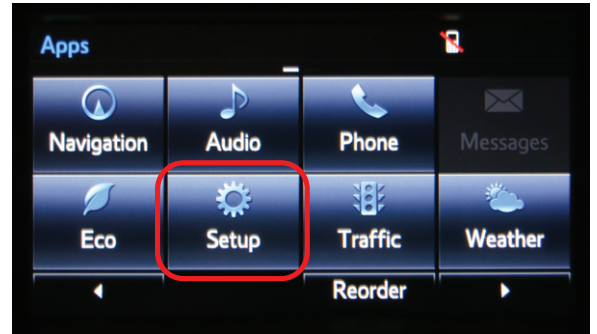
Figure 8.

Select *Setup* on the *Apps* screen.

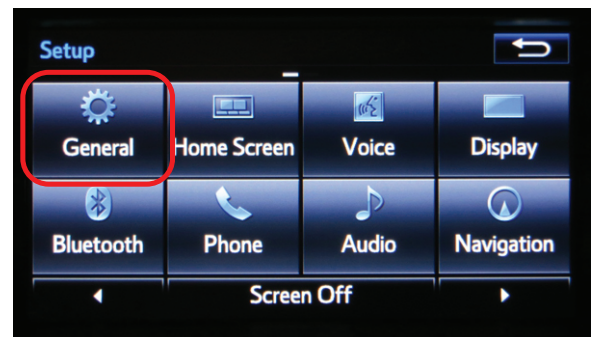
Figure 9.

7. Select *General* on the *Setup* screen.

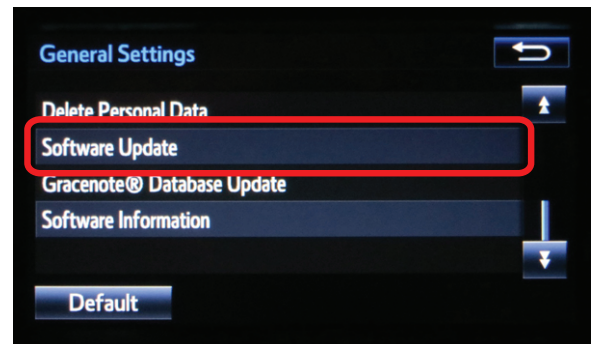
Figure 10.

8. Select *Software Update* from the list on the *General Settings* screen.

**HINT**  
 Scroll down the list until *Software Update* is displayed.

2. Perform steps 6 – 8 of the Software Update procedure to re-enter the *Software Update* screen.

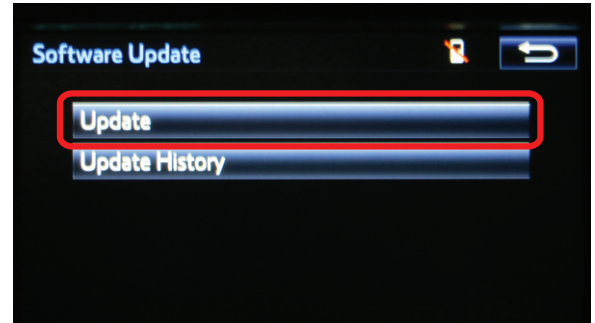
Figure 11.

9. Select *Update* on the *Software Update* screen.

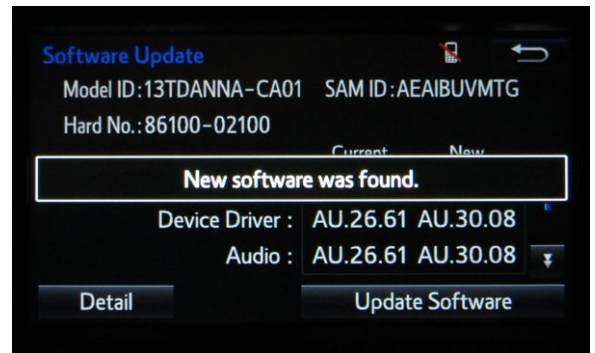
Figure 12.

If software has been detected properly, a "New software was found." pop-up will be displayed.

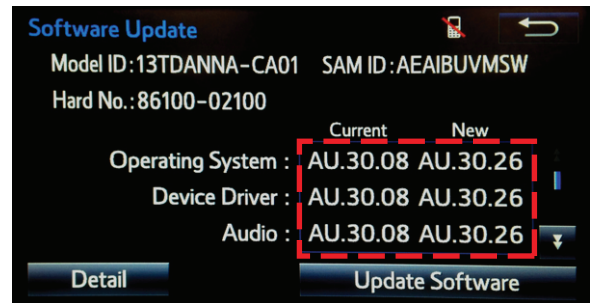
Figure 13.

- Verify that the new software is up-to-date on the *Software Update* screen.

**NOTE**  
*Update Software* is enabled only if there is an update newer than the current software.

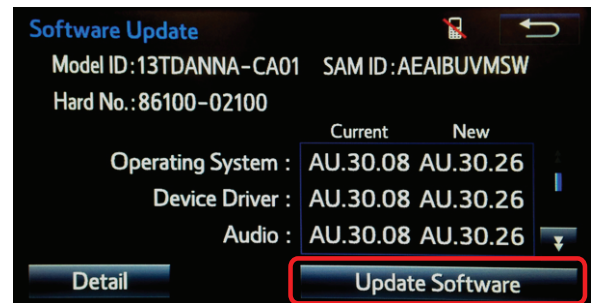
Figure 14.

- Select *Update Software* on the *Software Update* screen.

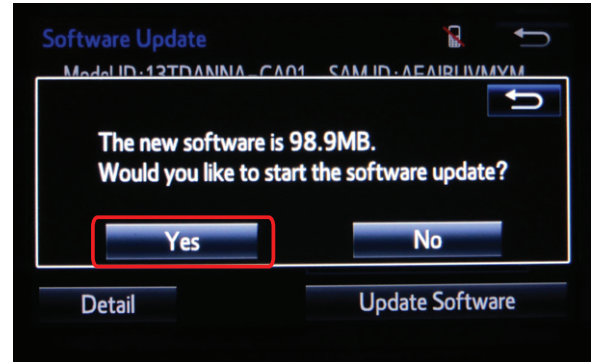
Figure 15.

12. Select *Yes* on the “*Would you like to start the software update?*” pop-up.

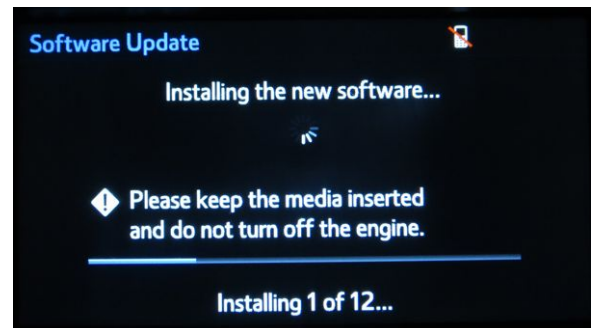
Figure 16.

13. The unit begins installation.

Do NOT turn off ACC before the software is ready for updating.

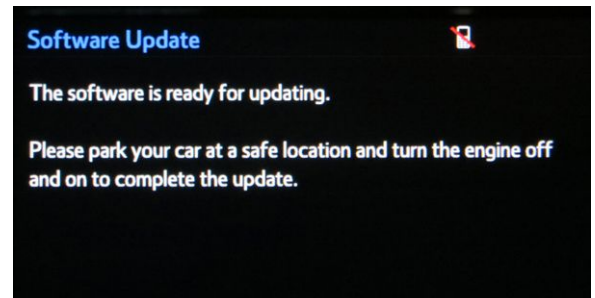
Figure 17.

14. When “*The software is ready for updating.*” displays, cycle the ignition OFF and wait for 30 seconds. Then cycle the ignition ON again.

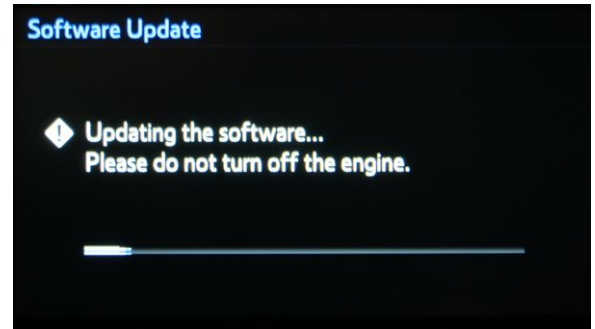
Figure 18.

15. Wait for the audio system to finish the software update.

**Do NOT turn off ACC before the next Toyota logo screen displays.**

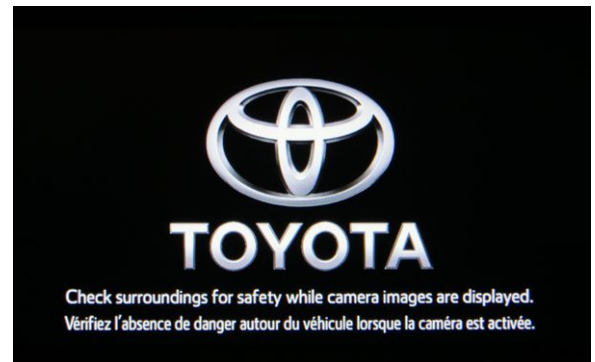
Figure 19.

16. When the Toyota logo screen is displayed, the update is finished.

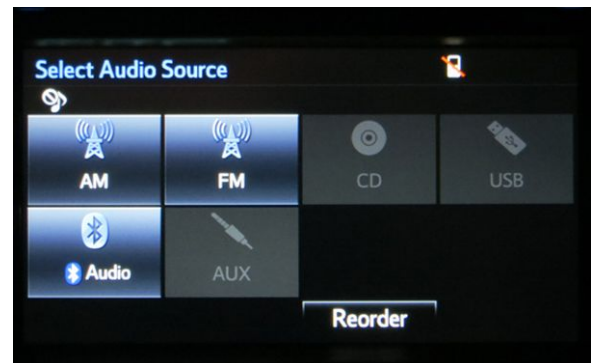
Figure 20.

1. Wait for the *Select Audio Source* screen to be displayed.

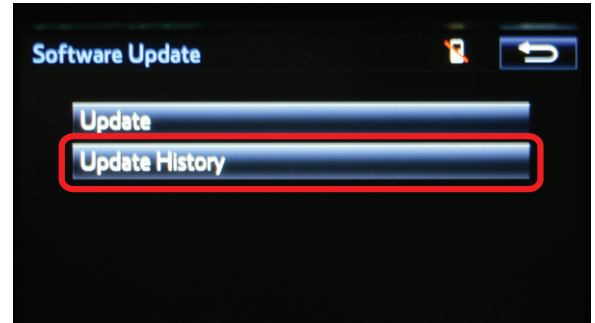
Figure 21.

3. Select *Update History* on *Software Update* screen.
