Techstream ECU Flash Reprogramming Procedure

Service Category Engine/Hybrid System

Section Emission Control

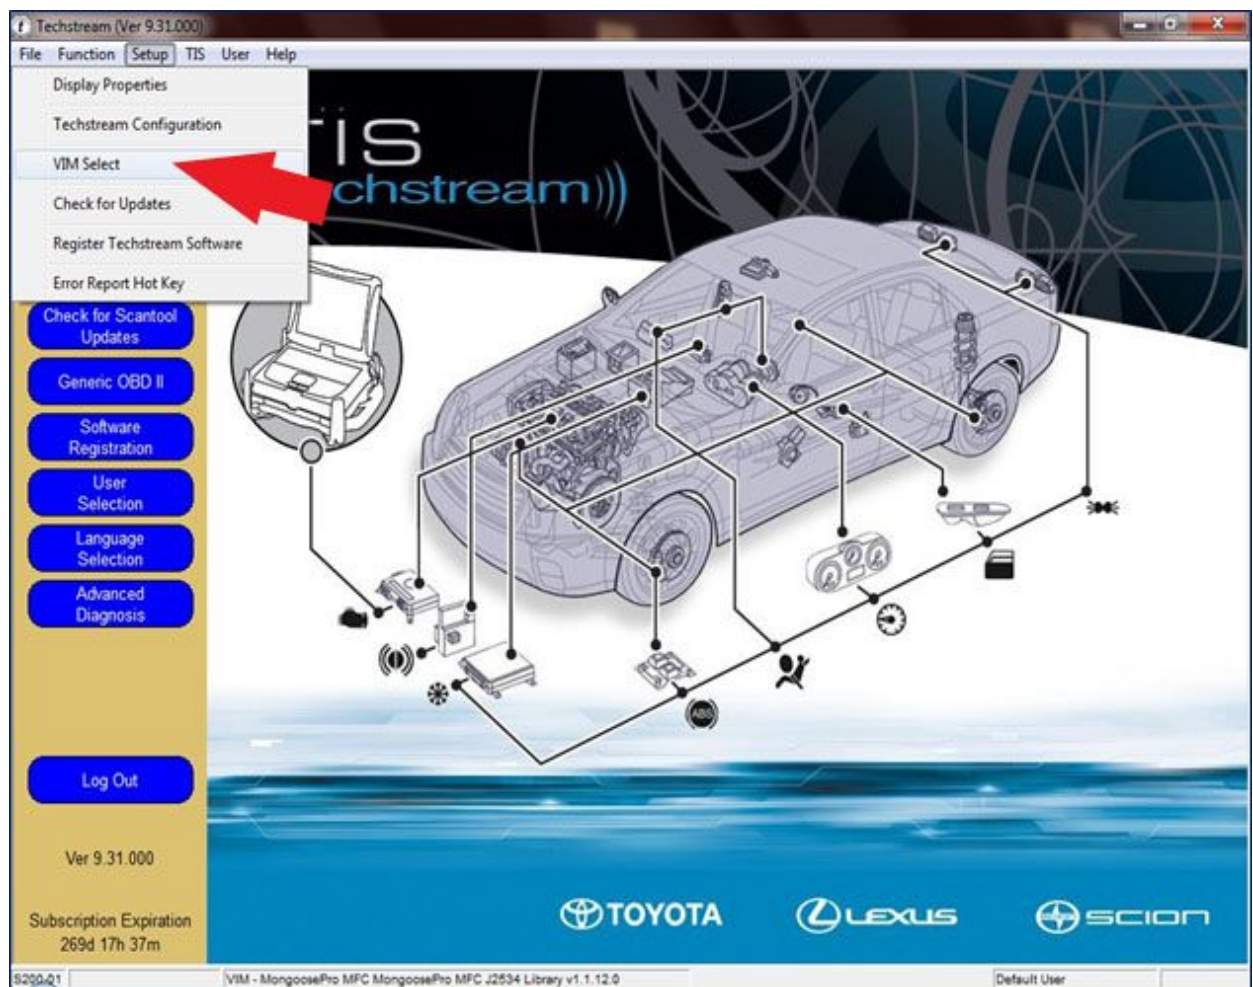
Figure 1.

1. Select *Setup* from the Techstream Main Menu screen.
2. Select *VIM Select* from the Setup drop down menu.

3. Select the correct Interface Setup from the drop down list.
 - If using Techstream 2.0, select *MongoosePro MFC*.
 - If using Techstream Lite, select *Mongoose MFC*, *MongoosePro MFC*, or *MongoosePro MFC2* (green) depending on the cable being used.

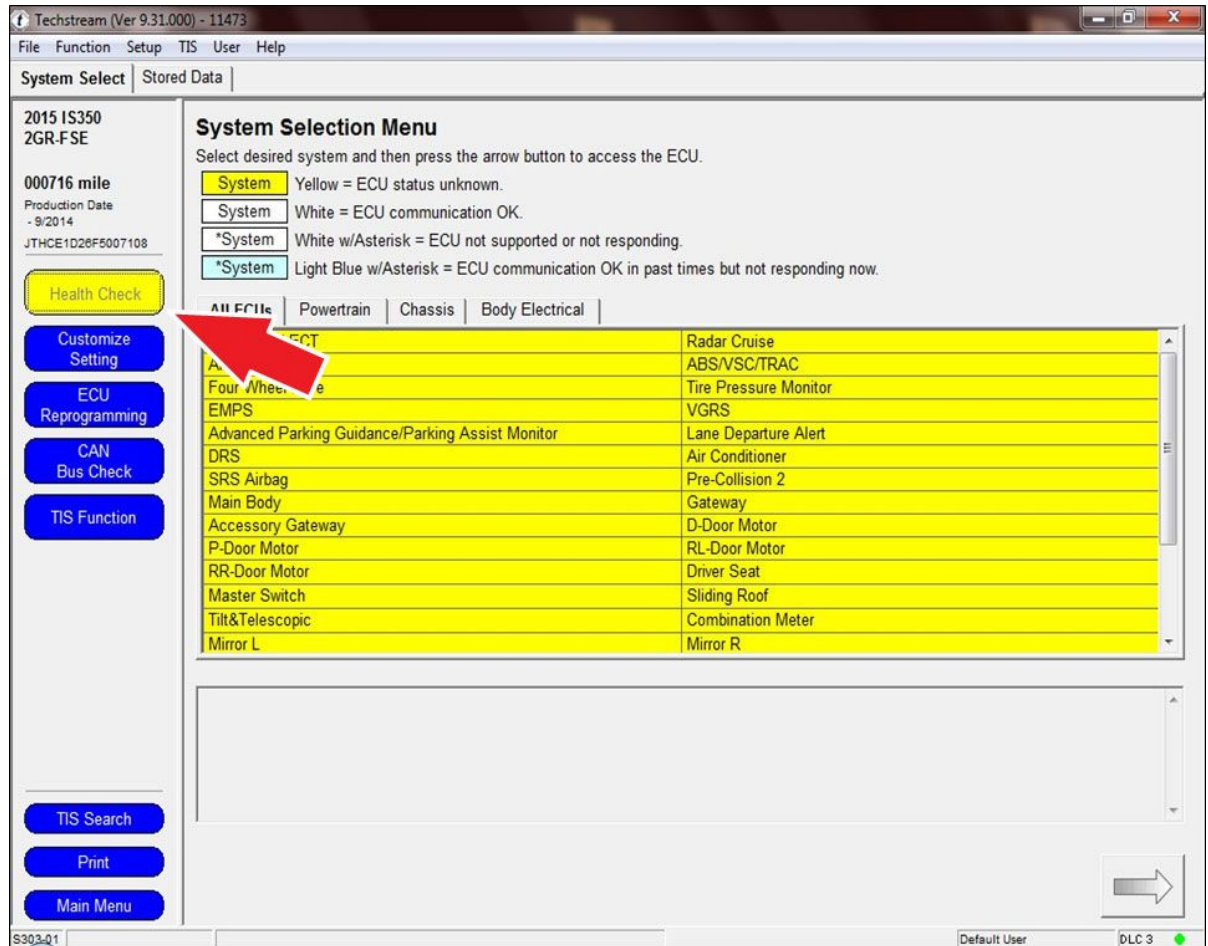
Figure 2.

1. Verify the vehicle's applicability for recalibration and locate desired calibration file.
 - A. Connect Techstream and establish a vehicle connection.
 - B. Click the *Health Check* button on the *System Select* tab.

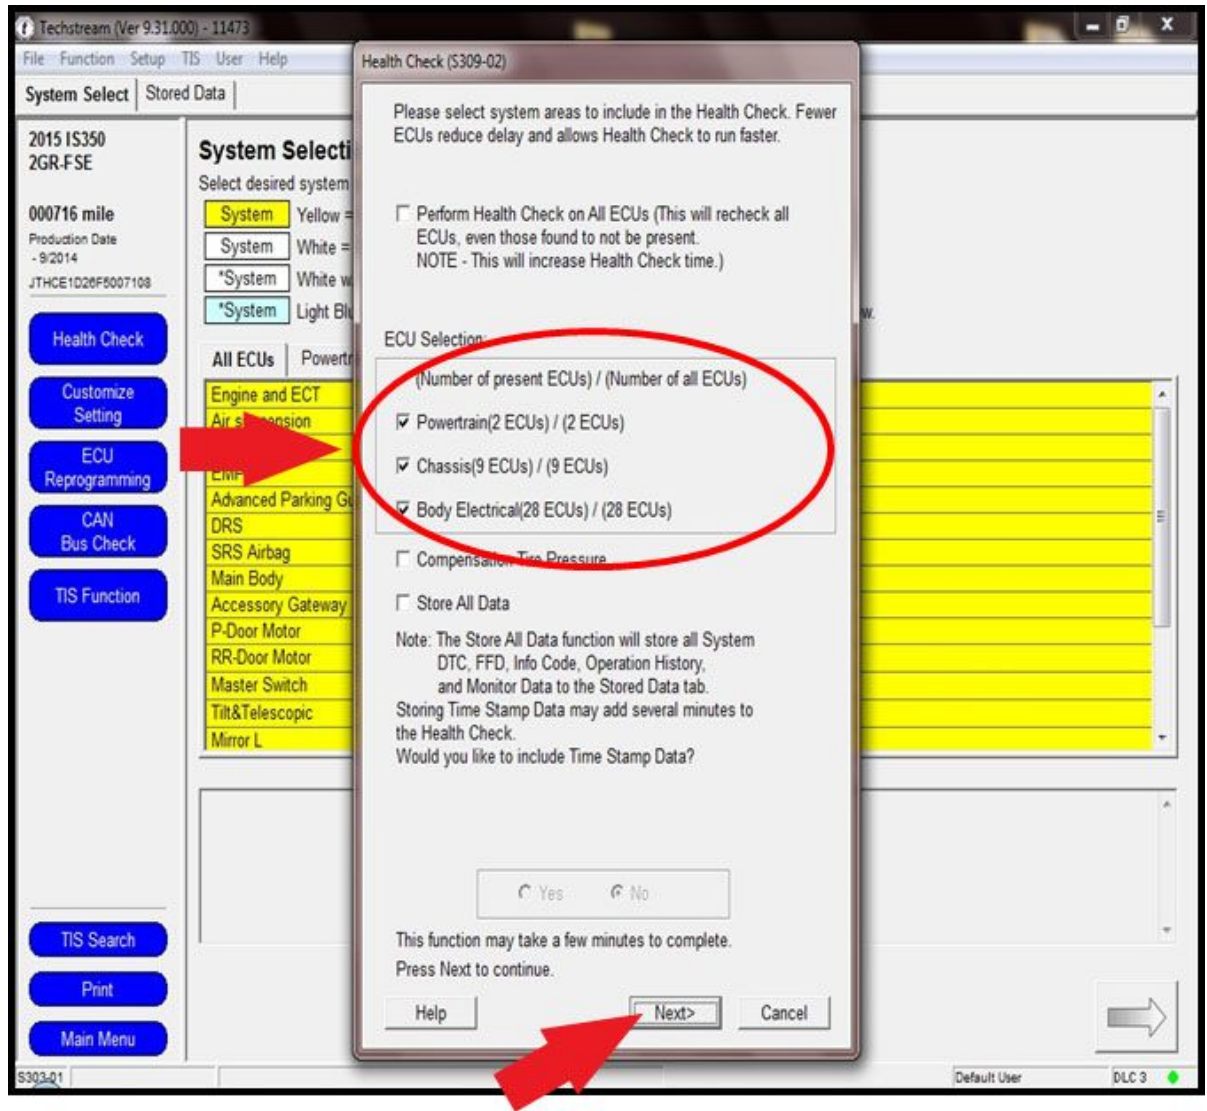
Figure 3.

C. Choose desired ECU group(s) in the *Health Check* dialog box.

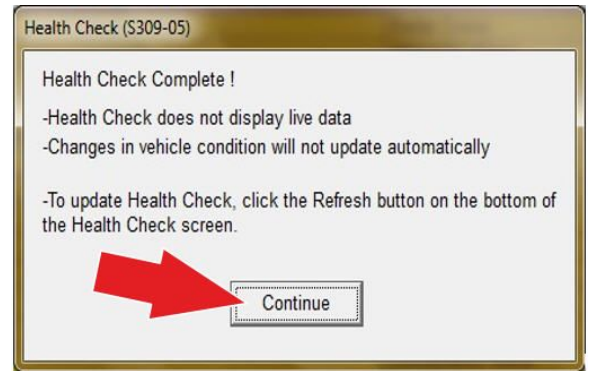
Figure 4.

E. Click *Continue* to view Health Check results.

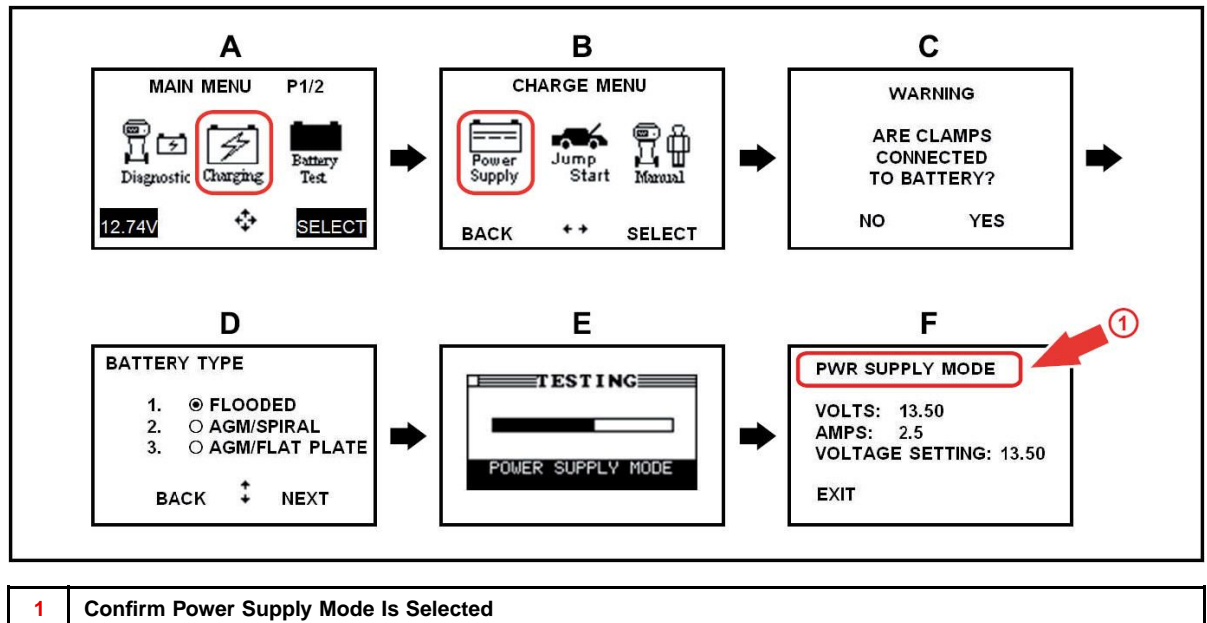
Figure 7.

- ECU damage may occur if the correct battery charger and mode setting are NOT used.
- Power Supply Mode is used to maintain battery voltage at 13.5 volts while flash reprogramming the vehicle.
- For details on how to use the GR8 Battery Diagnostic Station, refer to the [GR8 Instruction Manual](#) located on TIS, *Diagnostics – Tools & Equipment – Battery Diagnostics*.

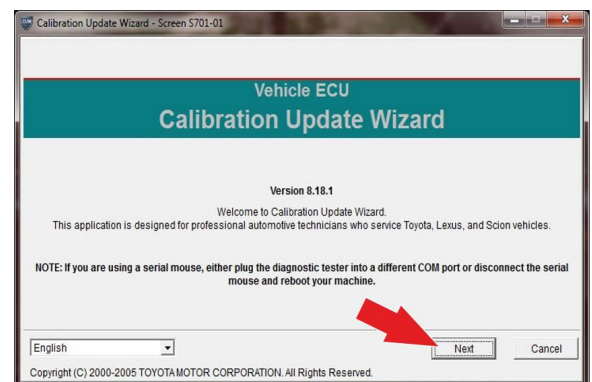
Figure 10.

- C. Click *Next* to start the calibration update process.

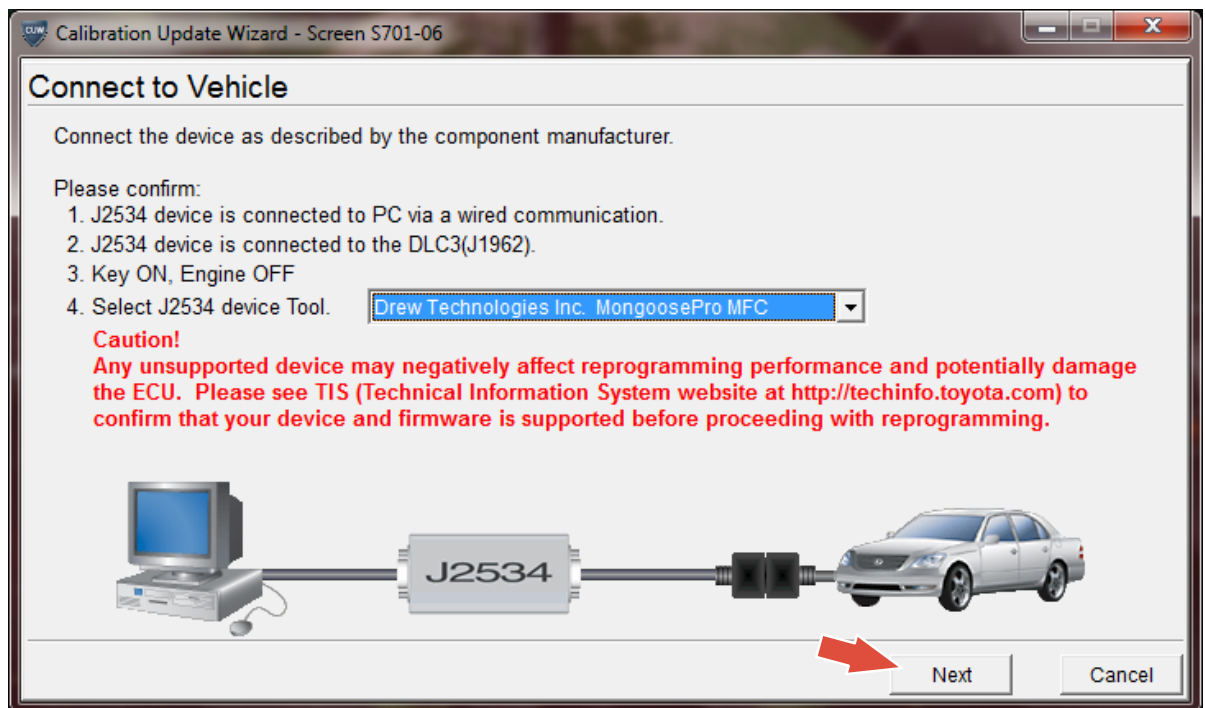
Figure 11. Using Techstream 2.0 or Techstream Lite

Then click *Next*.

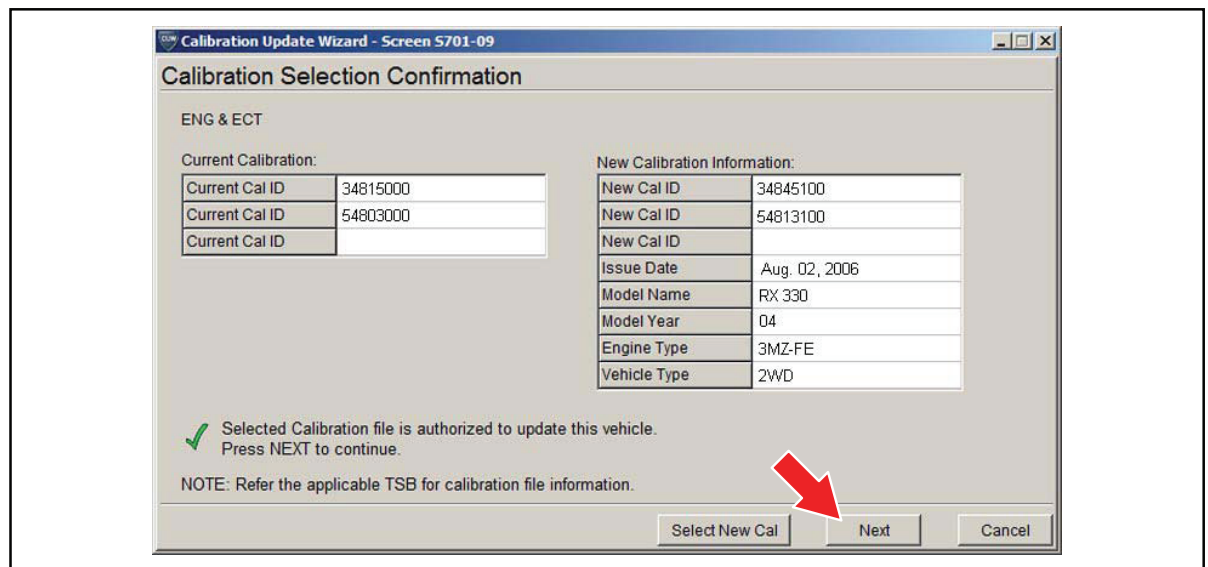
Figure 13.

- The total number of calibration IDs in the calibration file corresponds to the number of reprogrammable processors in the ECU.
- Each calibration file may contain up to three separate calibrations.
- Figure 15 shows an example of the update procedure for a two-processor ECU.

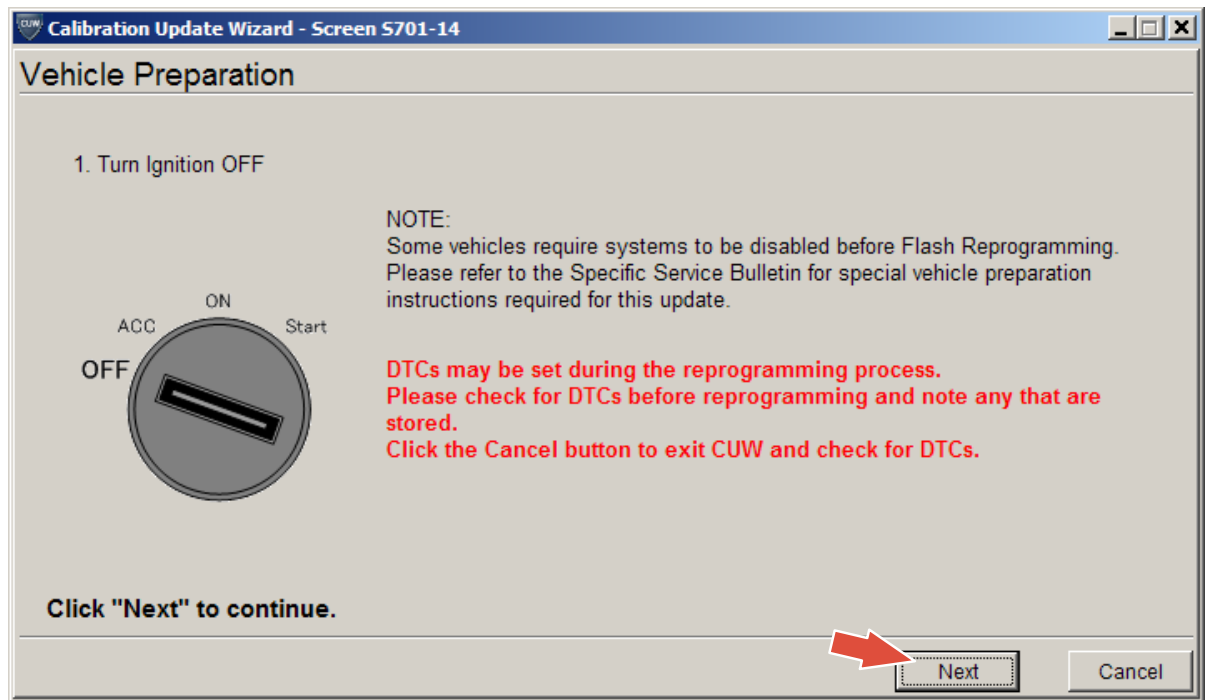
Figure 14.

F. Turn ignition OFF. Then click *Next*.

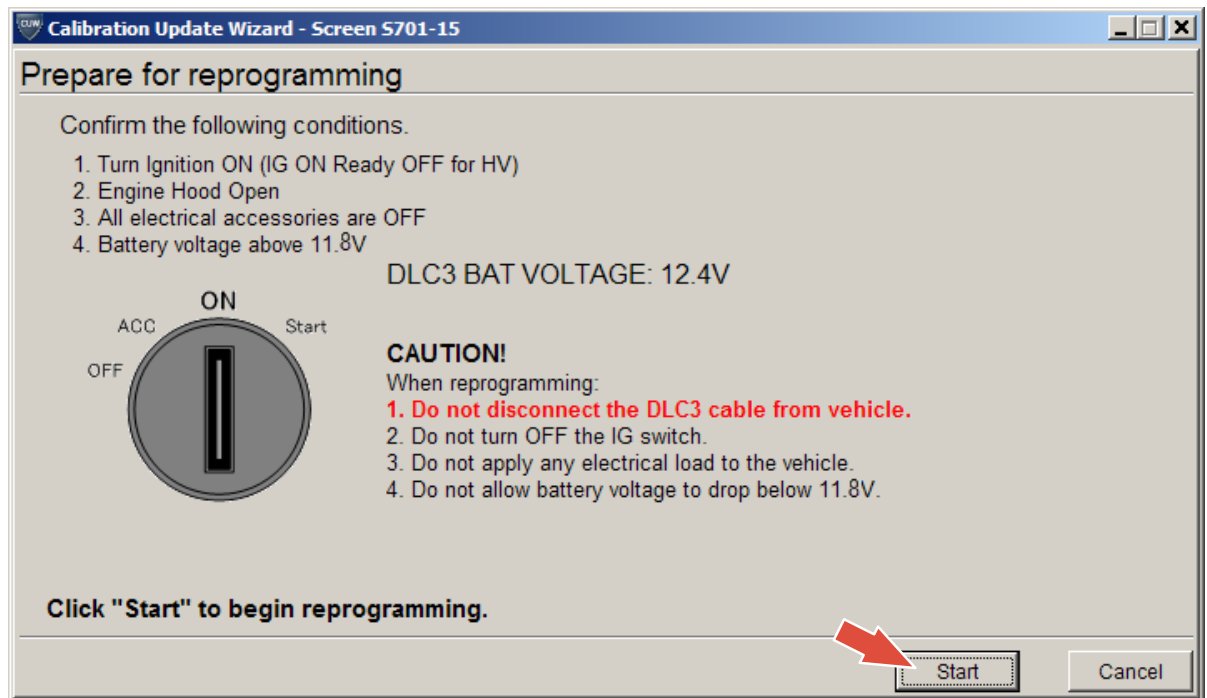
Figure 15.

Verify the vehicle is connected to a battery charger before continuing — If battery voltage falls below 11.8 volts, ECU damage may occur.

Then click *Start*.

If key cycle is NOT done properly, reprogramming will stop at 10% and Cal 1 will fail to load.

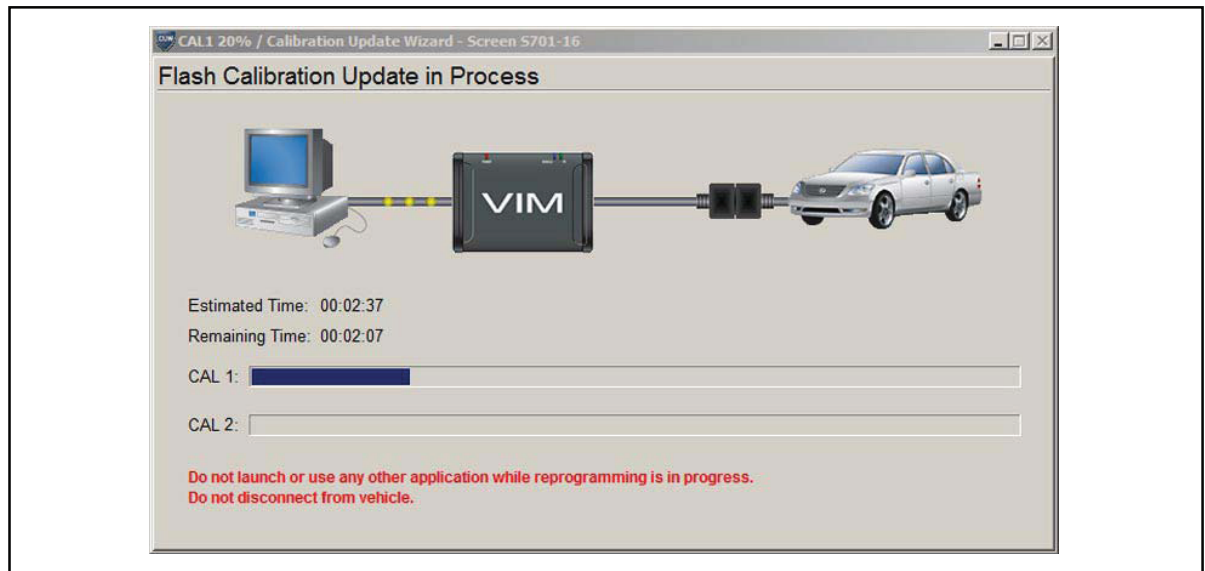
Figure 16.

- ECU flash reprogramming may take anywhere from 3 – 30 minutes per calibration file.
- Reprogramming time will vary depending on model and ECU communication protocol. Vehicles using CAN communication protocol will reprogram much faster (2 – 7 minutes).

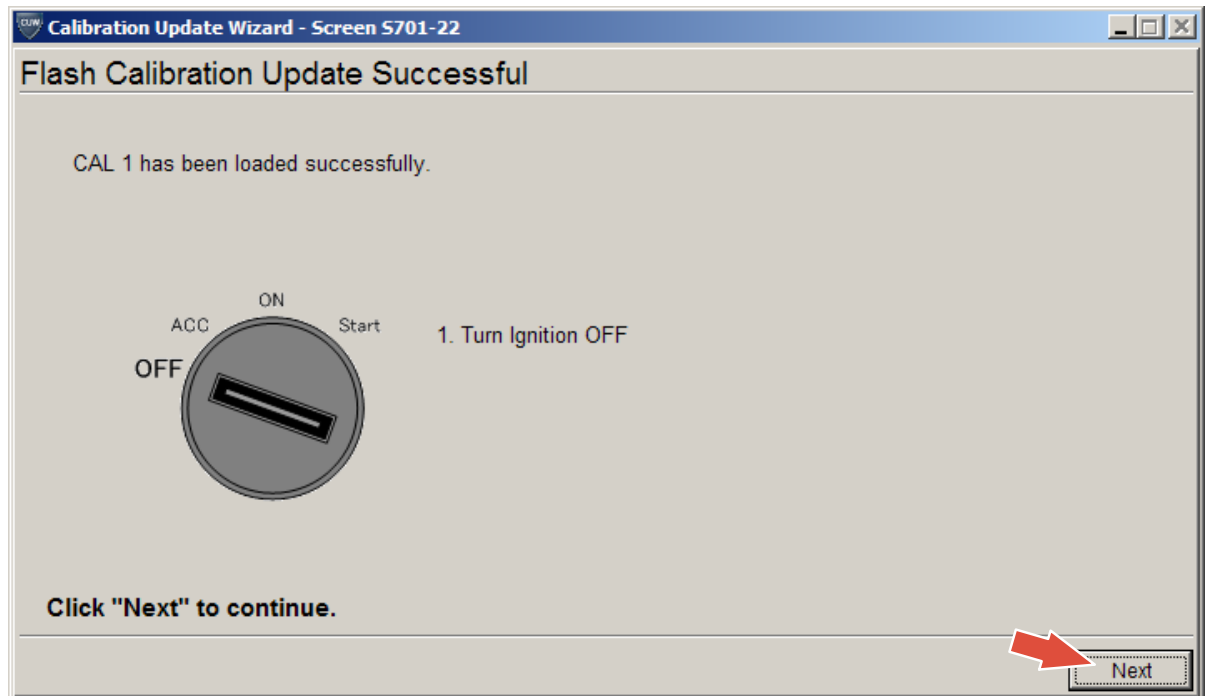
Figure 17.

- I. When Cal 1 has completed the update process, turn ignition OFF for a minimum of 10 seconds. Then click *Next*.

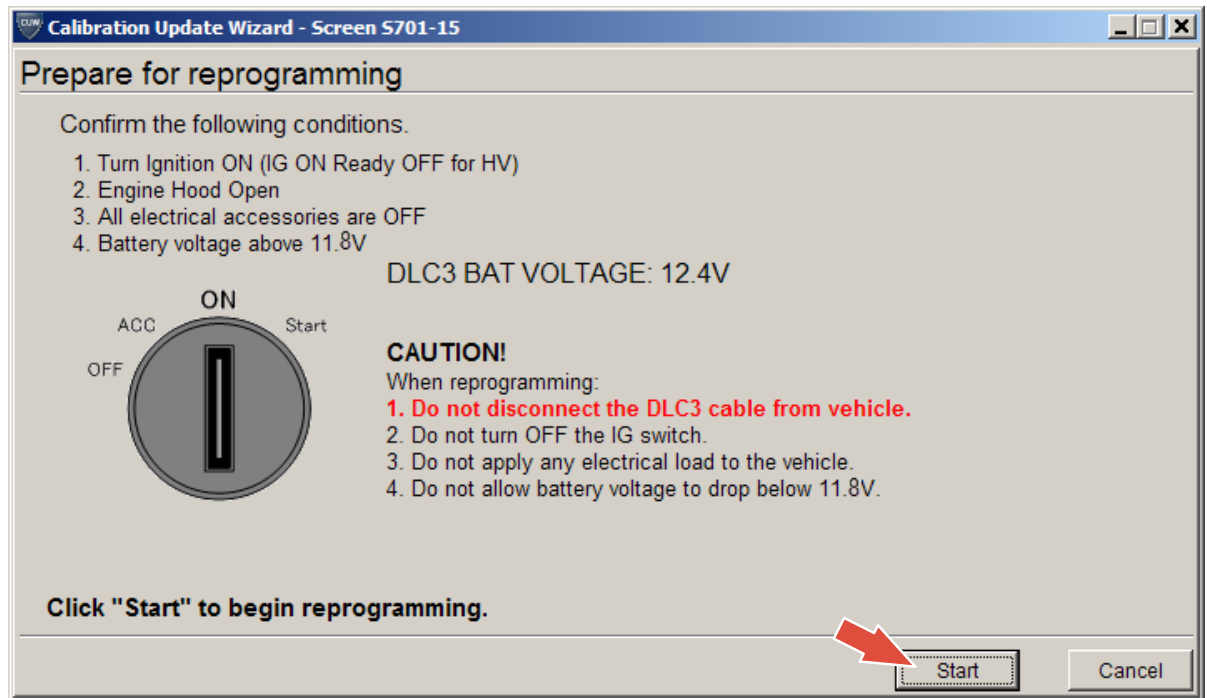
Figure 18.

J. Turn ignition to the ON position. Then click *Start*.

If key cycle is NOT done properly, reprogramming will stop at 10% and Cal 2 will fail to load.

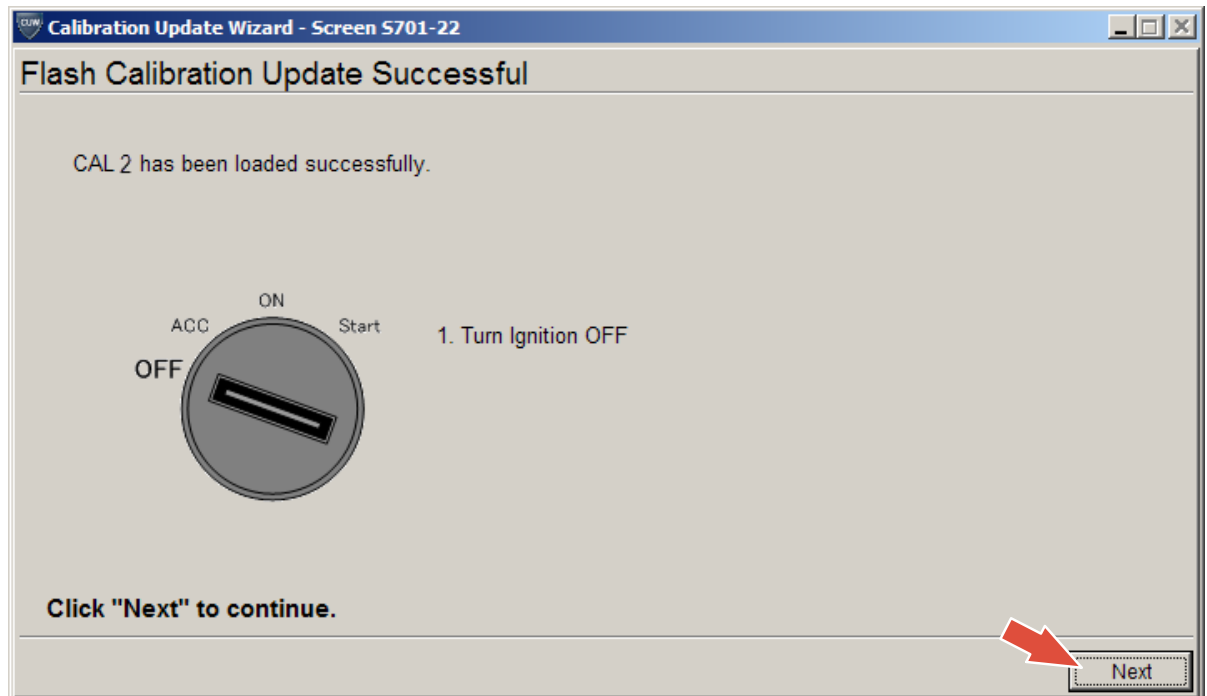
Figure 20.

L. Turn ignition OFF for a minimum of 10 seconds. Then click *Next*.

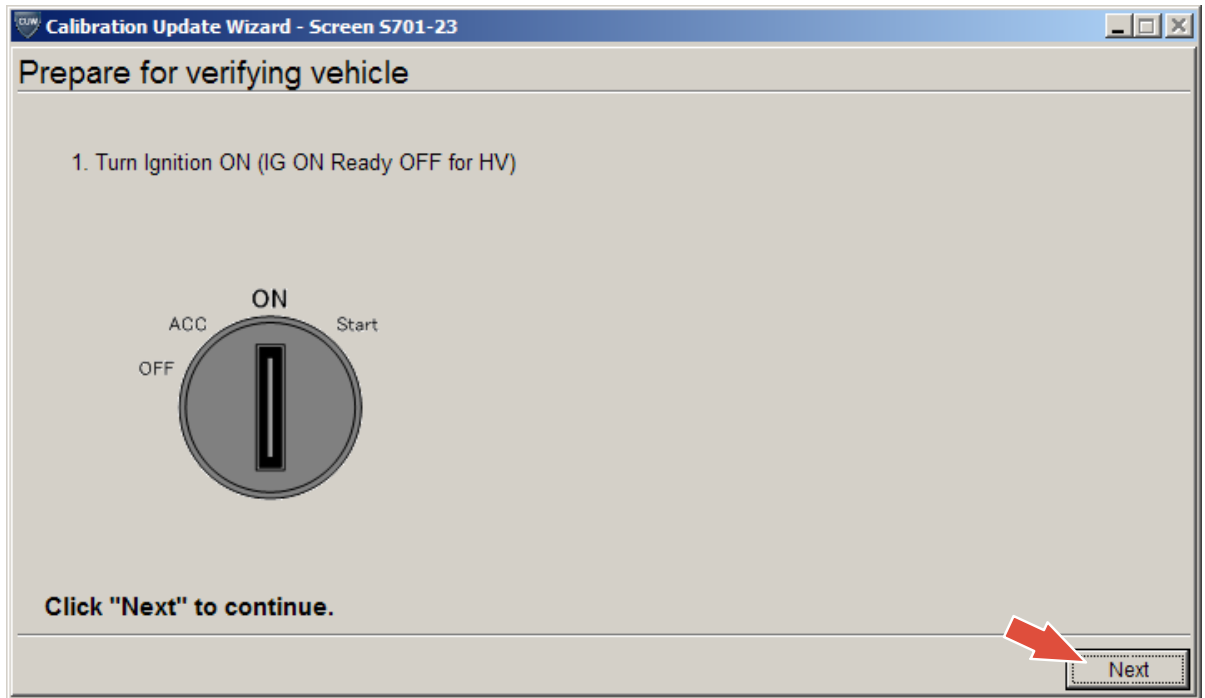
Figure 21.

M. Turn ignition to the ON position. Then click *Next*.

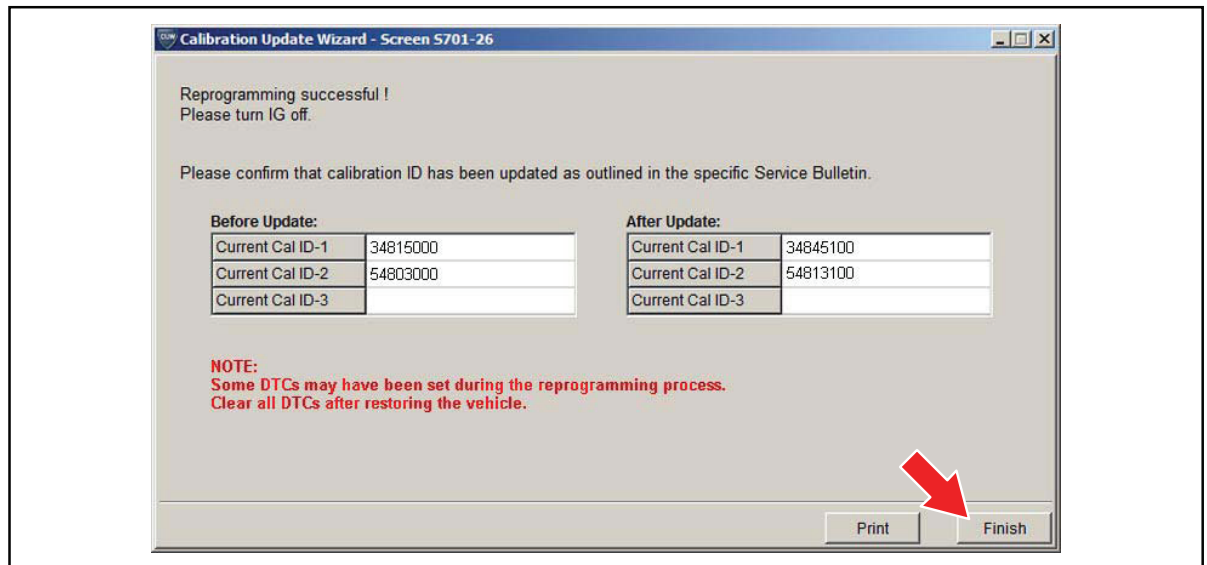
Figure 22.

N. Confirm all calibrations were updated as specified in the Service Bulletin. Then click *Finish*.
