# Techstream ECU Flash Reprogramming Procedure

Service Category Engine/Hybrid System

Section Emission Control

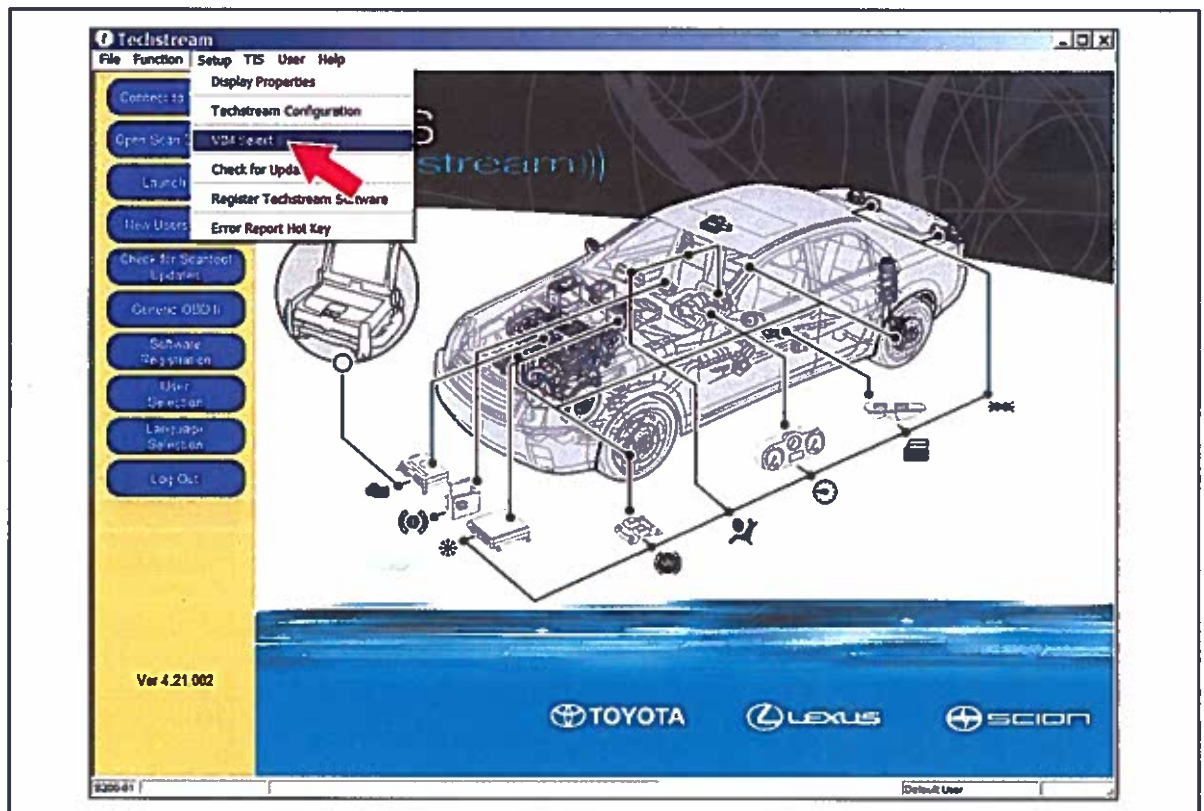
Figure 1.

1. Select *Setup* from the Techstream Main Menu screen.
2. Select *VIM Select* from the Setup drop down menu.

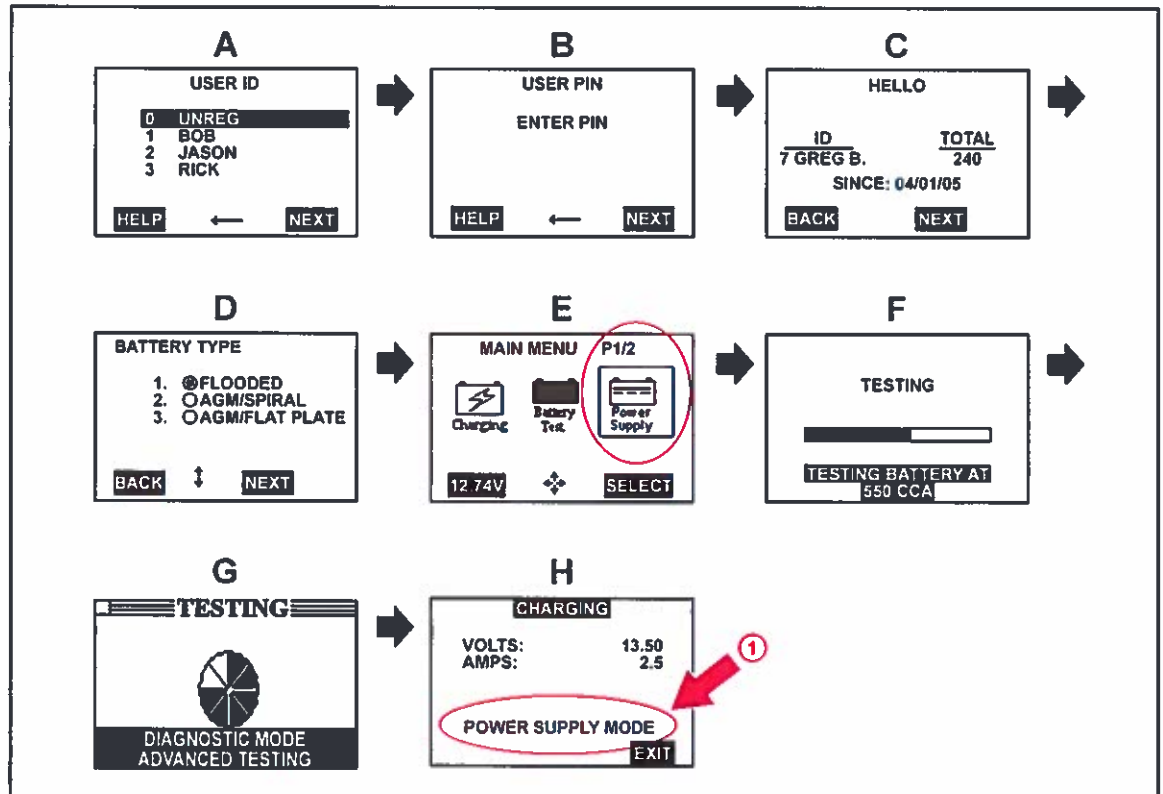
Figure 7.

- ECU damage may occur if the correct battery charger and mode setting are NOT used.
- Power Supply Mode is used to maintain battery voltage at 13.5 volts while flash reprogramming the vehicle.
- For details on how to use the GR8 Battery Diagnostic Station, refer to the [GR8 Instruction Manual](#) located on TIS, *Diagnostics – Tools & Equipment – Battery Diagnostics*.

**1** Confirm Power Supply Mode Is Selected

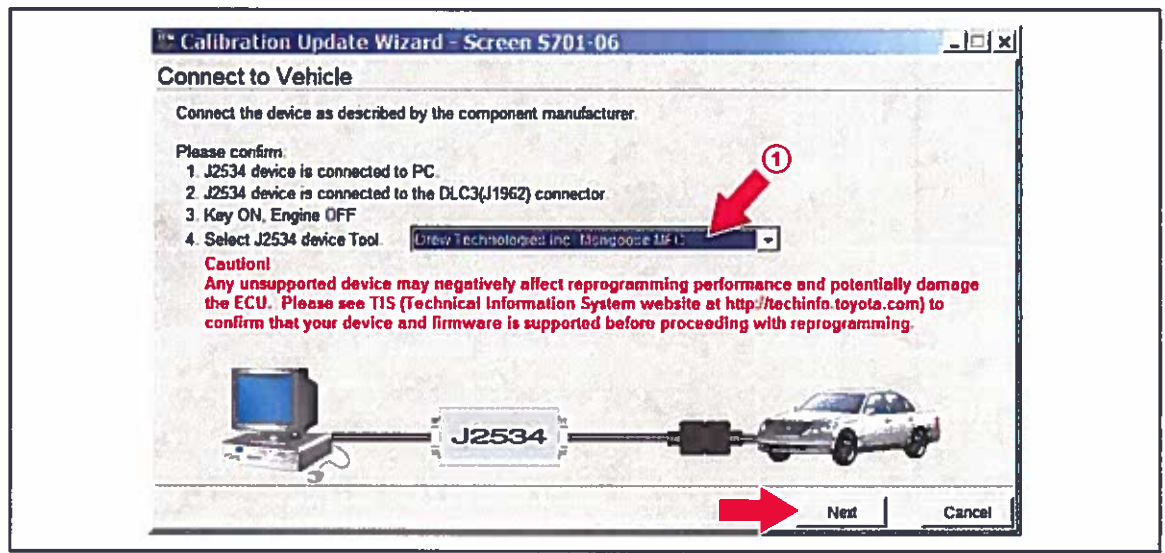
**Figure 12. Using Techstream 2.0 or Techstream Lite**

**1** Select Correct Device Tool ("Mongoose MFC" or "MongoosePro MFC")

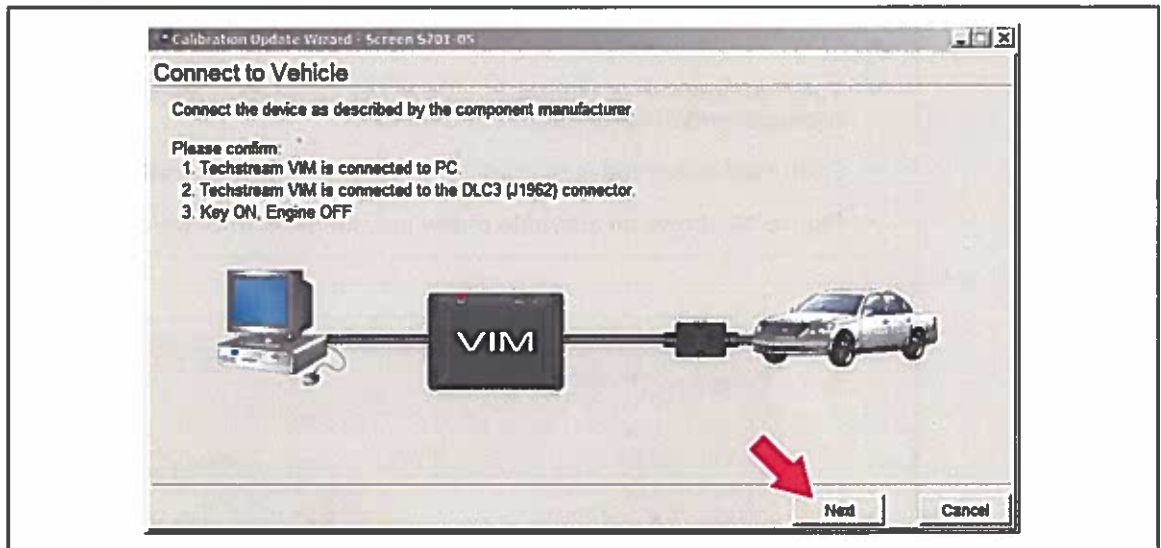
Figure 13. Using TIS Techstream
