Field Service Bulletin Trucks

Engine Control Module (ECM) and Aftertreatment Control Module (ACM), Reprogramming VN, VAH, VHD

FSB 284-065, Engine Control Module (ECM) and Aftertreatment Control Module (ACM), Reprogramming

(March 2018)

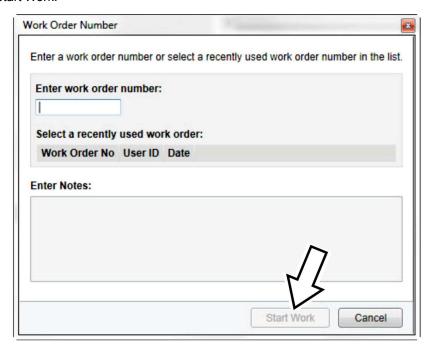
W2115477

- 6 Turn the ignition switch "ON".
- 7 Log in to PTT and Identify Vehicle is displayed.
- 8 Once the vehicle has been identified, enter the Work Order Number information, then click Start Work.

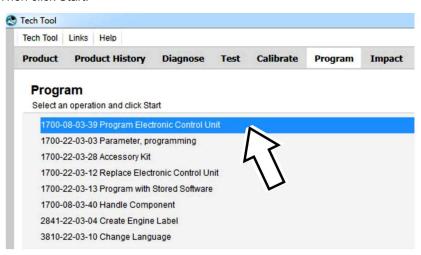
9 From the Main Menu select Program and **then** Program Electronic Control Unit 1700-08-03-39. Then click Start.

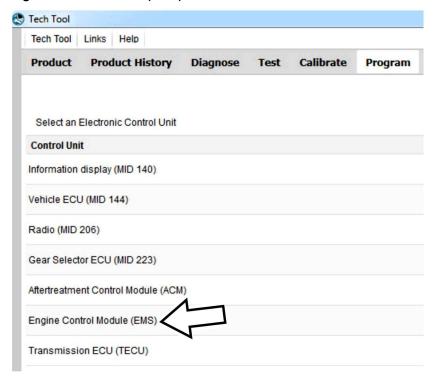
W2115479

11 Select Program to update the **ECM** with the latest software.

Programming options

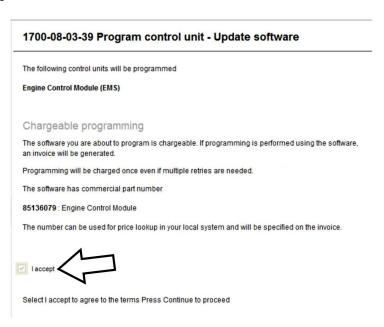
13 Select "I accept" to agree to the terms and press continue to proceed.
