# Techstream ECU Flash Reprogramming Procedure

Service Category    Engine/Hybrid System

Section            Engine Control

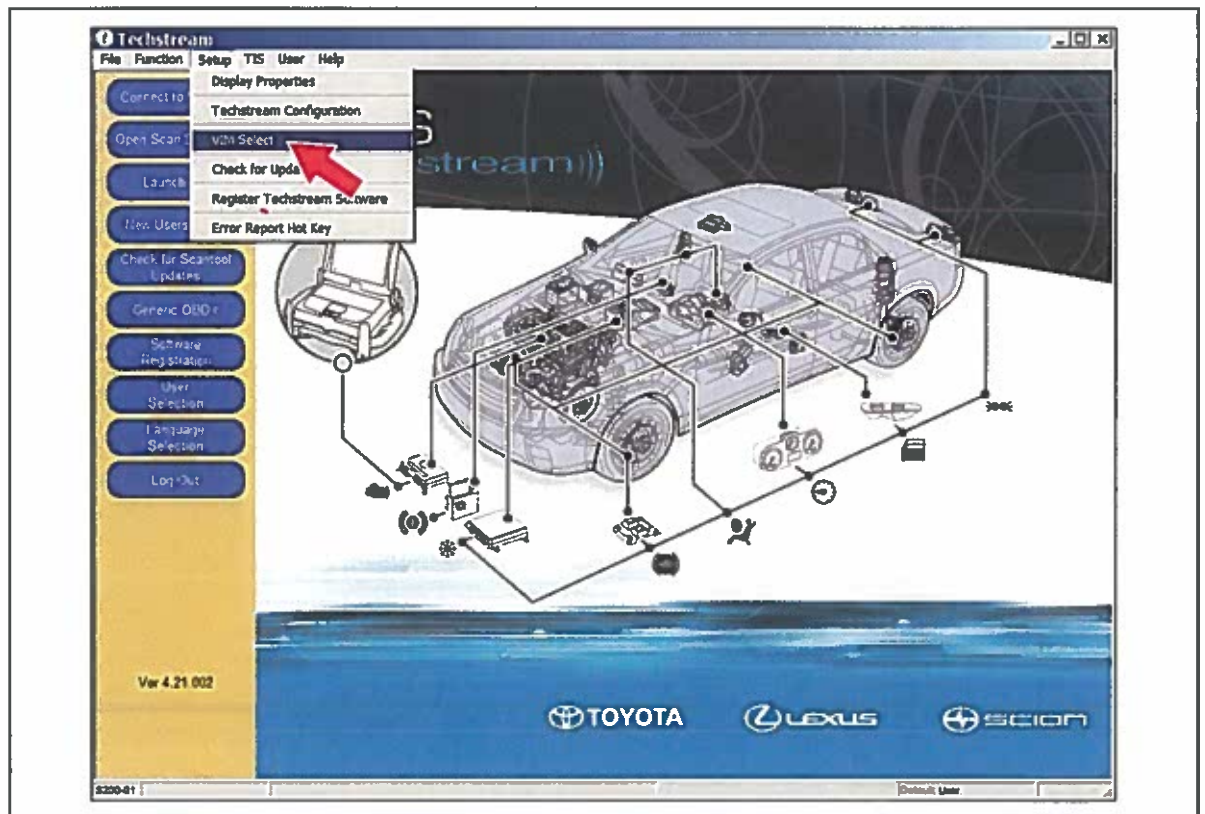
Figure 1.

1. Select *Setup* from the Techstream Main Menu screen.
2. Select *VIM Select* from the Setup drop down menu.

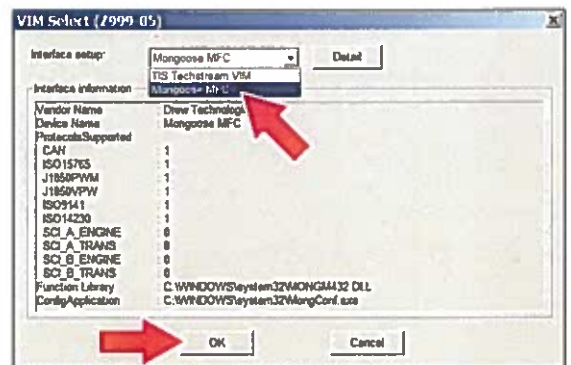
- If using Techstream Lite, select *Mongoose MFC*.

Mongoose MFC Software and Driver **MUST** be installed before Mongoose MFC selection will be available.

Figure 2. Select Mongoose MFC to Use Techstream Lite

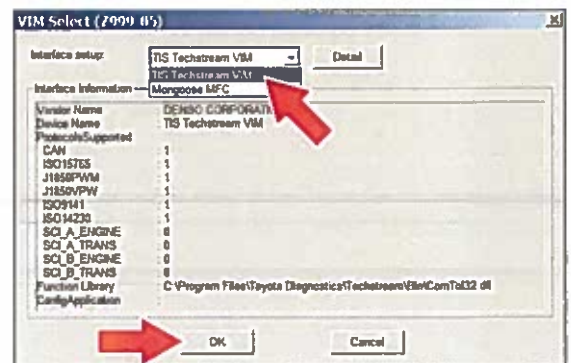
- If using TIS Techstream, select *TIS Techstream VIM* (this is the default).

Figure 3. Select TIS Techstream VIM (default) to Use TIS Techstream

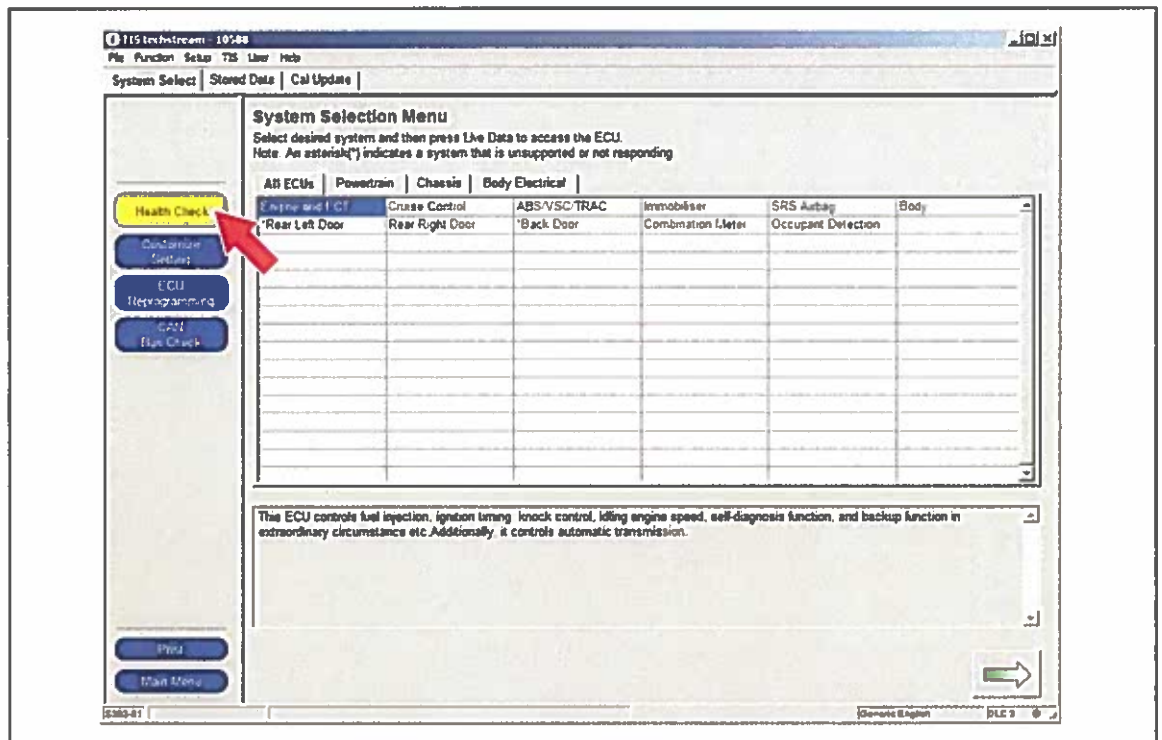
Figure 4.

1. Verify the vehicle's applicability for recalibration and locate desired calibration file.
  - A. Connect Techstream and establish a vehicle connection.
  - B. Click the *Health Check* button on the *System Select* tab.

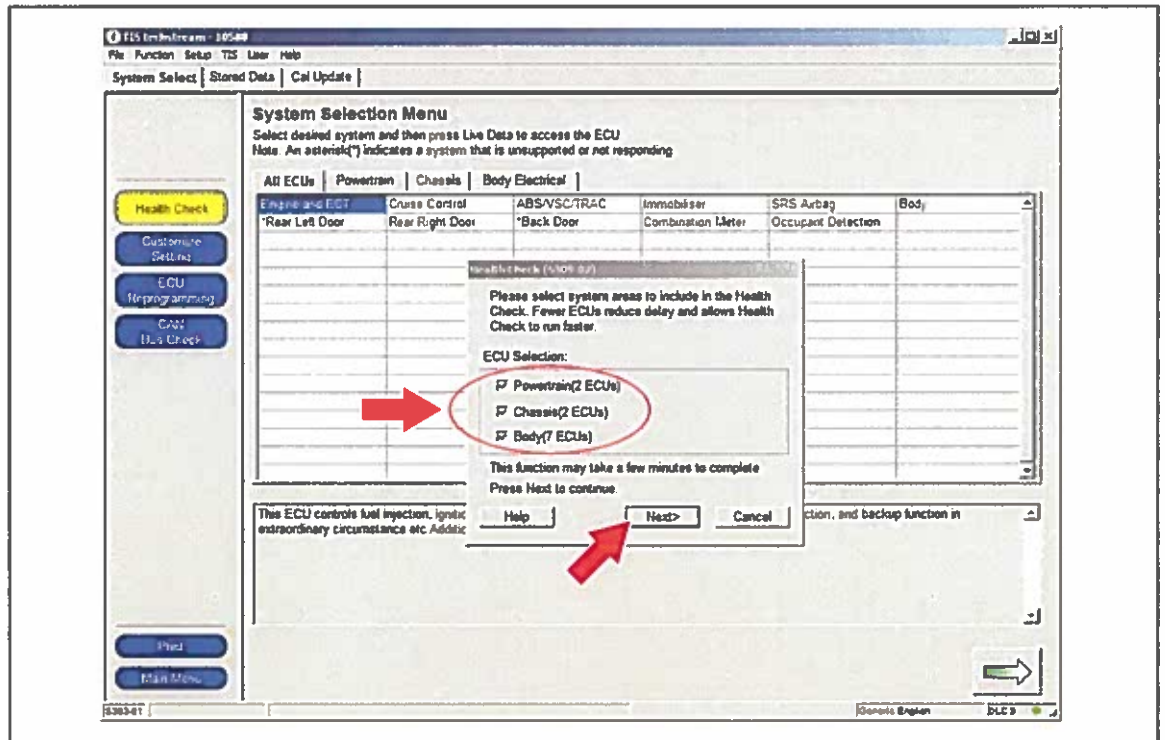
Figure 5.

- C. Choose desired ECU group(s) in the *Health Check* dialog box.

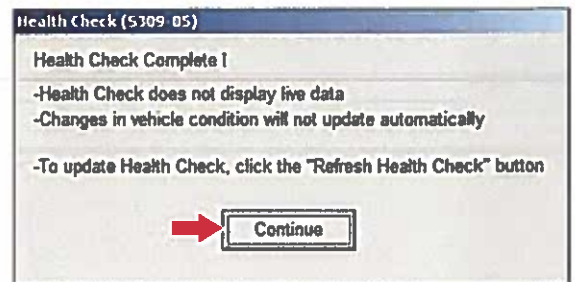
Figure 6.

- E. Click *Continue* to view *Health Check* results.

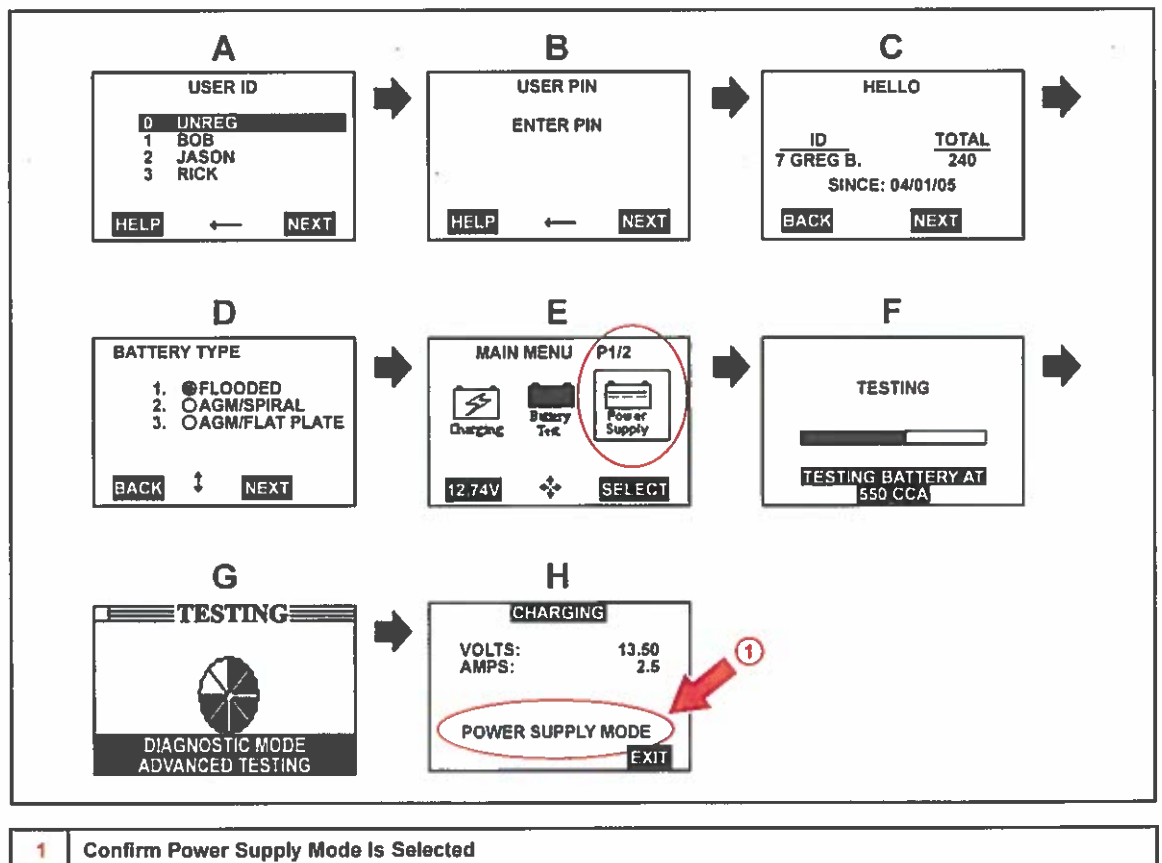
Figure 9.

- A. Connect the GR8 Battery Diagnostic Station to the vehicle and turn it ON.
- B. Select Power Supply Mode by following the screen flow below.

- ECU damage may occur if the correct battery charger and mode setting are NOT used.
- Power Supply Mode is used to maintain battery voltage at 13.5 volts while flash reprogramming the vehicle.
- For details on how to use the GR8 Battery Diagnostic Station, refer to the [GR8 Instruction Manual](#) located on TIS, *Diagnostics – Tools & Equipment – Battery Diagnostics*.

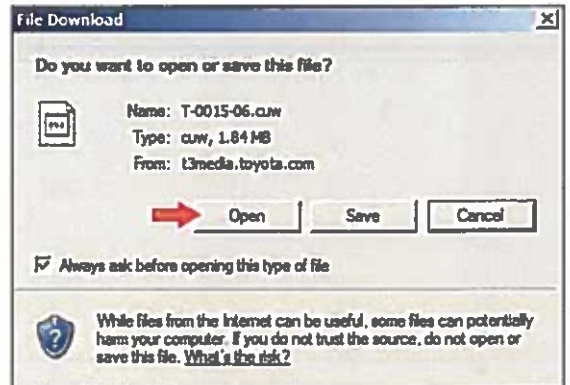
Figure 11.

- B. Click *Open* to load calibration file information.

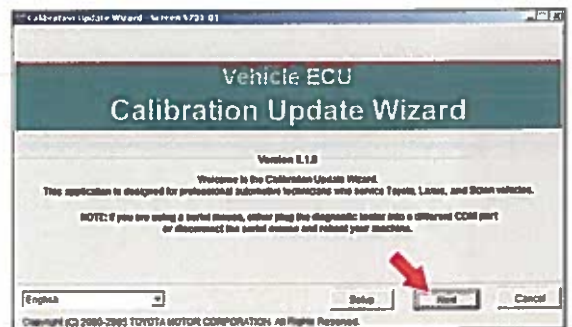
Figure 12.

- C. Click *Next* to start the calibration update process.

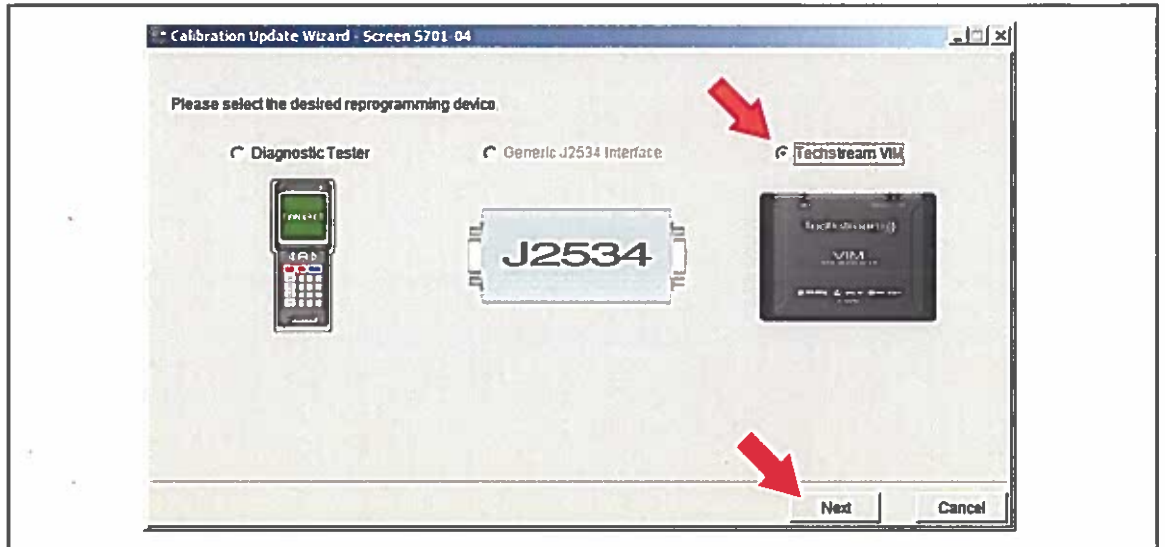
Figure 13.

- D. When using TIS Techstream, select *Techstream VIM* as the desired programming device. Then click *Next*.

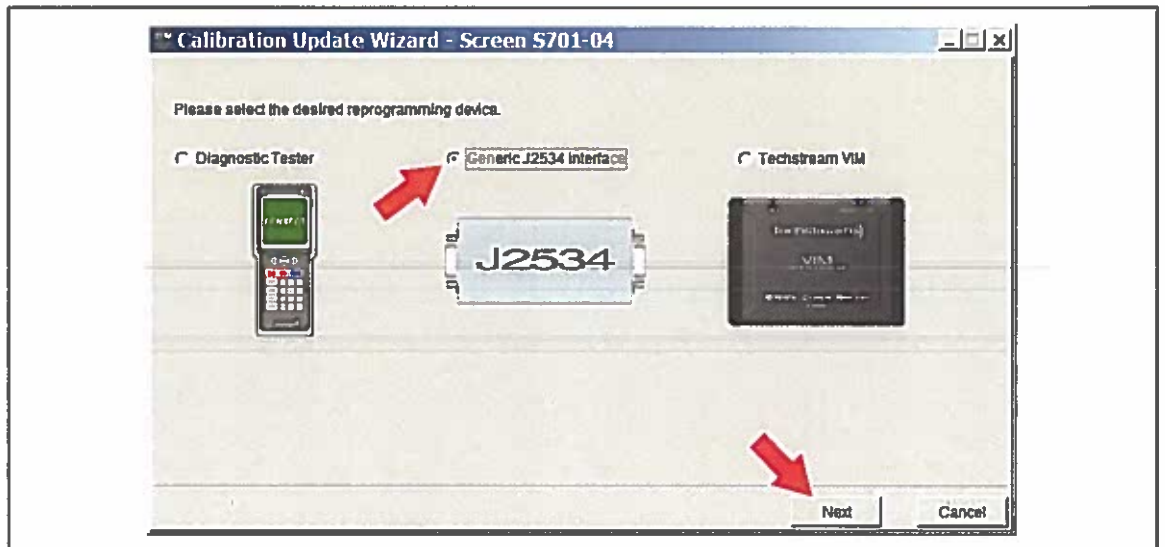
Figure 14.

When using Techstream Lite, select *Generic J2534 Interface*. Then click *Next*.

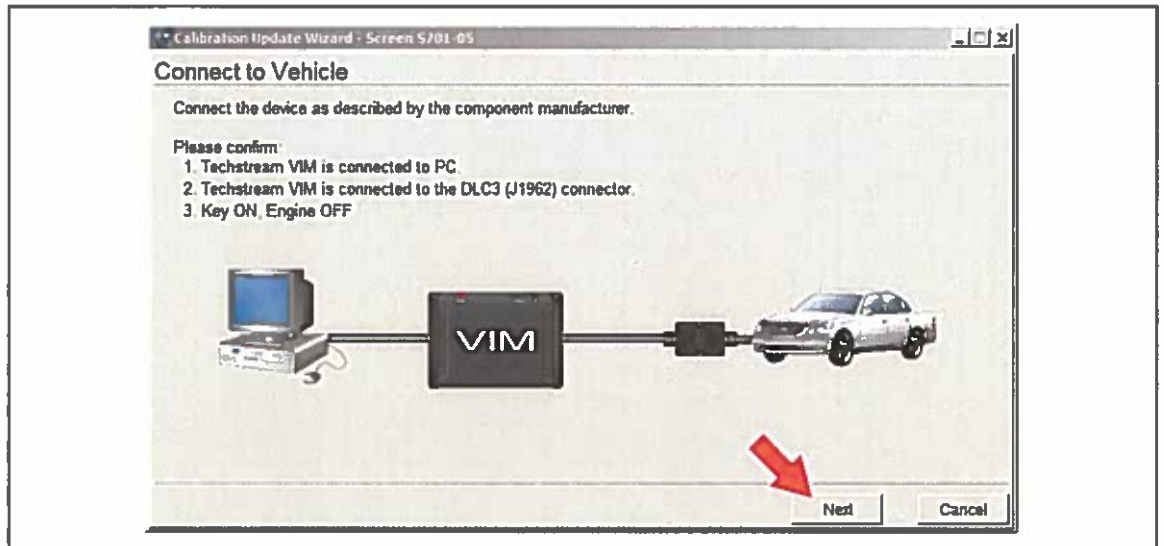
E. Confirm the following:

Figure 15. Using TIS Techstream

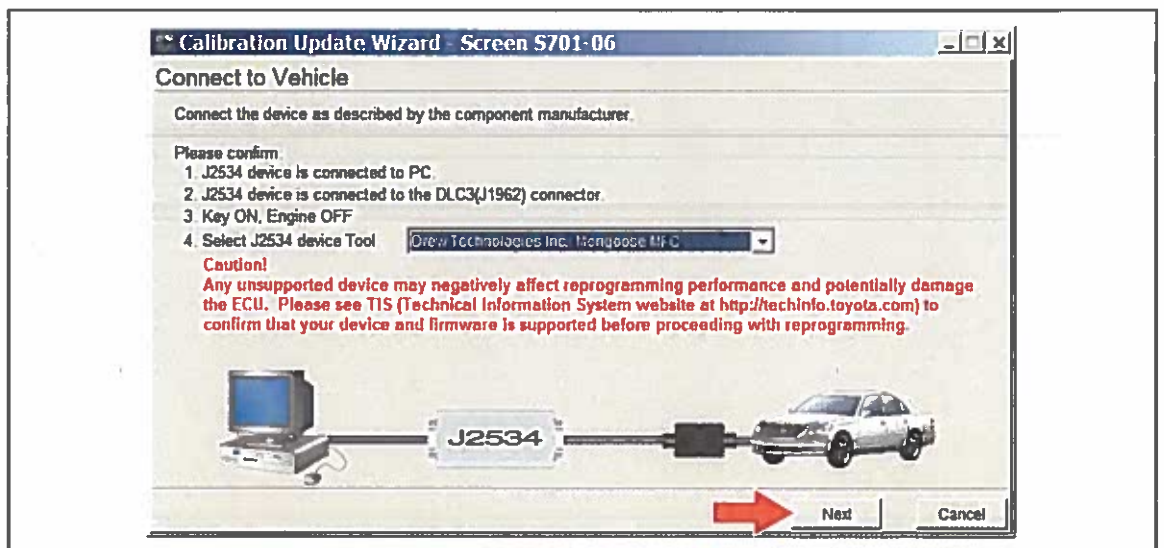
Figure 16. Using Techstream Lite

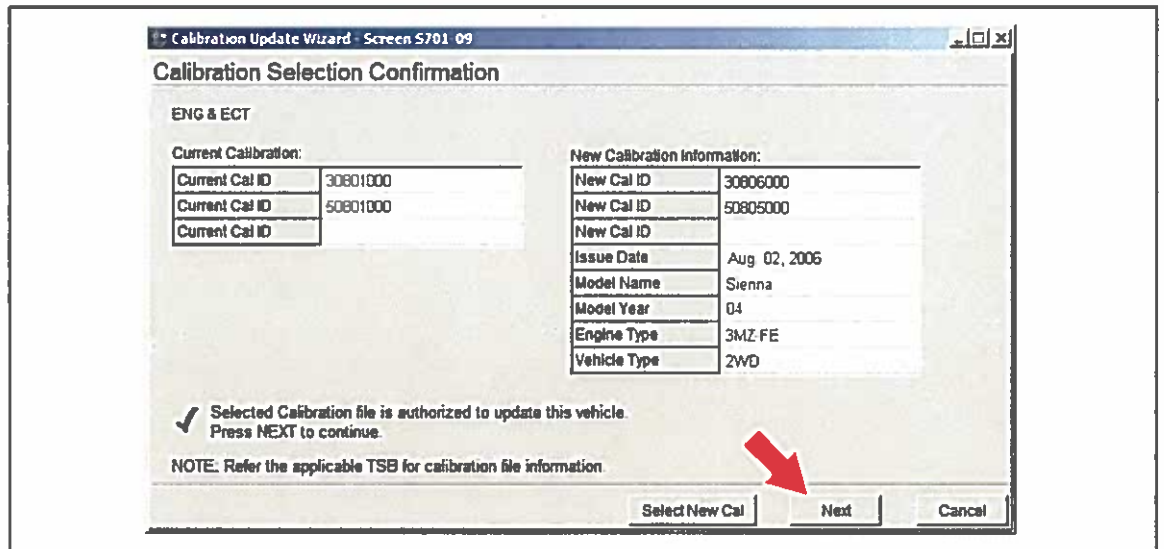
Figure 17.

F. Verify correct current calibration and new calibration information. Then click *Next*.

- The total number of calibration IDs in the calibration file corresponds to the number of reprogrammable processors in the ECU.
- Each calibration file may contain up to three separate calibrations.
- Figure 17 shows an example of the update procedure for a two-processor ECU.

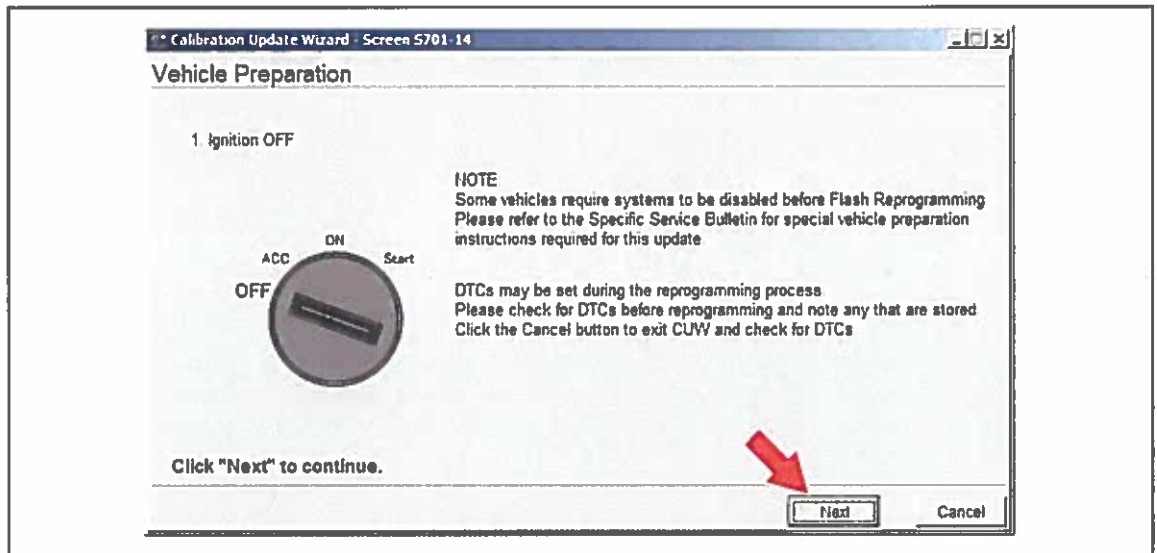
Figure 18.

G. Turn ignition OFF. Then click *Next*.

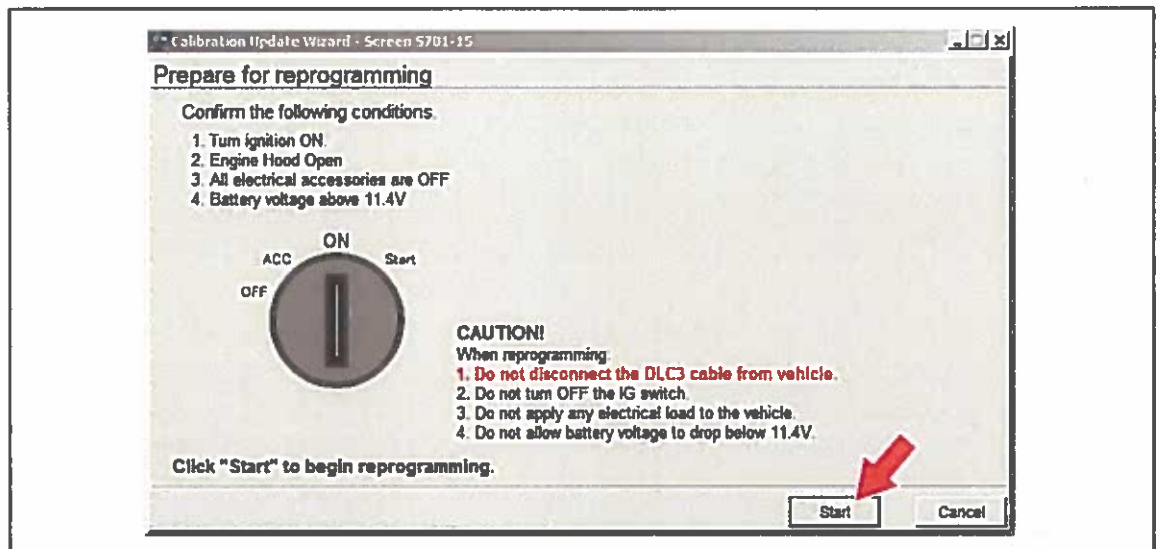
Figure 19.

Verify the vehicle is connected to a battery charger before continuing — If battery voltage falls below 11.4 volts, ECU damage may occur.

Then click *Start*.

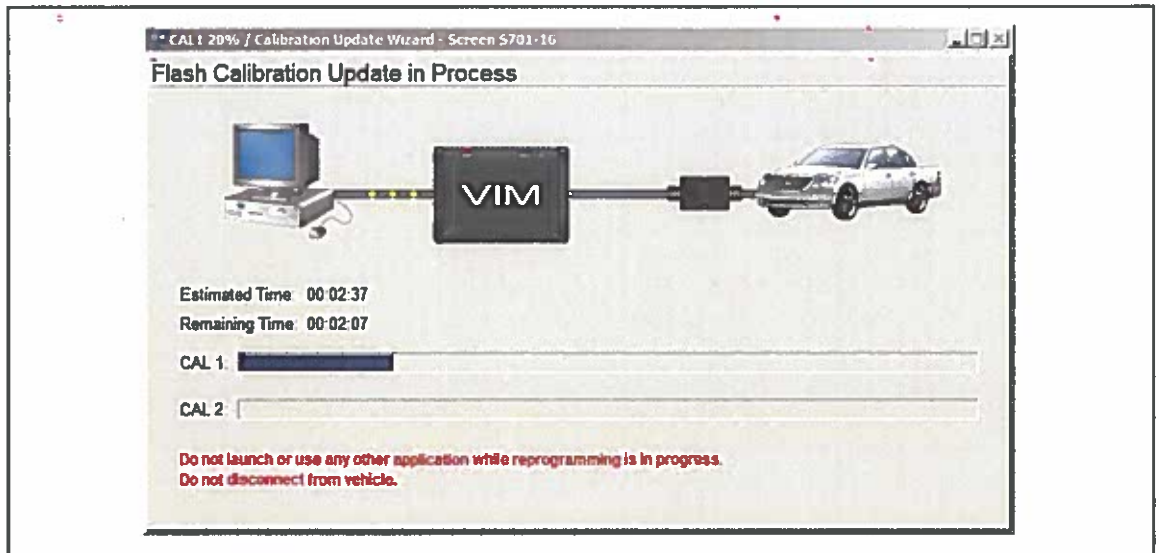
Figure 20.

- ECU flash reprogramming may take anywhere from 3 – 30 minutes per calibration file.
- Reprogramming time will vary depending on model and ECU communication protocol. Vehicles using CAN communication protocol will reprogram much faster (2 – 7 minutes).

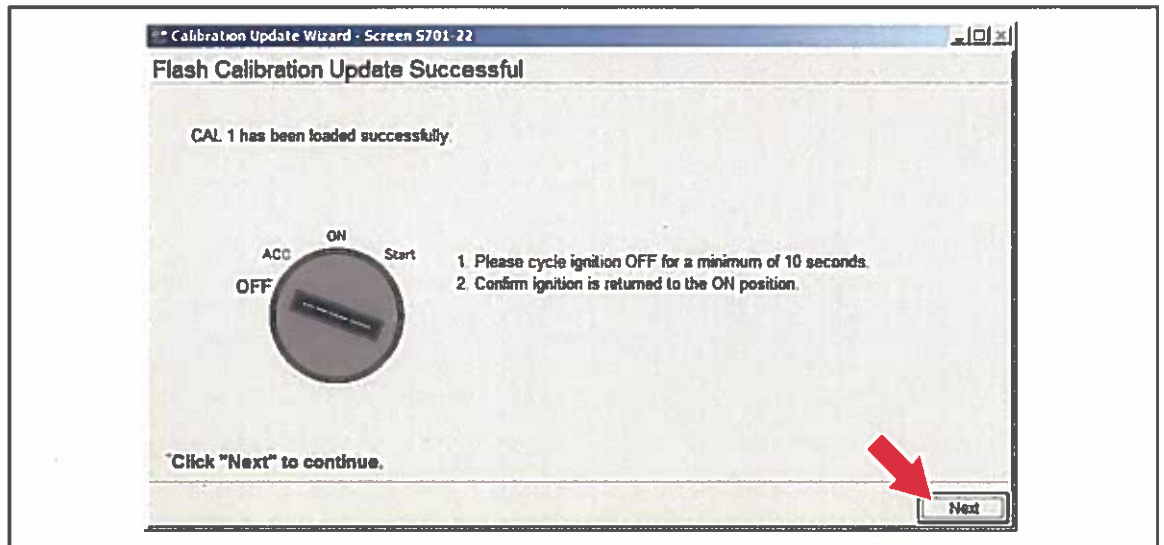
Figure 21.

- J. When Cal 1 has completed the update process, turn ignition OFF for a minimum of 10 seconds. Then click *Next*.

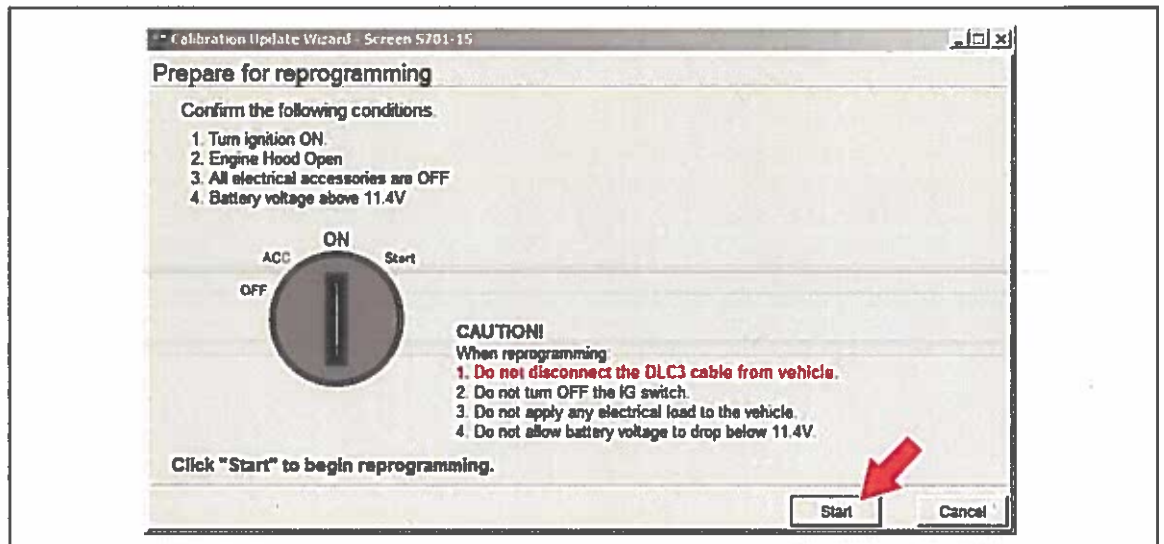
Figure 22.

- K. Turn ignition to the ON position. Then click *Start*.

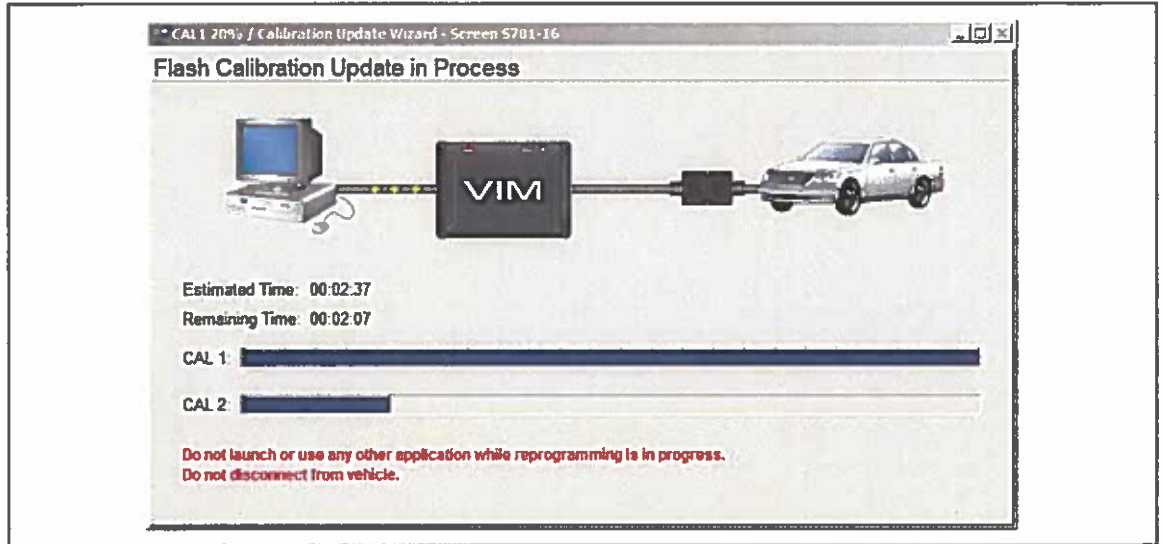
Figure 23.

- L. Do NOT disturb the vehicle during flash reprogramming.

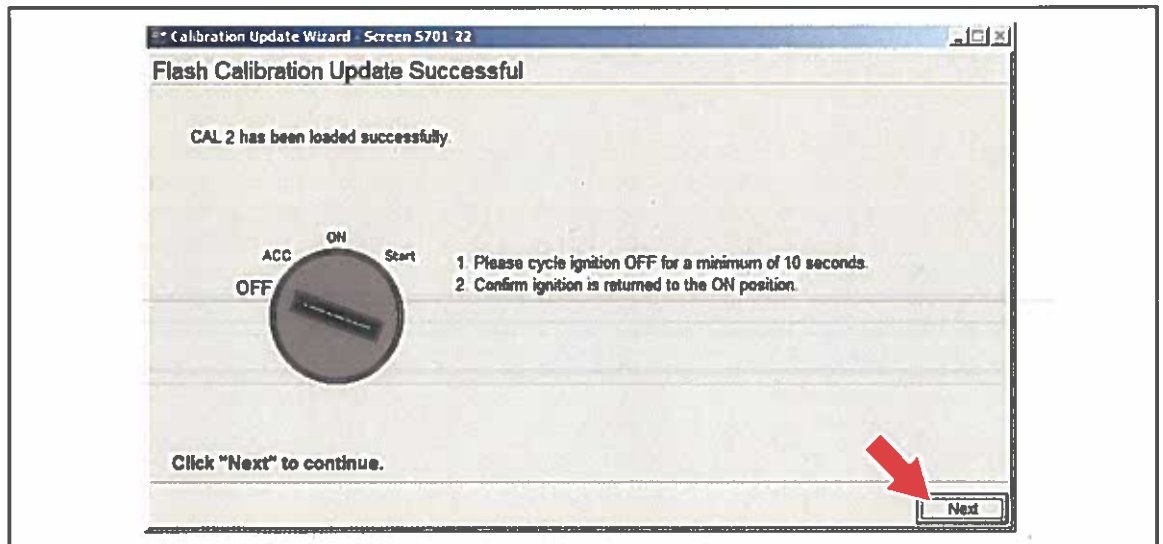
Figure 24.

- M. Turn ignition OFF for a minimum of 10 seconds. Then click *Next*.

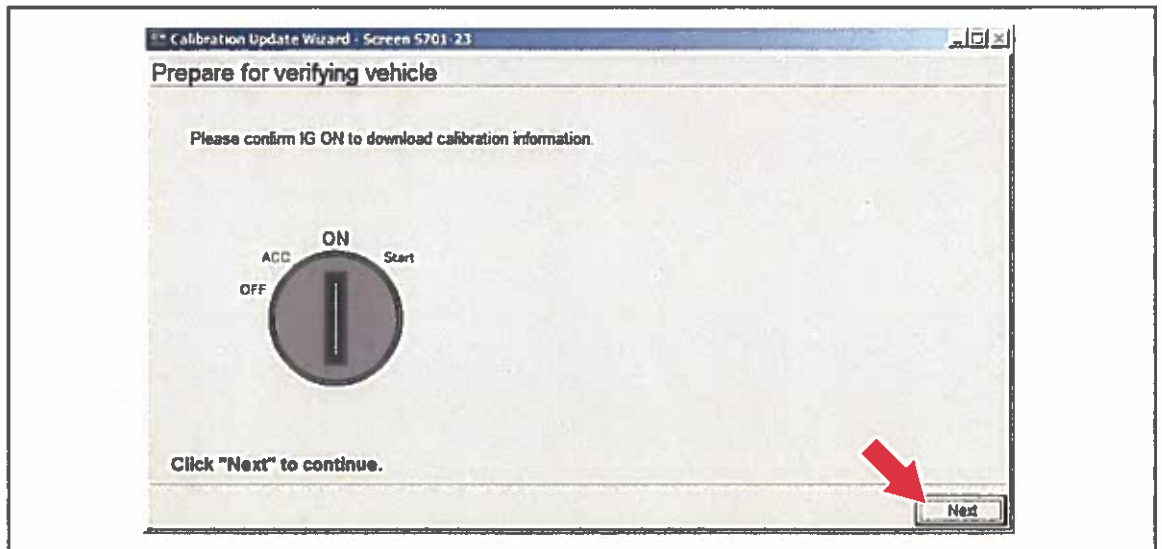
Figure 25.

N. Turn ignition to the ON position. Then click *Next*.

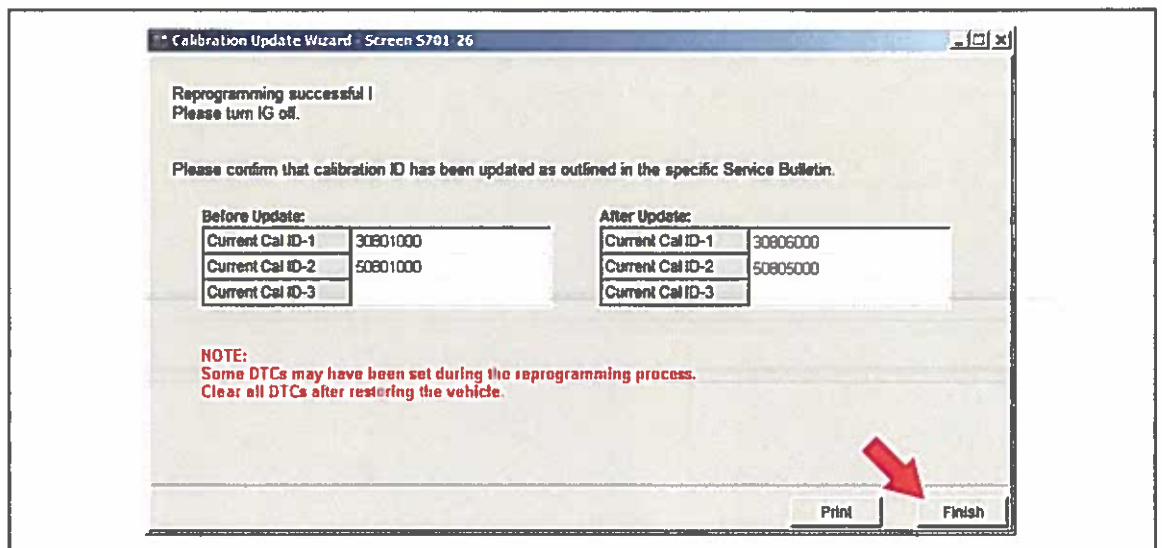
Figure 26.

O. Confirm all calibrations were updated as specified in the Service Bulletin. Then click *Finish*.

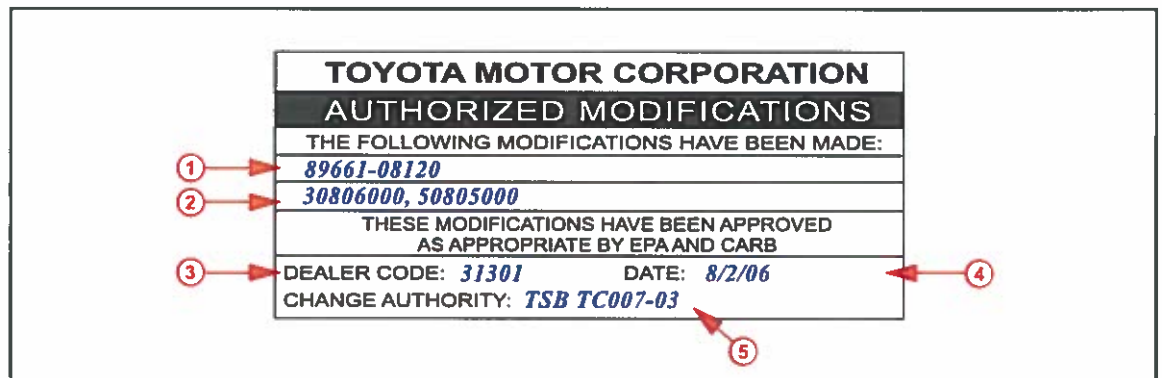
Figure 27.

- A. Using a permanent marker or ball point pen, complete the Authorized Modifications Label and attach to the vehicle. The Authorized Modifications Label is available through the MDC, P/N 00451-00001-LBL.

1	Replacement ECU Part Number
2	Calibration ID(s)
3	Dealer Code

4	Date Completed
5	Service Bulletin or Campaign Number
