Techstream ECU Flash Reprogramming Procedure

Service Category Engine/Hybrid System

Section Engine Control

| YEAR(S) | MODEL(S) | ADDITIONAL INFORMATION |
|---|---|---|
| 2004 – 2014 | FR-S, iQ, iQ EV, tC, xA, xB, xD | |

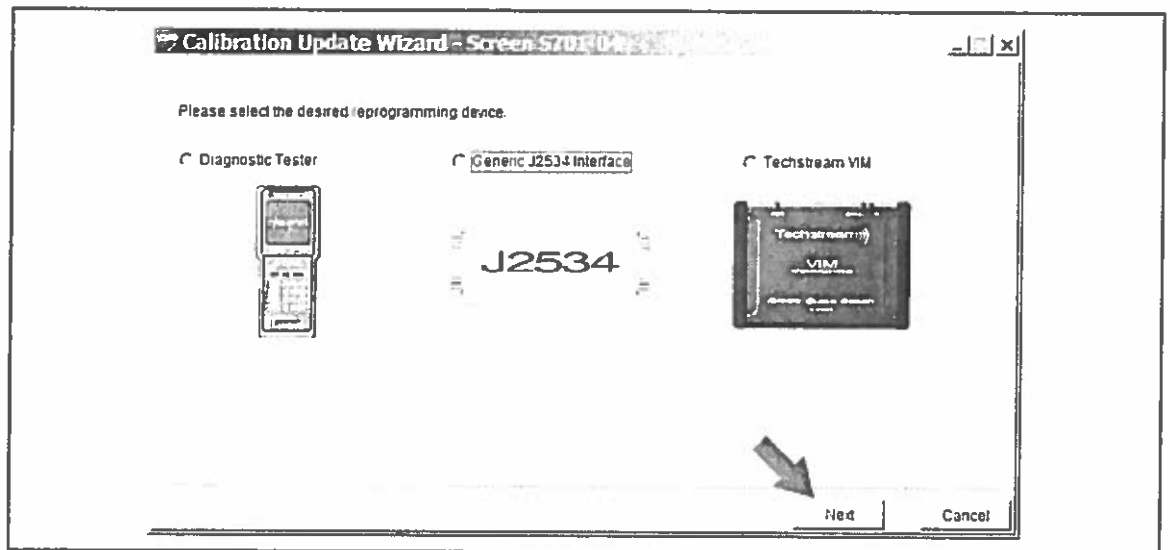
Figure 11.

D. Select the correct reprogramming device.

- If using Techstream 2.0, select "Generic J2534 Interface".
- If using Techstream Lite, select "Generic J2534 Interface".
- If using Techstream, select "Techstream VIM".

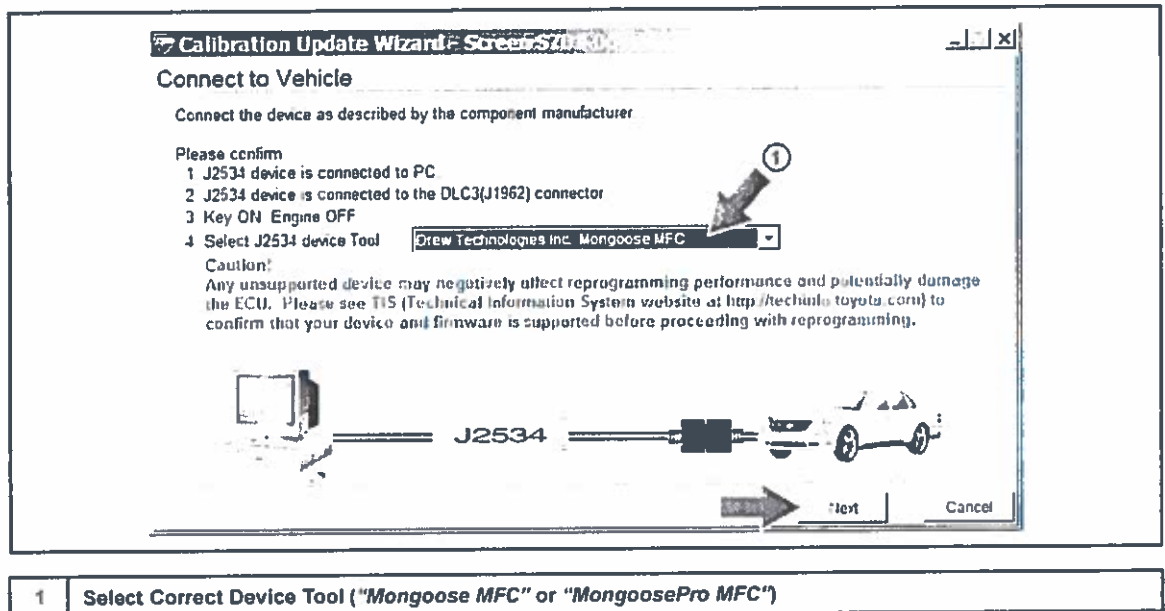
E. Confirm the following:

- PC is connected to VIM.
- VIM is connected to DLC3 connector.
- Ignition is ON and engine is OFF.

Figure 12. Using Techstream 2.0 or Techstream Lite
