SERVICE BULLETIN

2015-2018 MURANO; AUTOMATIC BACK DOOR DOES NOT OPERATE AND RELATED DTCs

APPLIED VEHICLES: 2015-2018 Murano (Z52)

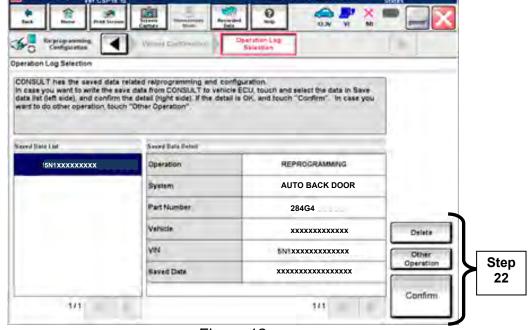
- 22. If the screen in Figure 12 appears, first select **Delete**, then **Confirm**, and then **Other Operation**.
 - This will erase the Saved Data List and restart the reprogram from page 9, step 16.
 You must go back to step 12.
 - If no **Saved Data List** is stored, Figure 13 on the next page will be displayed. Proceed to step 23.
