EL18-007

INFINITI; MICROPHONE DOES NOT WORK

APPLIED VEHICLES: 2018 QX60 (L50)
2018 QX80 (Z62)

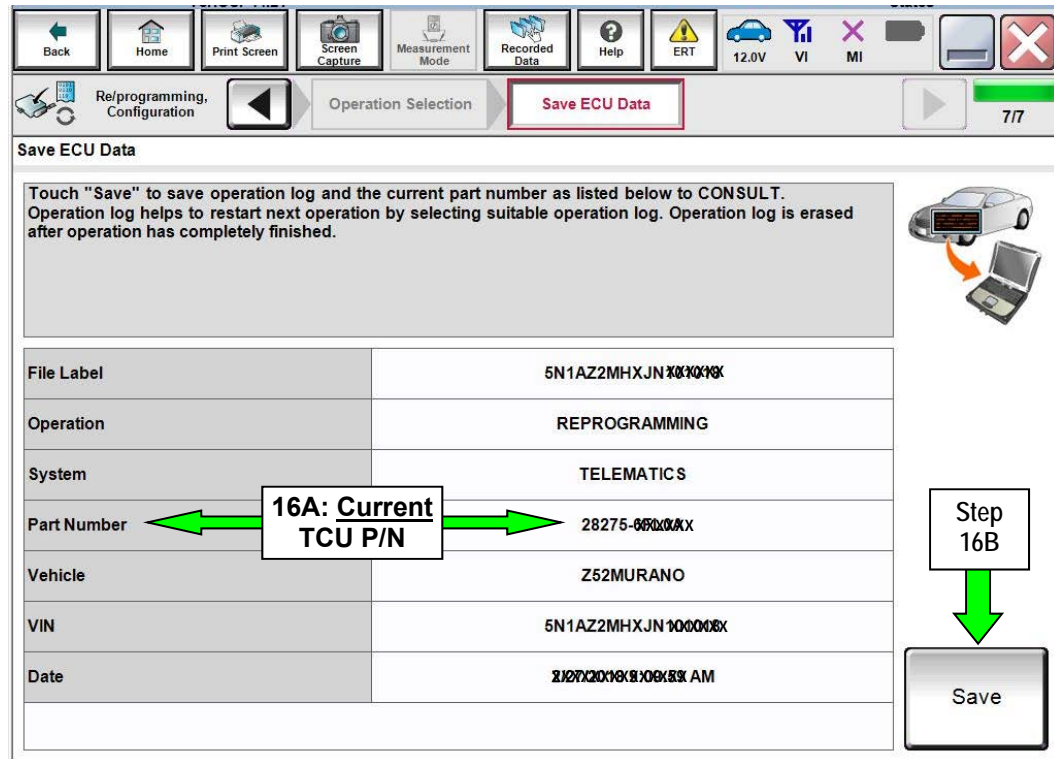
Figure 8

16. When you get to the screen shown in Figure 8, confirm this bulletin applies as follows.

A. Find the TCU Part Number and write it on the repair order.

NOTE: This is the current TCU Part Number (P/N).

B. Compare the P/N you wrote down to the numbers in the **Current TCU Part Number** column in **Table A** below.

- If there is a match, select **Save**, and then continue with the reprogramming procedure on page 7.
- If there is not a match, this bulletin does not apply. Refer to ASIST for further diagnostic and repair information.

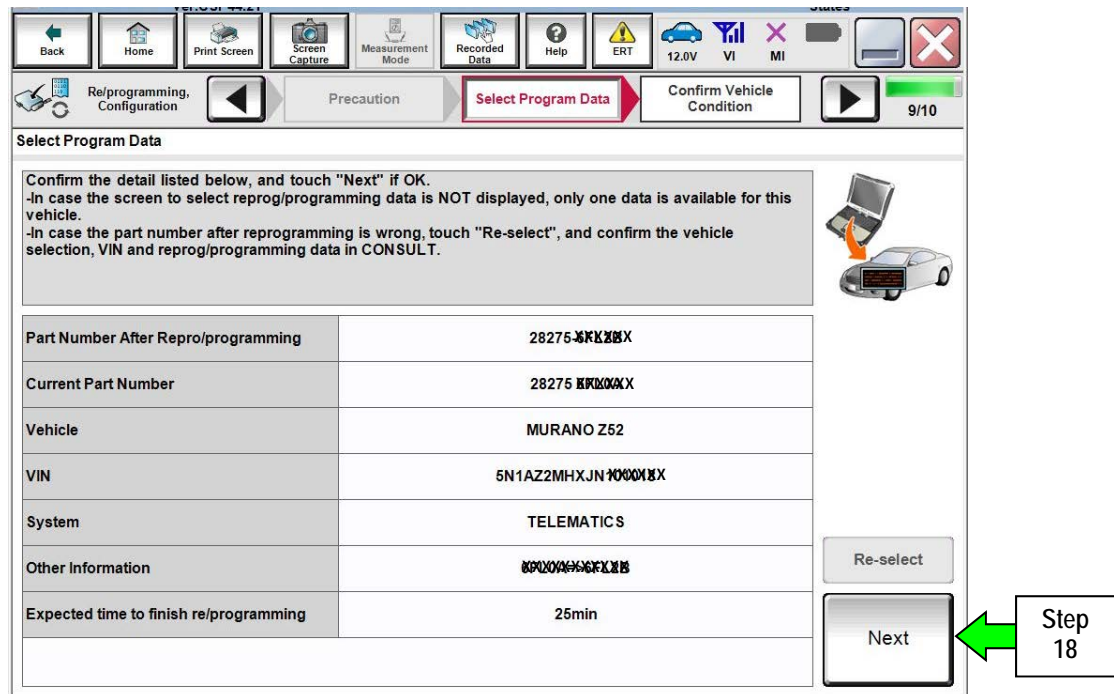
Figure 10

18. Verify the **Current Part Number** and **Part Number After Reprogramming** are different, and then select **Next**.

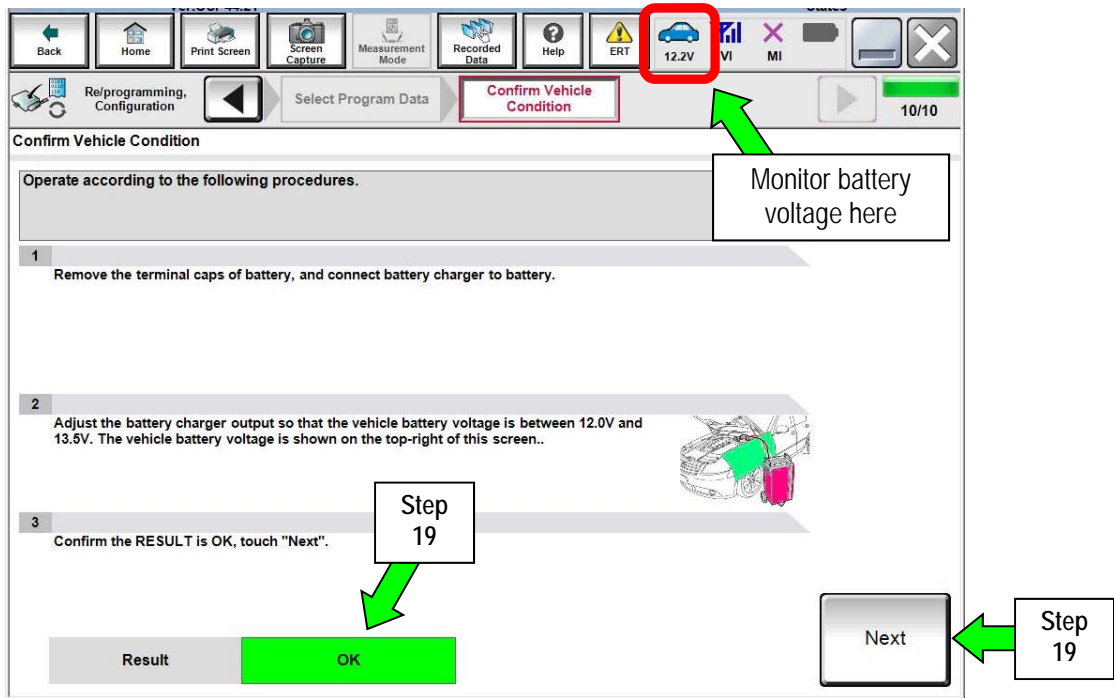
Figure 11

- Verify OK is highlighted green (battery voltage must be between 12.0 and 15.5 volts), and then select Next.

IMPORTANT: Battery voltage must stay between 12.0 and 15.5 volts during reprogramming. If not, reprogramming may be interrupted and the TCU may be damaged.

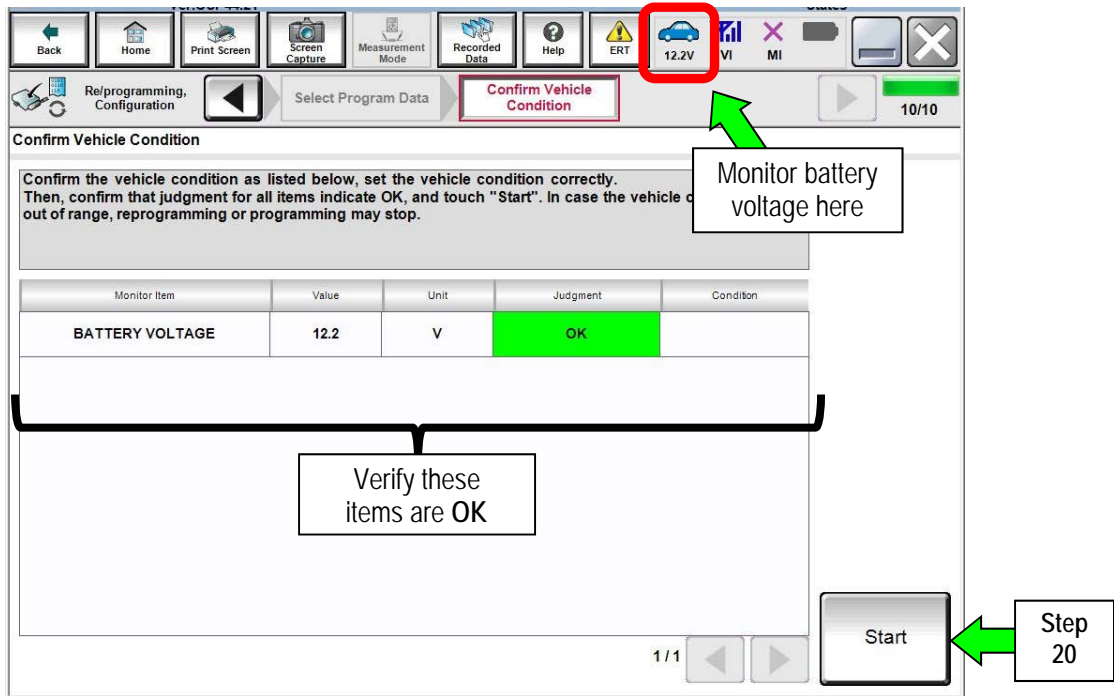
Figure 12

- Verify all items listed under Confirm Vehicle Condition are OK, and then select Start.

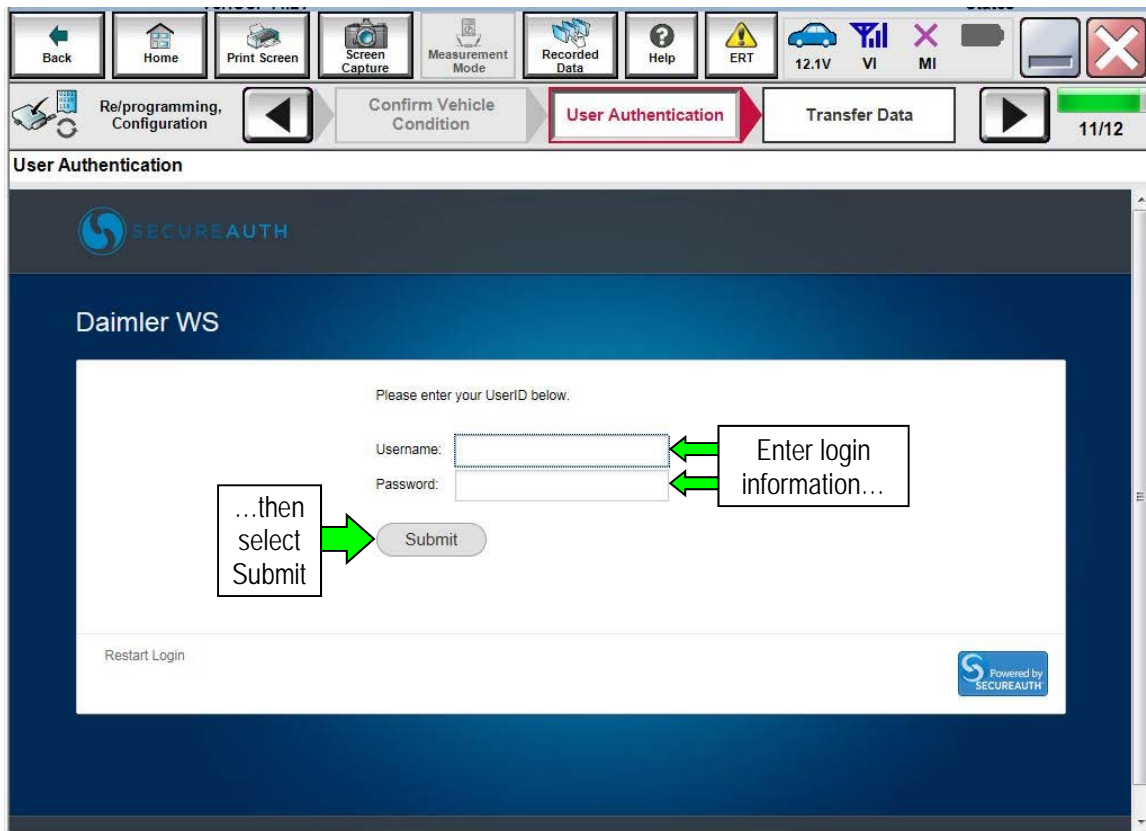
Figure 15

23. Start the reprogramming process by selecting **Submit**.

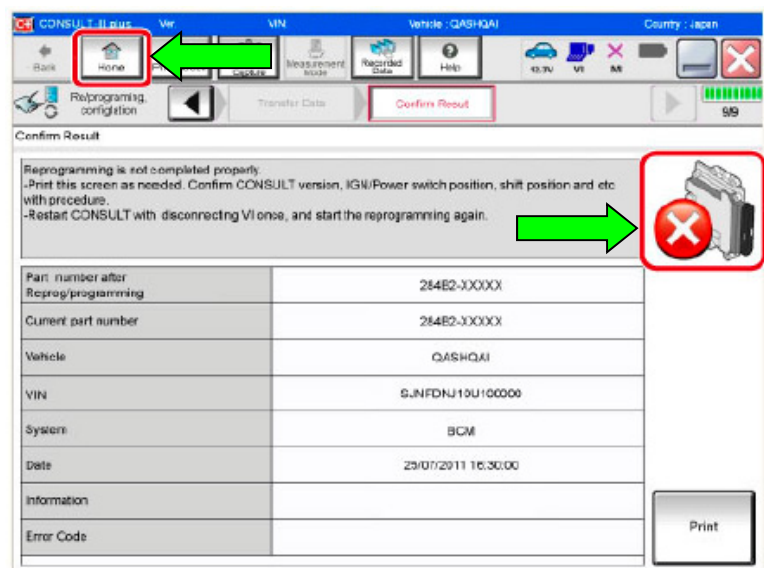
Figure 19

If reprogramming does not complete and the “X” icon displays as shown in Figure 19:

- Check battery voltage (12.0 – 15.5 V).
- CONSULT A/C adapter is plugged in.
- Ignition is ON, engine OFF.
- Transmission is in Park.
- All C-III plus / VI cables are securely connected.
- All C-III plus updates are installed.
- **Select Home, and restart the reprogram procedure from the beginning.**
