09021 Version 3

## MID Displays ACC, CMBS, LKAS, RDM, Brake Warnings and Other Listed Symptoms

Supersedes 17-064, dated September 23, 2017, to revise the information highlighted in yellow

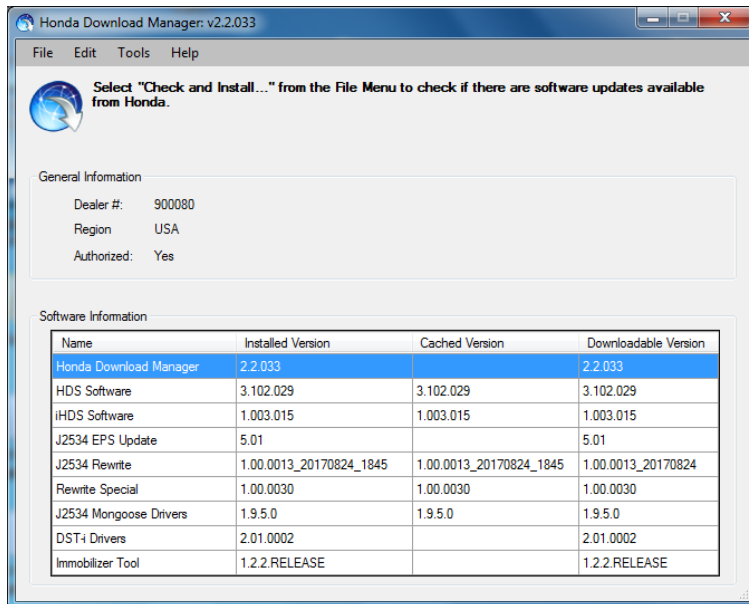
Select Open HDS Download Manager, and use the File pull-down menu to select Check and Install.

NOTE: If you are not connected to the Internet, you will see an error message indicating the i-HDS cannot check for updates; connect to the Internet to make sure you have the latest i-HDS software.

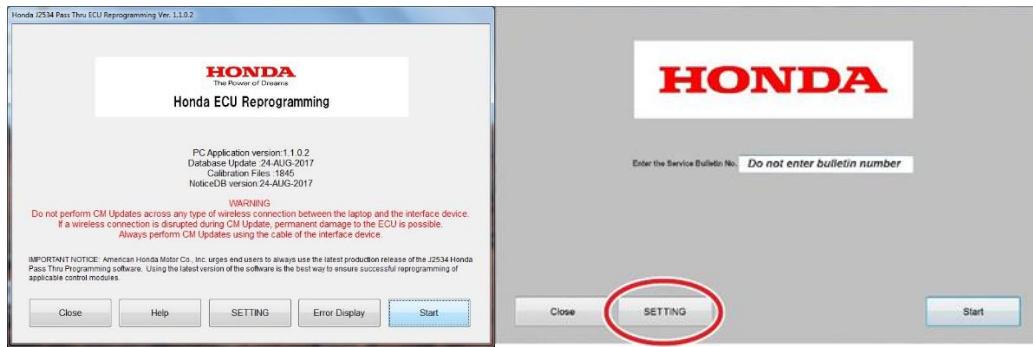
To change this, click on either of the **SETTING** selection buttons at the bottom of the J2534 initial screens as shown.
