ITB16-048c

VOLUNTARY SERVICE CAMPAIGN 2013 JX35 AND 2014 QX60; CVT

CAMPAIGN ID #: PC501
APPLIED VEHICLE: 2013 JX35 (L50)
2014 QX60 (L50)

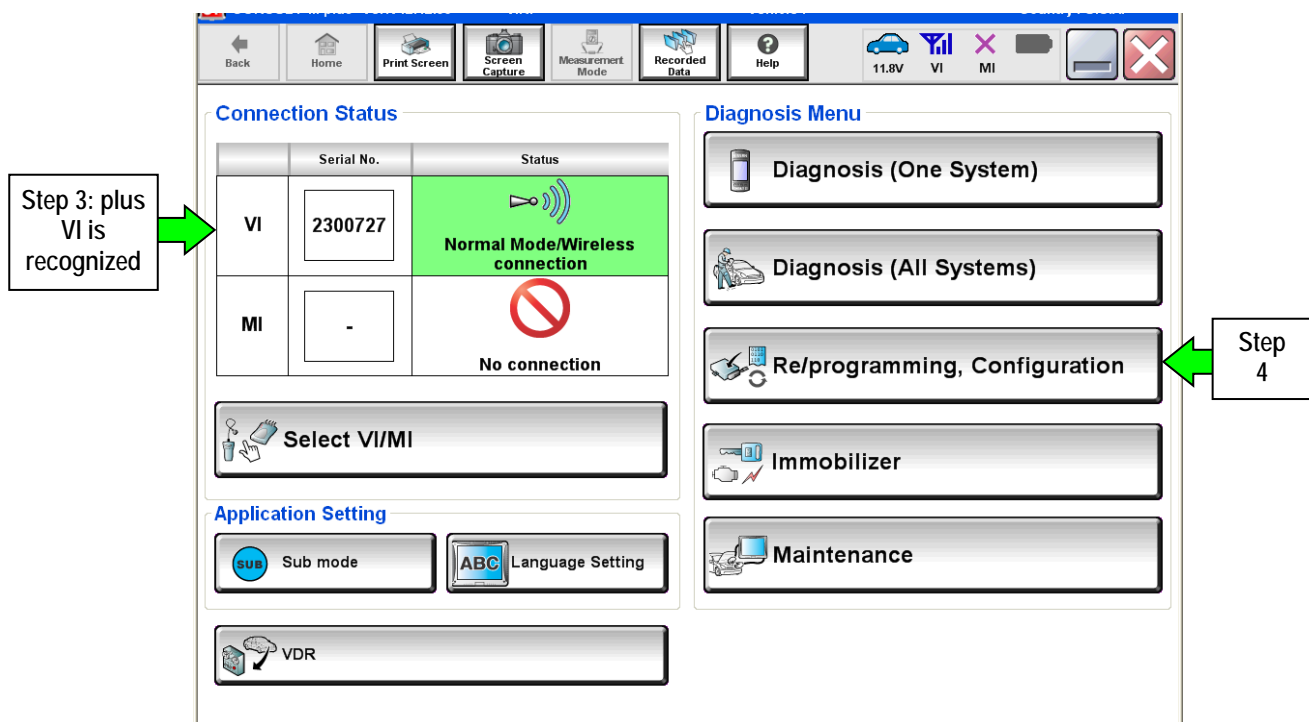
Figure 1

1. Connect the CONSULT PC to the vehicle to begin the reprogramming procedure.
2. Start C-III plus.
3. Wait for the plus VI to be recognized.
 - The serial number will display when the plus VI is recognized.
4. Select **Re/programming, Configuration**.

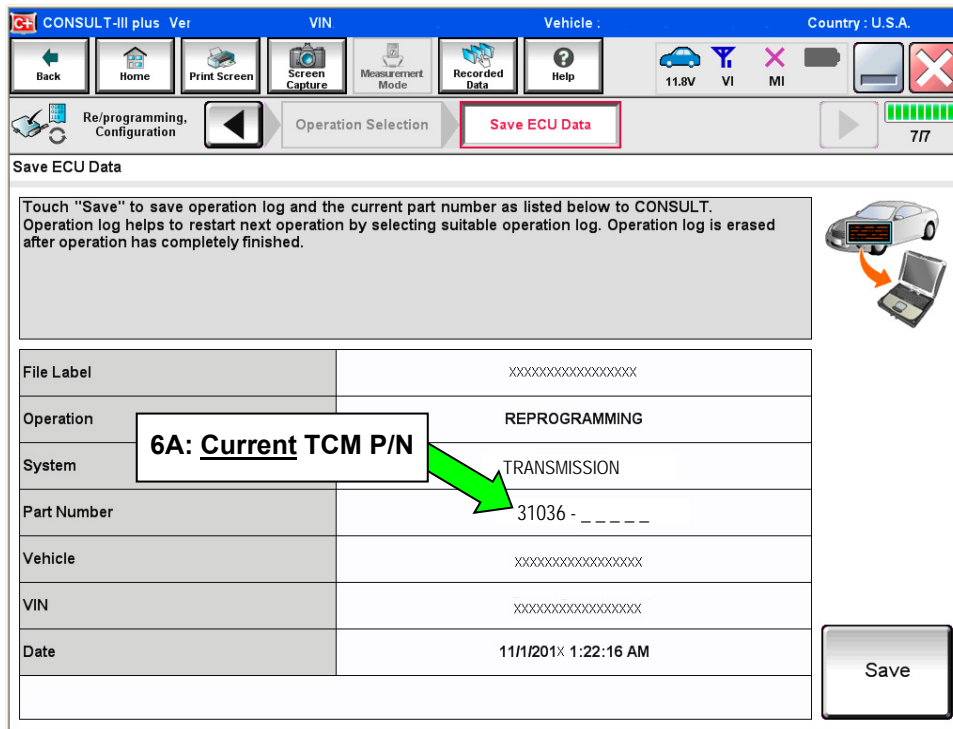
6. When you get to the screen shown in Figure 2, confirm this bulletin applies as follows.

A. Find the TCM Part Number and write it on the repair order.

NOTE: This is the current TCM Part Number (P/N).

5. Follow the on-screen instructions and navigate the C-III plus to the screen shown in Figure 2 on the next page.

B. Compare the P/N you wrote down to the numbers in the **Current TCM Part Number** column in **Table A** below.

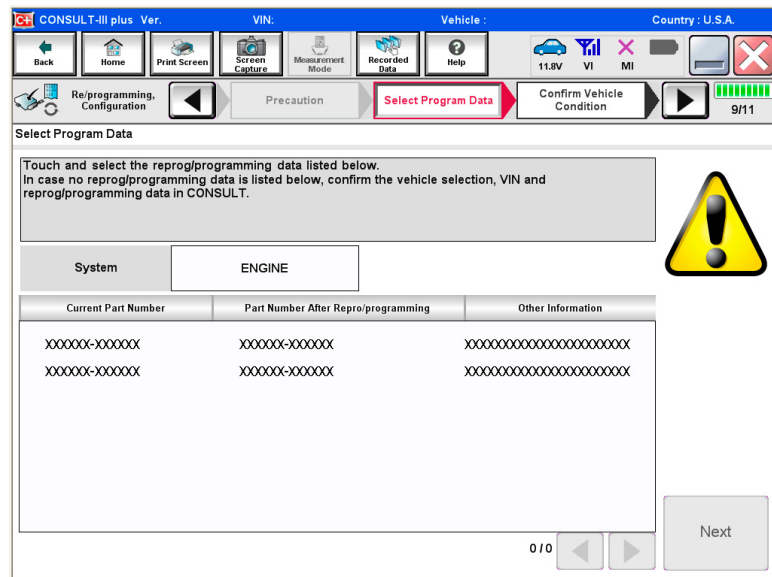
NOTE: In some cases, more than one new P/N for reprogramming is available.

- If more than one new part number is available, the screen in Figure 3 displays.
- Select and use the reprogramming option that **does not** have the message "Caution! Use ONLY with ITBXX-XXX".
- If you get this screen and it is **blank** (no reprogramming listed), it means there is no reprogramming available for this vehicle. Check service COMM to confirm this bulletin applies to the vehicle you are working on.

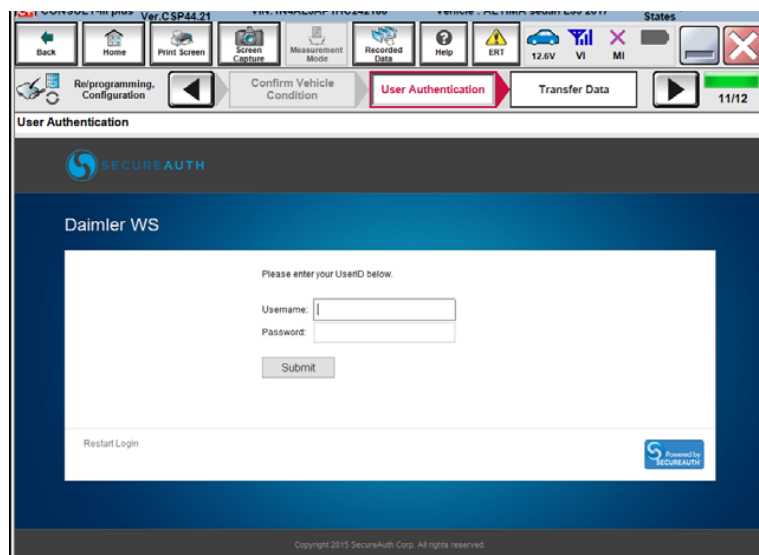
Figure 4

- Before reprogramming will start, you will be required to enter your User Name and Password.
 - The CONSULT PC must be connected to the Internet (Wi-Fi or cable).
 - If you do not know your User Name and Password, contact your Service Manager.

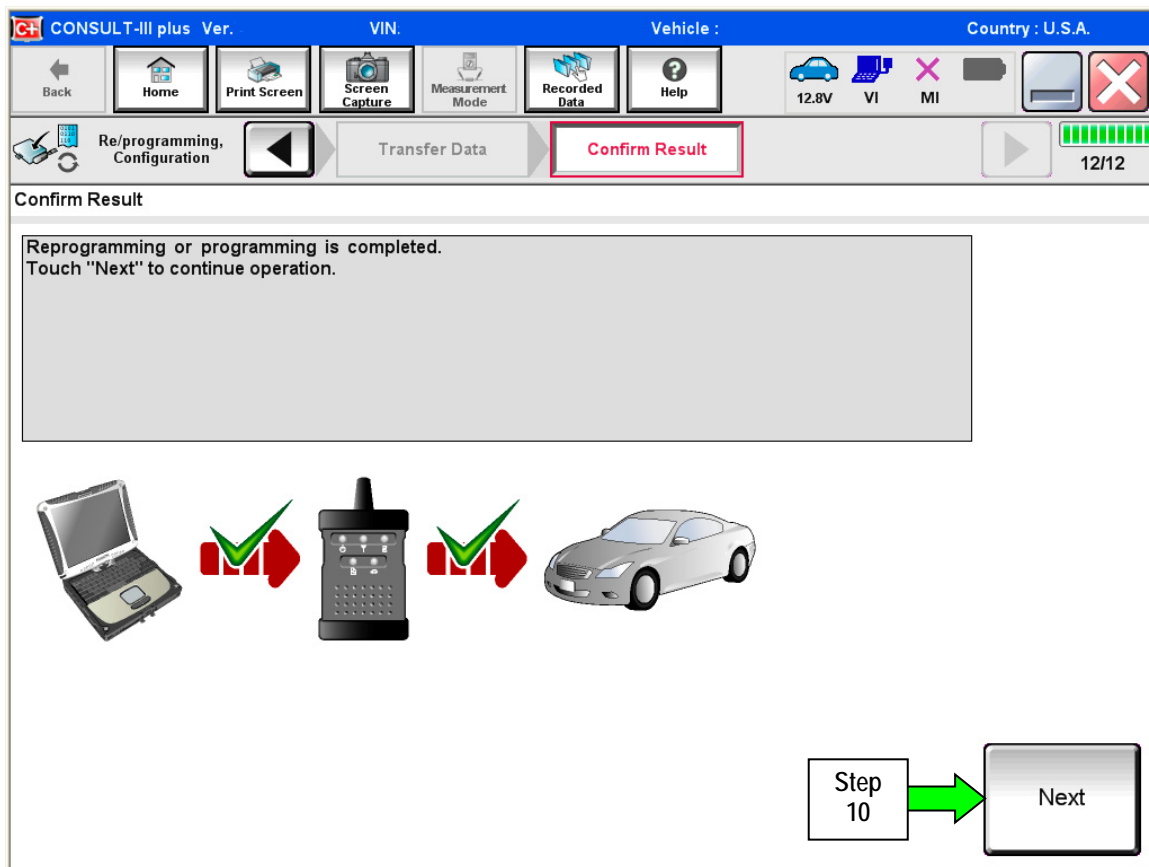
8. When the screen in Figure 5 displays, reprogramming is complete.

NOTE: If the screen in Figure 5 does not display (indicating that reprogramming did not complete), refer to the information on the next page.

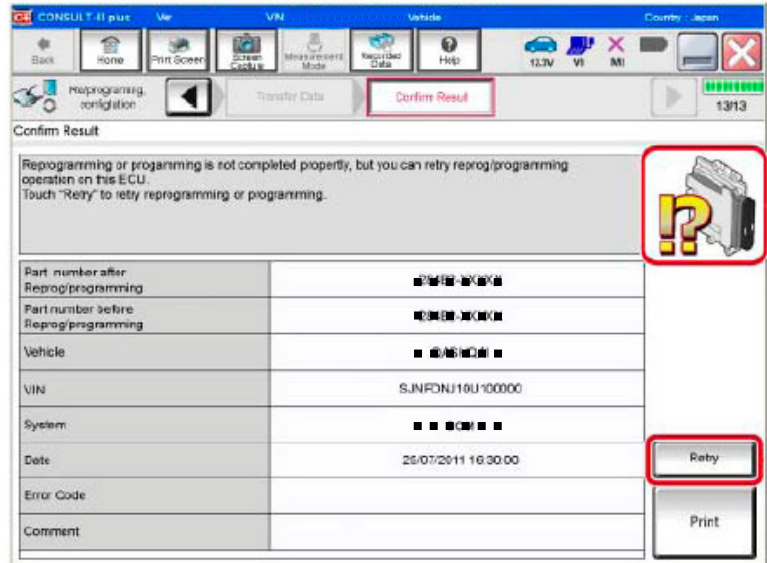
Figure 6

If reprogramming does not complete and the “!?” icon displays as shown in Figure 6:

- Check battery voltage (12.0–15.5 V).
- Ignition is ON, engine OFF.
- External Bluetooth® devices are OFF.
- All electrical loads are OFF.
- Select retry and follow the on screen instructions.
- “Retry” may not go through on first attempt and can be selected more than once.

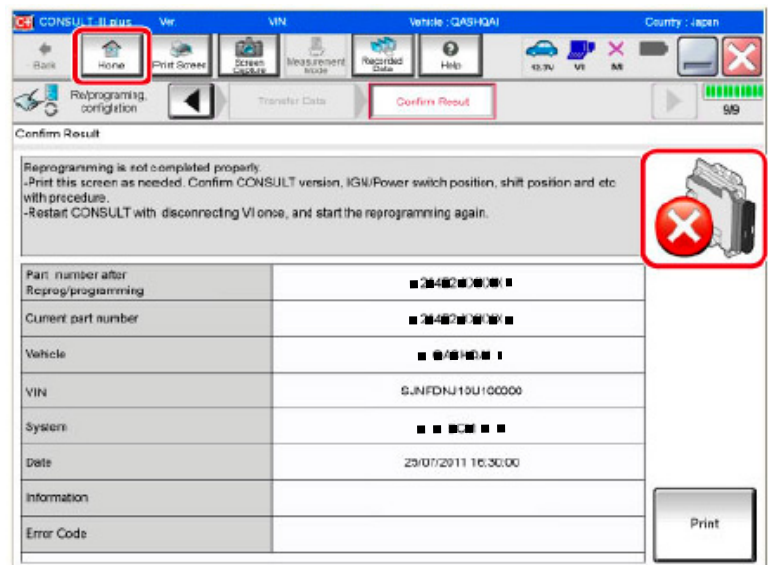
Figure 7

If reprogramming does not complete and the “X” icon displays as shown in Figure 7:

- Check battery voltage (12.0 – 15.5 V).
- CONSULT A/C adapter is plugged in.
- Ignition is ON, engine OFF.
- Transmission is in Park.
- All C-III plus / VI cables are securely connected.
- All C-III plus updates are installed.
- Select Home, and restart the reprogram procedure from the beginning.

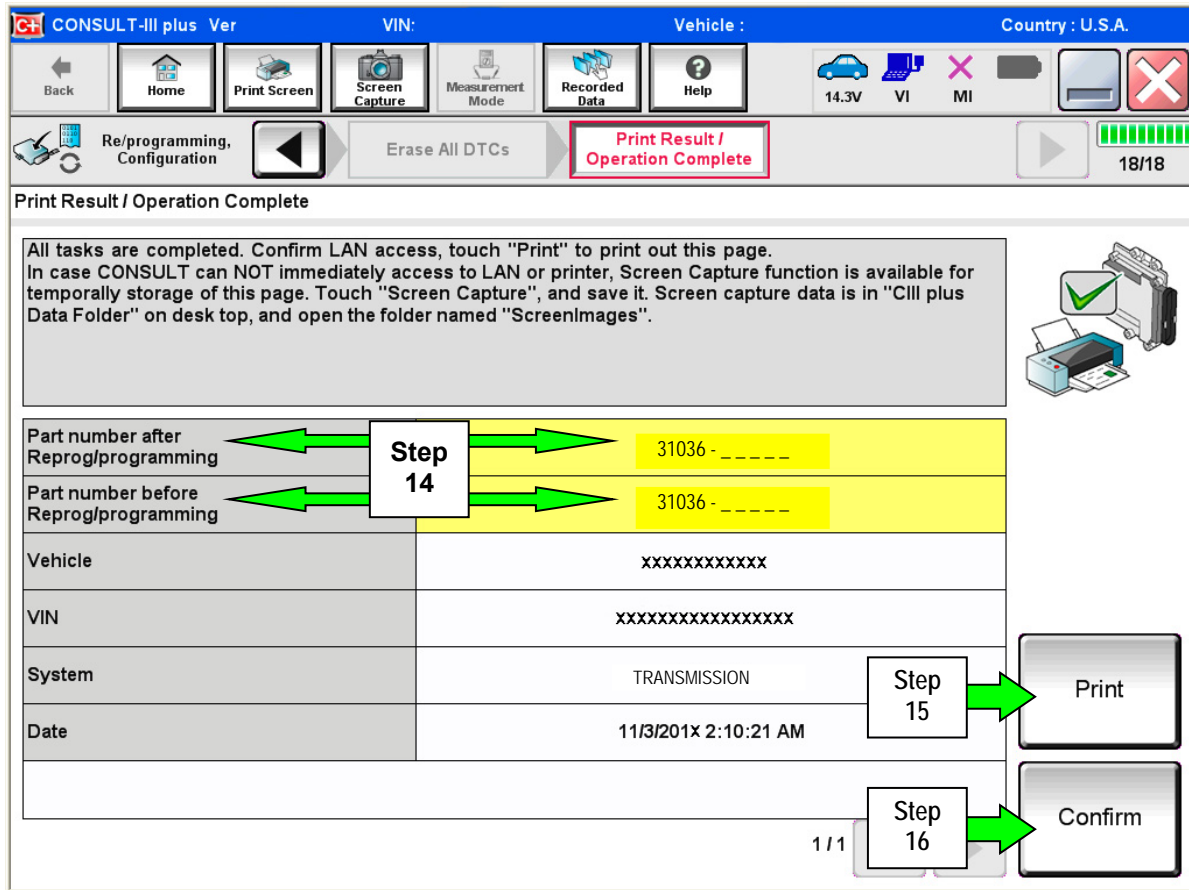
11. Follow the on-screen instructions to **Confirm Shift Lever Position Display**.
12. Follow the on-screen instructions to **Erase DTCs**.
13. When the entire reprogramming process is complete, the screen in Figure 8 will display.
14. Verify the before and after part numbers are different.
15. Print a copy of this screen (Figure 8) and attach it to the repair order for warranty documentation.
16. Select **Confirm**.
