EC18-009a

2017-2018 QX60; MIL ON WITH DTC P219F

APPLIED VEHICLES: 2017-2018 QX60 (L50)
APPLIED ENGINE: VQ35DD (direct injection)

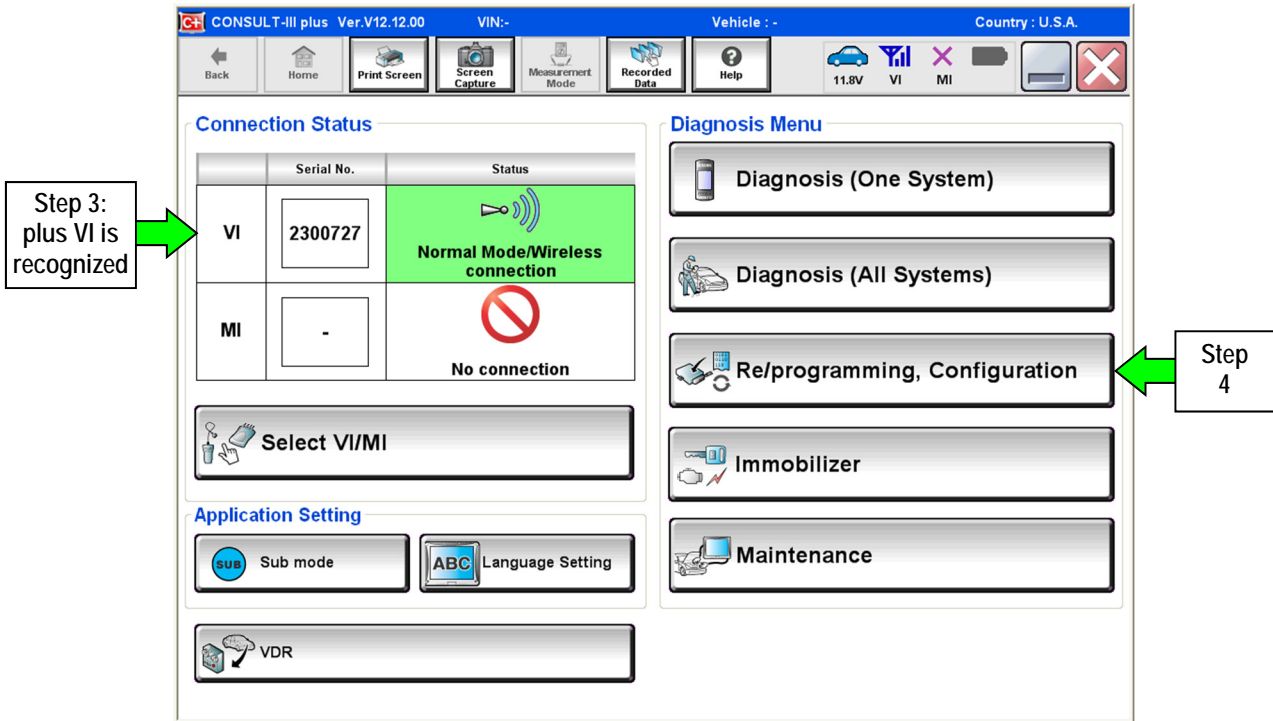
1. Connect the CONSULT PC to the vehicle to begin the reprogramming procedure.
2. Start C-III plus.
3. Wait for the plus VI to be recognized.
 - The serial number will display when the plus VI is recognized.
4. Select **Re/programming, Configuration**.

- In some cases, more than one new P/N for reprogramming is available.
 - In this case, the screen in Figure 1 displays.
 - Select and use the reprogramming option that **does not** have the message “Caution! Use ONLY with ITBXX-XXX”.
- If you get this screen and it is blank (no reprogramming listed), it means there is no reprogramming available for this vehicle. Close C-III plus and refer back to ASIST for further diagnosis.

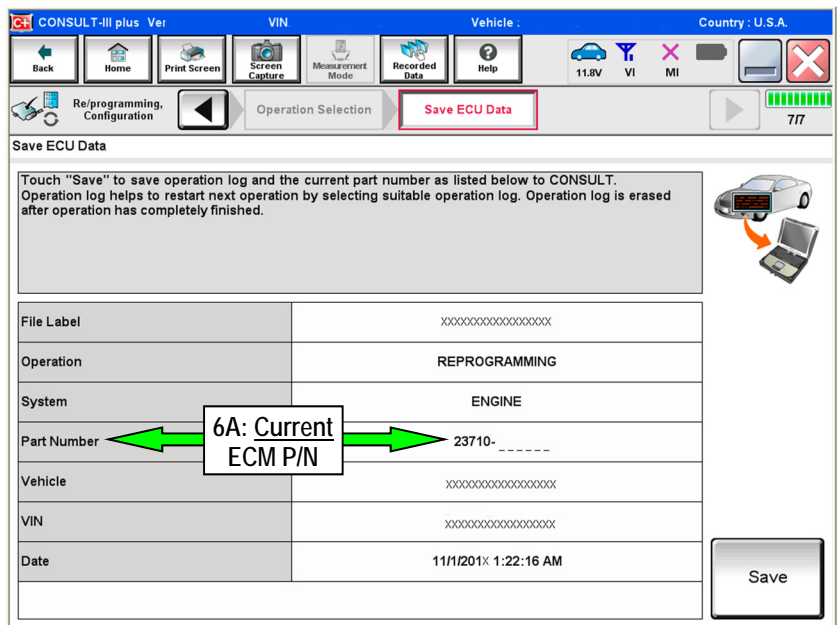
6. When you get to the screen shown in Figure 2, confirm this bulletin applies as follows:

A. Find the ECM **Part Number** and write it on the repair order.

NOTE: This is the current ECM Part Number (P/N).

5. Follow the on-screen instructions and navigate C-III plus to the screen shown in Figure 2 on the next page.

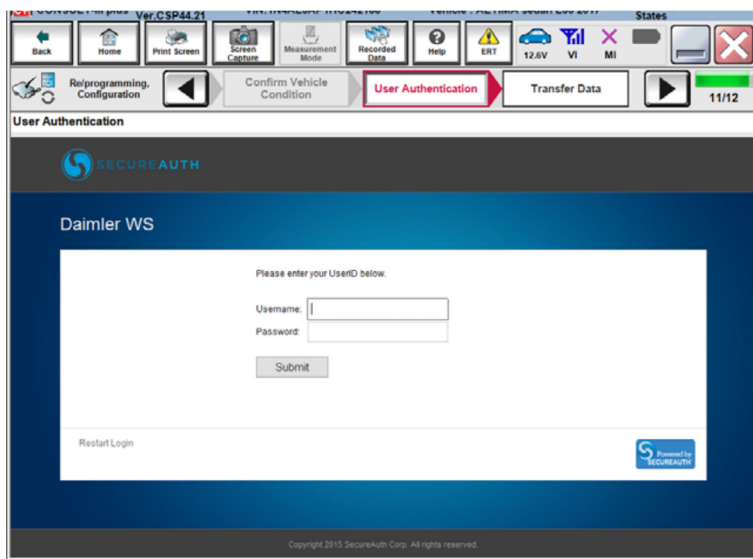
Figure 4

- Before reprogramming will start, you will be required to enter your User Name and Password.
 - The CONSULT PC must be connected to the Internet (Wi-Fi or cable).
 - If you do not know your User Name and Password, contact your Service Manager.

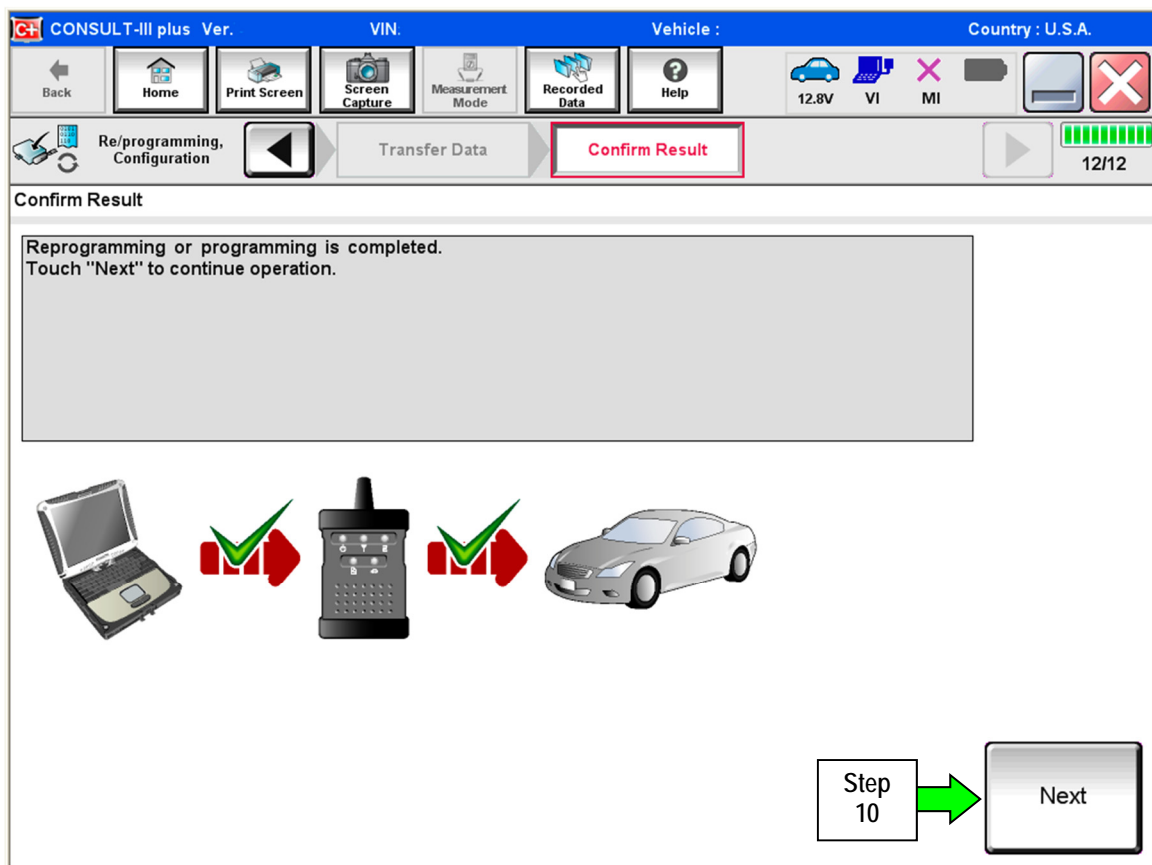
8. When the screen in Figure 5 displays, reprogramming is complete.

NOTE: If the screen in Figure 5 does not display (indicating that reprogramming did not complete), refer to the information on the next page.

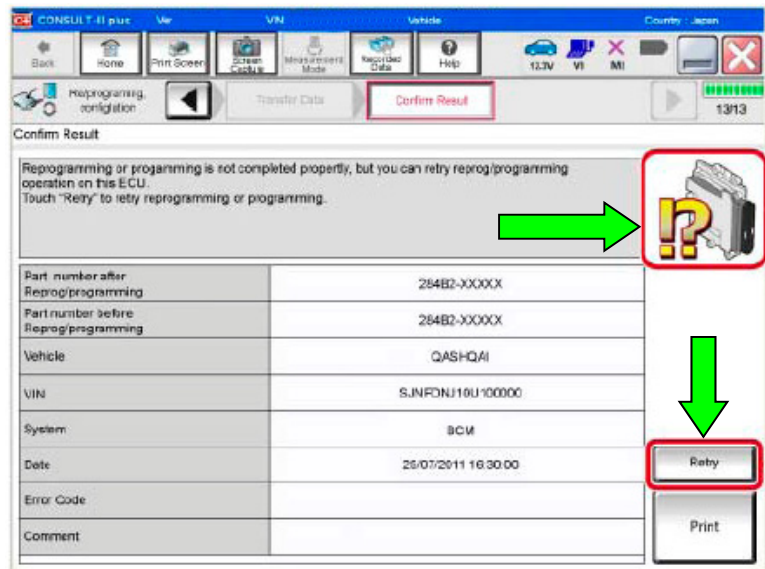
Figure 6

If reprogramming does not complete and the “!” icon displays as shown in Figure 6:

- Check battery voltage (12.0–15.5 V).
- Ignition is ON, engine OFF.
- External Bluetooth® devices are OFF.
- All electrical loads are OFF.
- Select retry and follow the on screen instructions.
- “Retry” may not go through on first attempt and can be selected more than once.

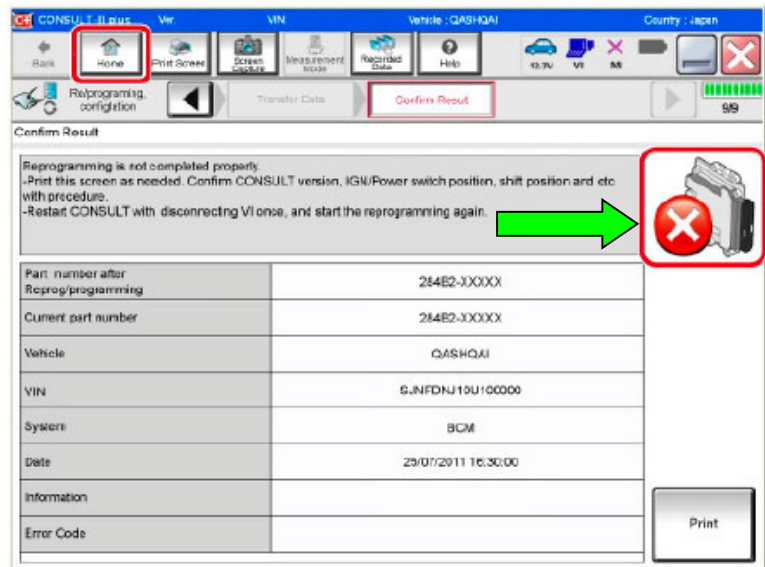
Figure 7

If reprogramming does not complete and the “X” icon displays as shown in Figure 7:

- Check battery voltage (12.0 – 15.5 V).
- CONSULT A/C adapter is plugged in.
- Ignition is ON, engine OFF.
- Transmission is in Park.
- All C-III plus / VI cables are securely connected.
- All C-III plus updates are installed.
- Select Home, and restart the reprogram procedure from the beginning.

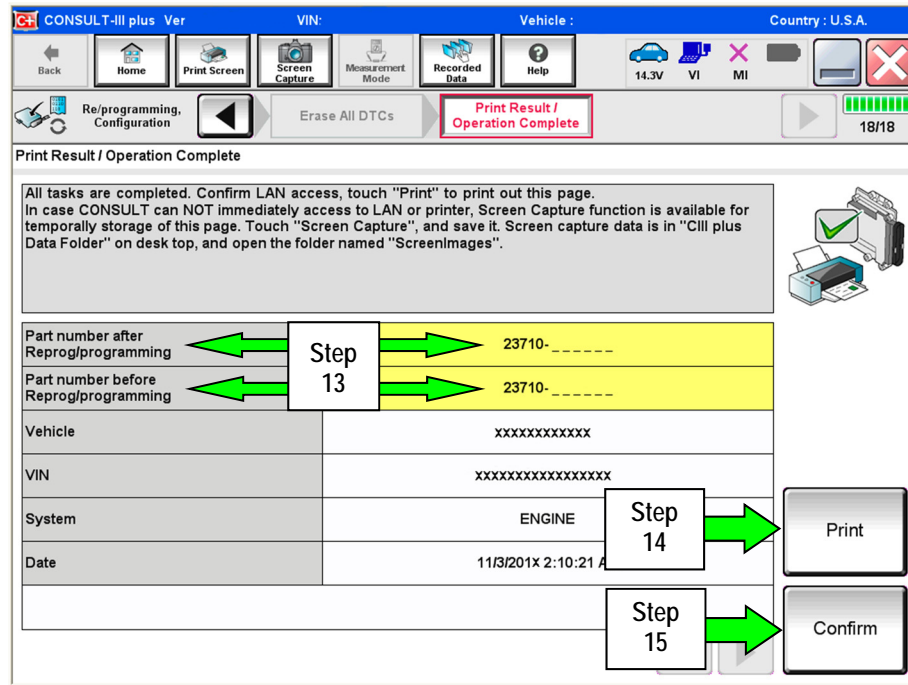
12. When the entire reprogramming process is complete, the screen in Figure 8 will display.
13. Verify the before and after part numbers are different.
14. Print a copy of this screen (Figure 8) and attach it to the repair order for warranty documentation.
15. Select Confirm.
