Volvo Models

Volvo Model	VNR, VNX, VNL, VHD, VAH
Engine family	
Engine family	11L Engine, 13L Engine
Emission Standa	rd
Emission Standard	US17 GHG
** SOLUTION **	
Title	Volvo Chassis - Vehicles Equipped With A Vertical Selective Catalytic Reduction (SCR) System - Diagnostic Trouble Codes (DTC) P1031 With Possible P24DA Lighting The Malfunction Indicator Lamp (MIL) - US17+OBD16 (GHG17, Common Rail Fuel System) Emissions, Commonly Model Year 2018
Cause	Fault Code P1031 - Particulate Matter (PM) Sensor Clogged Tip may occur in GHG17 vehicles that are equipped with a vertical SCR catalyst. P1031 may be accompanied by P24DA - PM Sensor Exhaust Sample Error. When the Confirmed DTC status is checked in Detailed Fault Information from the Diagnose screen in Premium Tech Tool (PTT), status will show True.
Solution	DO NOT Replace the PM sensor for P1031 and/or P24DA prior to performing the steps below.

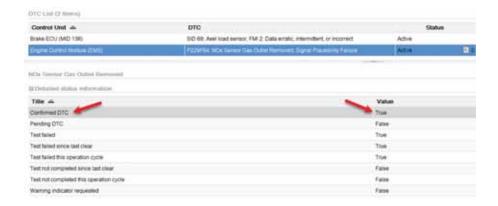
Review the Detailed Status Information for the relevant code on the DTC Readout.
